The Collapse of the Cypress Viaduct During the Loma Prieta Earthquake of October 17, 1989

Mohamed M. Eid

This study includes investigations about the Cypress Viaduct collapse reported by:

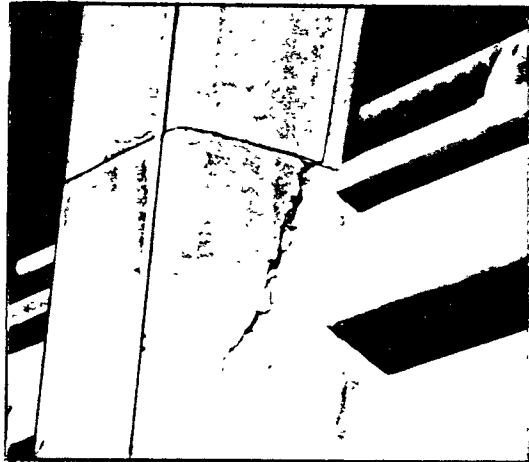
Bents 32–55 were B1 bents which remained standing after the earthquake. However, some bents showed significant cracking in the lower girder-to-column joint region (Figure 1.8)

Figure 1.8 Cracking Below the West Shear Key, Bent 55

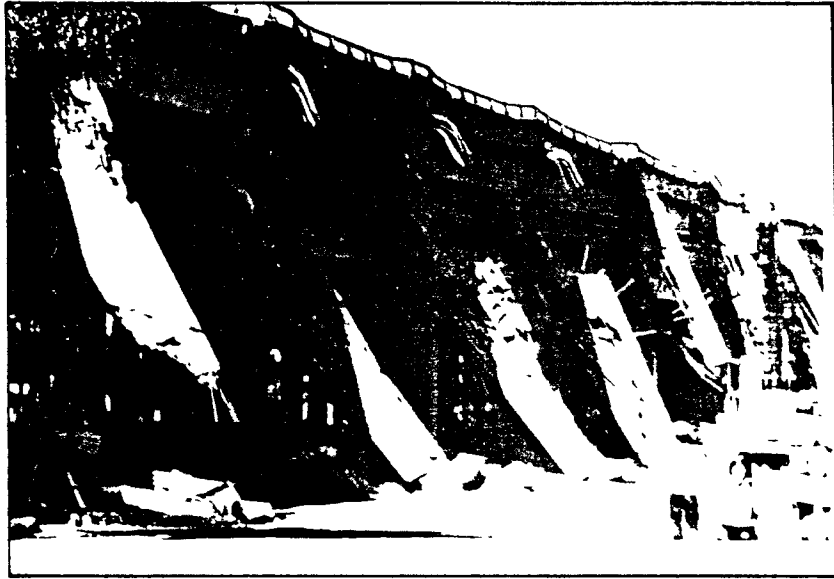
The upper girder-to-column joints suffered varying amount of damage. In some instance, the joint region failed completely and the column was lying on the ground. In other cases, the column hung from remnants of the nearly destroyed upper joints (Figures 1.10–1.12).

Figure 1.10 The Collapse Between Bents 84 and 90

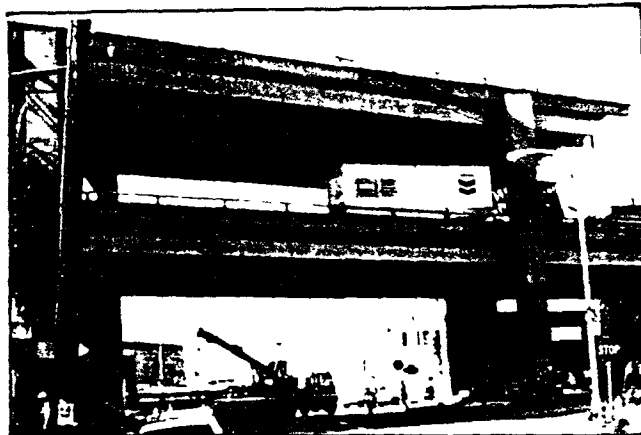
Figure 1.19 View of the Standing Bents 96 and 97

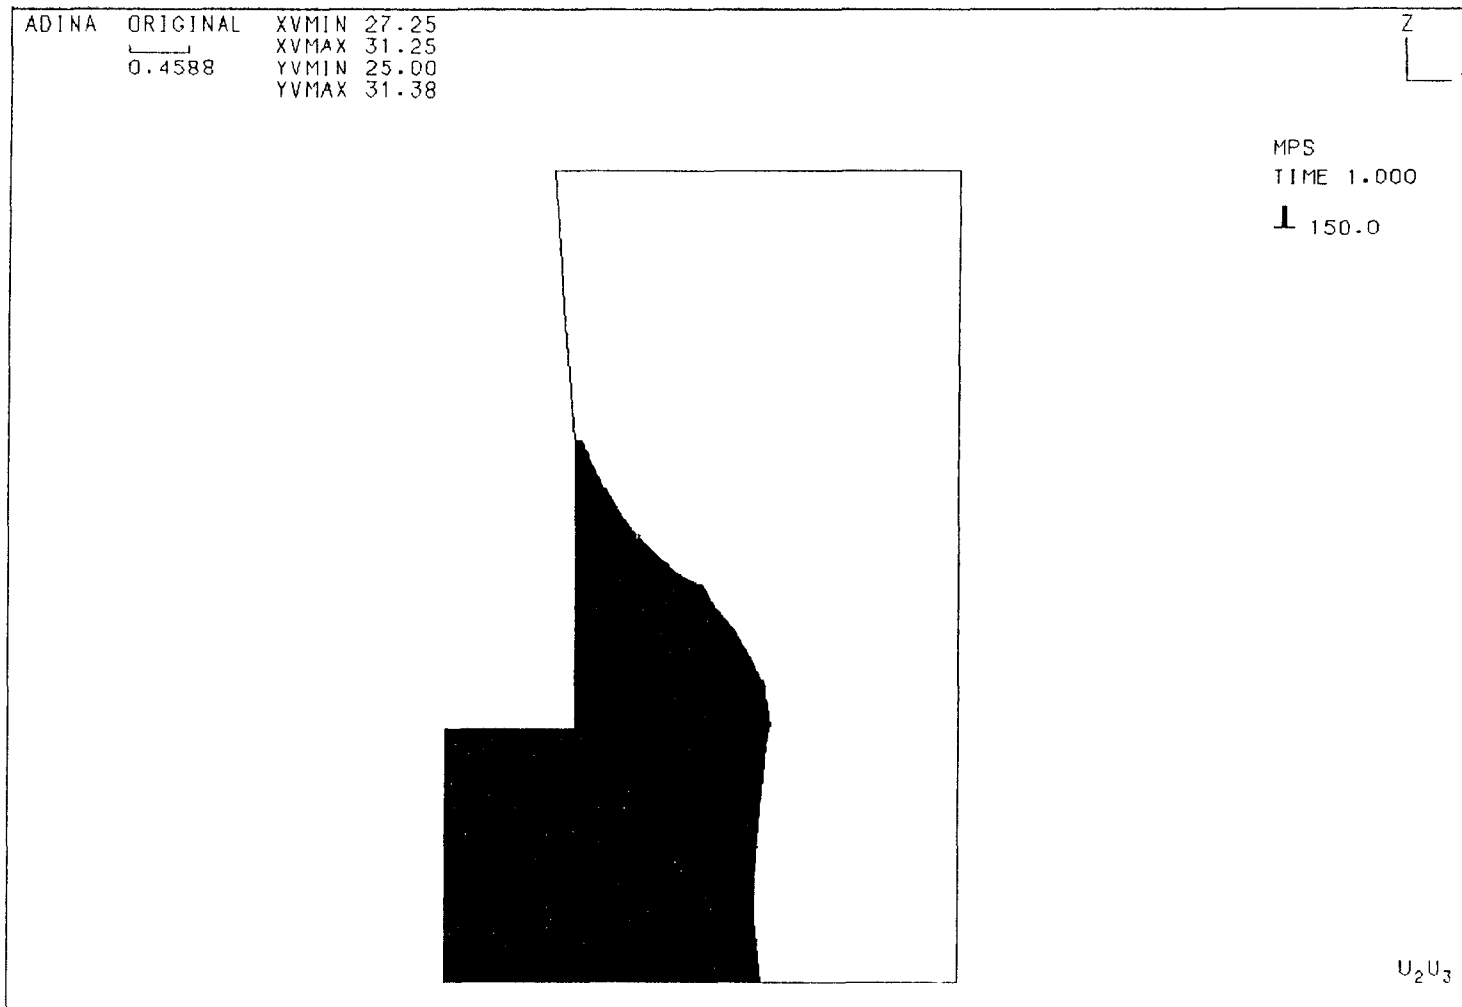
From above, the maximum seismic shear force (604 kips) would not cause flexural failure at section 1–1 or section 3–3 or cause shear transfer failure at section 1–1. But it would cause shear failure at section 2–2 and extensive flexural cracking at sections 1–1 and 3–3. It would also cause steel yielding at section 3–3.

Figure 4.42 Tensile Stresses in Lower Girder-to-Column Joint

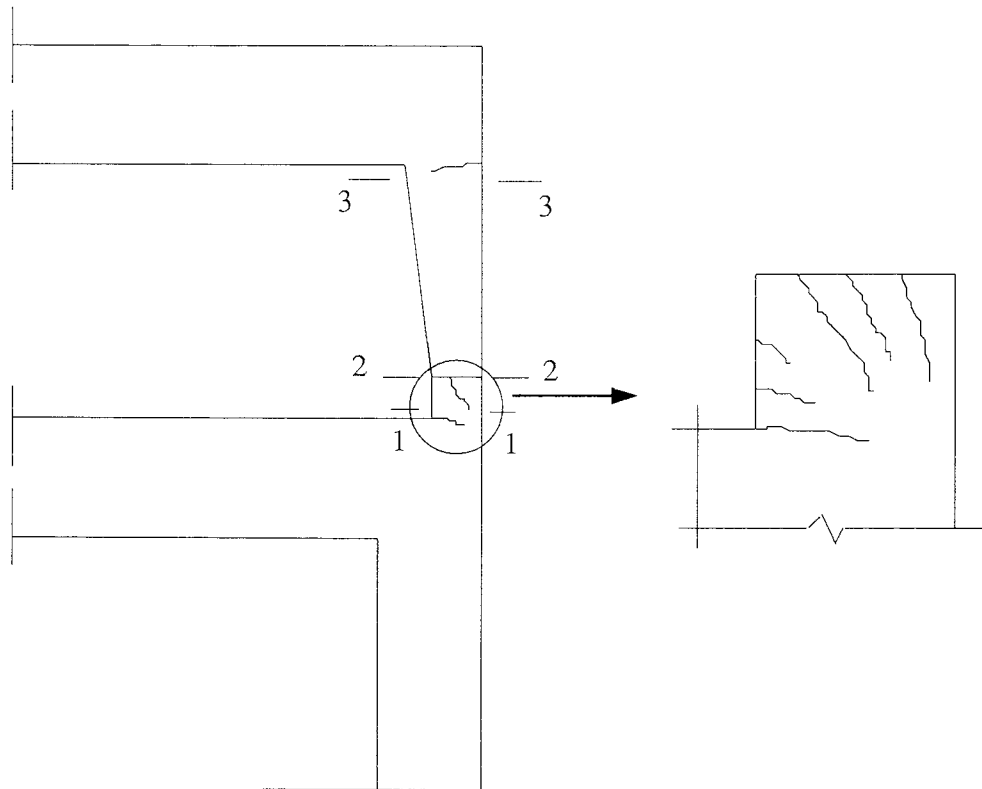
The pedestals (the part of the upper columns below the shear keys) on both sides of the bent suffered shear failure at section 2-2 and extensive flexural cracking at section 1-1 (Figure 4.45). This enabled the gravity load of the upper story to push the pedestals down and away (laterally) from the bent causing the upper deck to fall down on top of the lower deck as shown in Figure 4.46. The collapse appeared to be perfectly vertical due to the fact that the lateral displacement of the upper deck was small. The extensive cracking at section 3-3 (both sides of the section) allowed rotation of the upper columns at that location, suggesting that the upper columns pushed the pedestals in an inclined direction away from the bent.

Figure 4.45 Damage to B1 Bents

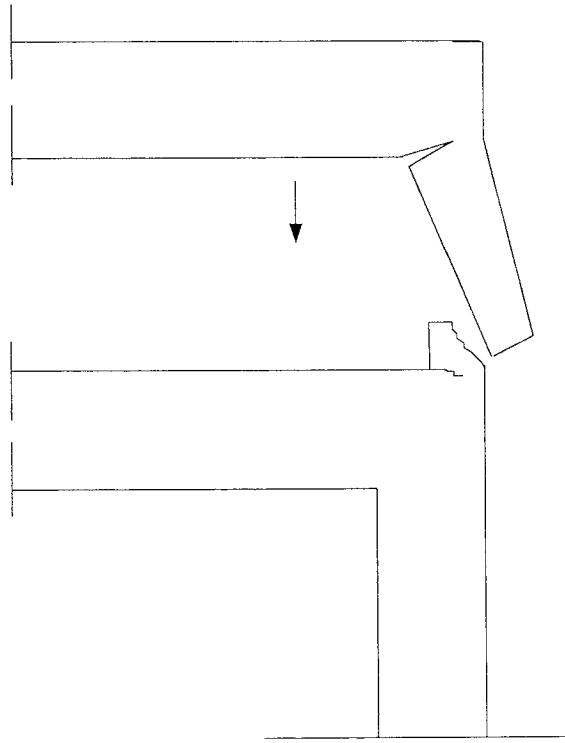
Figure 4.46 Collapse of B1 Bent

The maximum seismic axial force in the upper columns due to the vertical component of the ground motion is 70 kips = $0.025W$ = 1/10 of the gravity loads resisted by upper column, which is insignificant to cause vertical failure. But this might have contributed to pushing the pedestals downward.
