ATTACHMENT SYSTEMS FOR CURTAIN
WALL CONSTRUCTION
AND
MAINTENANCE REQUIREMENTS

A Thesis
Submitted to The Faculty of
New Jersey Institute of Technology
in Partial Fulfillment of the Requirements for the Degree of
Master of Science in Civil Engineering

Department of Civil and Environmental Engineering
October 1993

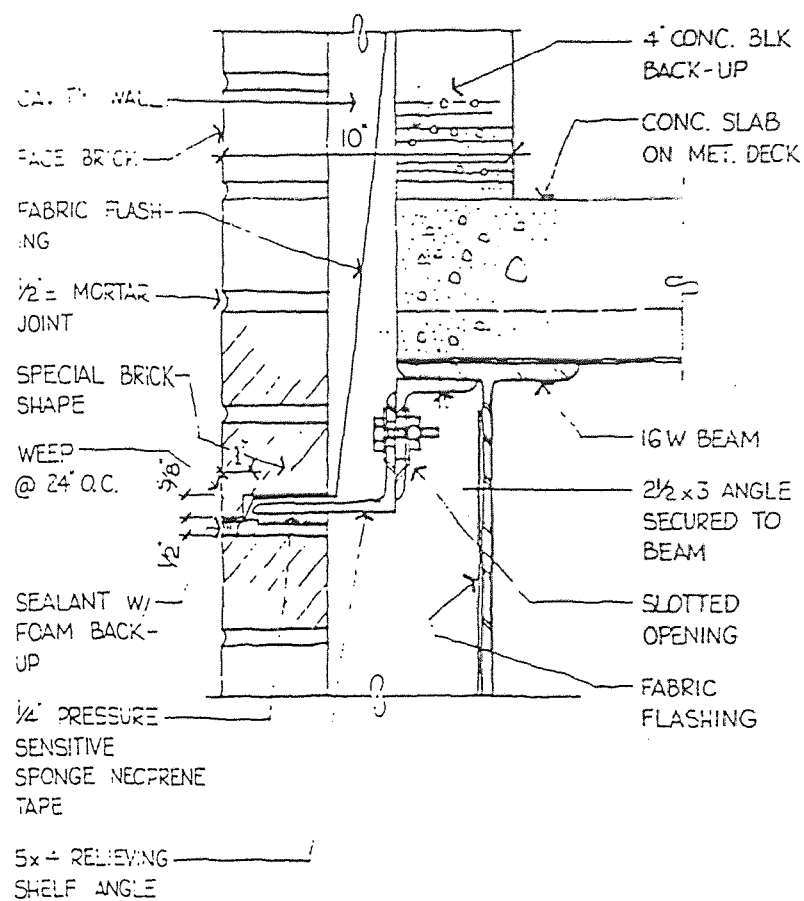
Figure 1.2 Brick Relieving Angle (3)

It should be noted that many brick veneer walls and stone clad buildings, seen commonly in New York City, are also curtain wall type construction. It is possible that some analogies can be drawn between these types of structure (see figure 1.2 and 1.3). The cavity wall construction consists of a block back up separated from the brick veneer by a cavity. The block back up bears directly on the concrete floor slab and the brick veneer is supported by steel relieving angles which are bolted and/or welded to the structural steel spandrel beam. In some instances, the relieving angle may be attached directly to the concrete by means of inserts or anchors (discussed in Chapter 4). Figure 1.3 outlines the special attachment system that is required above openings. In this case, the relieving angle is attached to the structure using bolted angles which are "hung" from the structural steel.

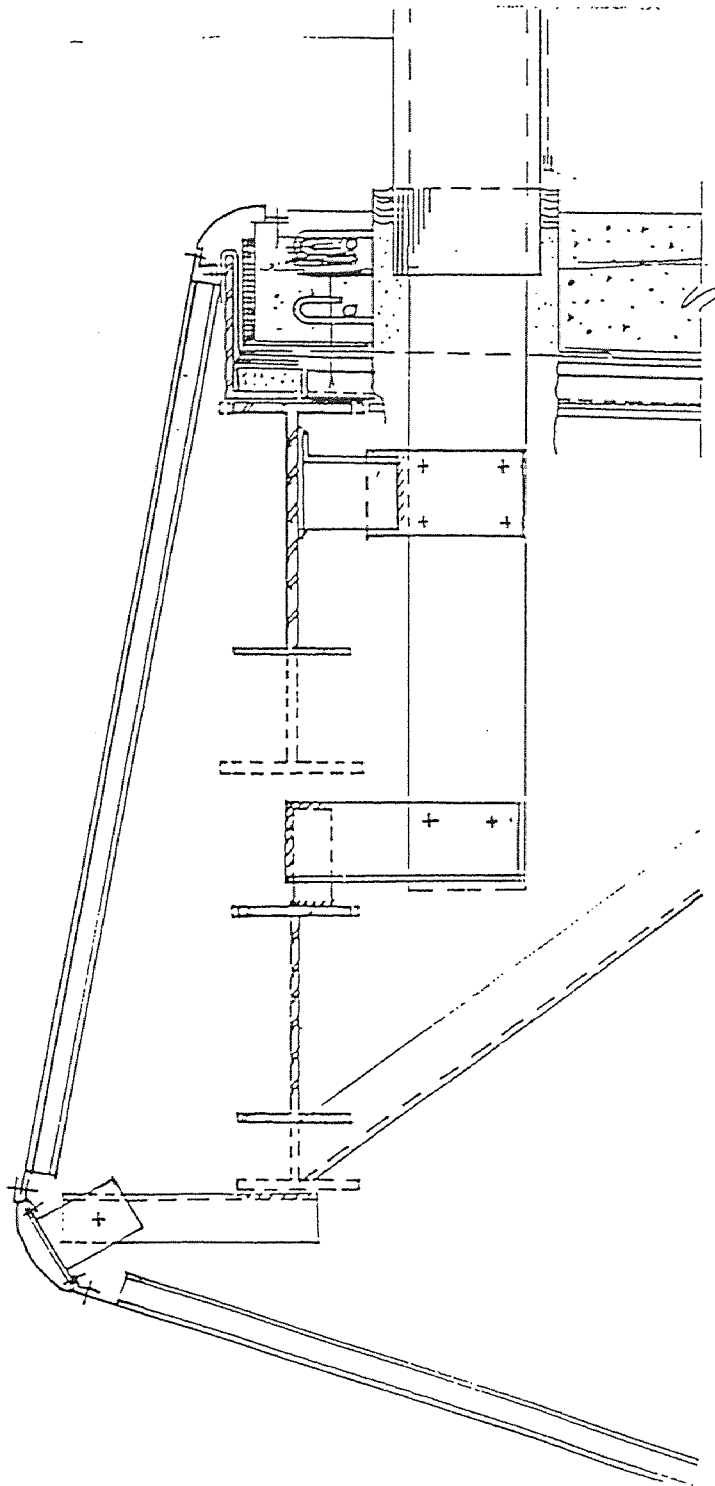
Figure 1.4 Attachment System for Extruded Aluminum Panels

On July 1, 1992, during approximately fifty mile per hour winds, two extruded aluminum panels (12'x4') became detached from the 57th floor of a building in mid-town Manhattan. These were attached to the structure by means of angle clips and were bolted with ferrous metal anchors (see figure 1.4). During this occurrence, there were no injuries and no damage to surrounding buildings.

Section 1.4 details the failure of Aluminum panels atop the Pan Am building in Manhattan, (see figure 1.4). A caulked joint at the top of the panel failed and subsequently caused the failure of the whole system. Water infiltrated behind the panels and caused galvanic action between the steel screws and the aluminum panel. It was found that many of the spacers installed at the angle were completely deteriorated.

A Stud Weld system was designed to re-attach the top of the panel to the structural steel, (see figure 6.3). These were drilled directly through the panel and welded to the structural steel behind. The success of this system can be measured by the fact that New York has endured two 100 miles per hour storms in the latter part of 1992. (Note; these panels failed during 50 mph winds). However, inspection and repair will be extremely difficult and expensive at some future date.

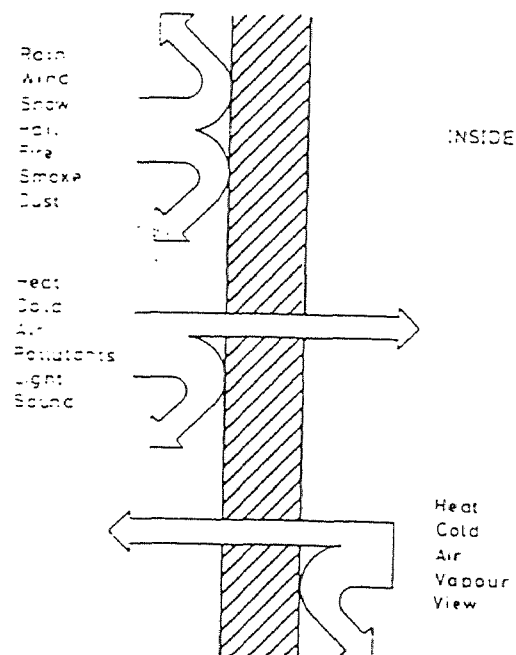
Figure 2.1 Functional Requirements of a Curtain Wall (3)

Curtain walls are designed to meet basic functional requirements (see figure 2.1).

1. Separate exterior from interior.
2. Provide selective filter (windows and doors).
3. Make Building weatherproof and windproof.

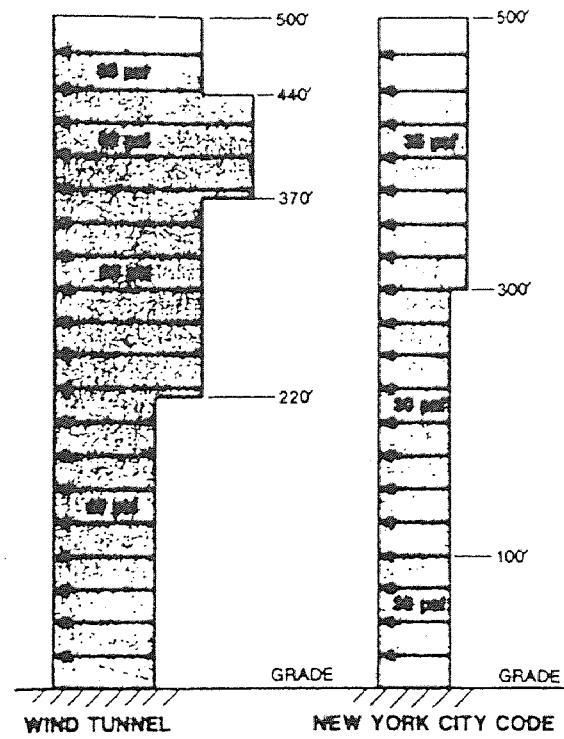
Figure 2.2 ANSI Design Standards (ENR Magazine) (7)

All buildings must be designed to withstand wind-loading. In New York City, this wind loading can be as much as 80 to 100 miles per hour. In other parts of the country, the wind speed may be as high as 200 miles per hour. The American standards ANSI A-58.1/1982 is entitled "minimum design wind loads...buildings and structures." This standard details the design requirements for wind loads (see figure 2.2) (7). Depending on how tall the building is, facade design loads increase. However, these facade loads do not account for the wind tunnel effect occurring in built up areas. The standards requires design loading that is constant from floor to floor. At a certain elevation above grade, the design load requirement is increased. However, wind tunnel tests show that pressure distribution on the facade of a multi-story building is by no means linear (see figures 2.2 and 2.3). (4) This variation is caused by the effect of surrounding buildings and turbulence

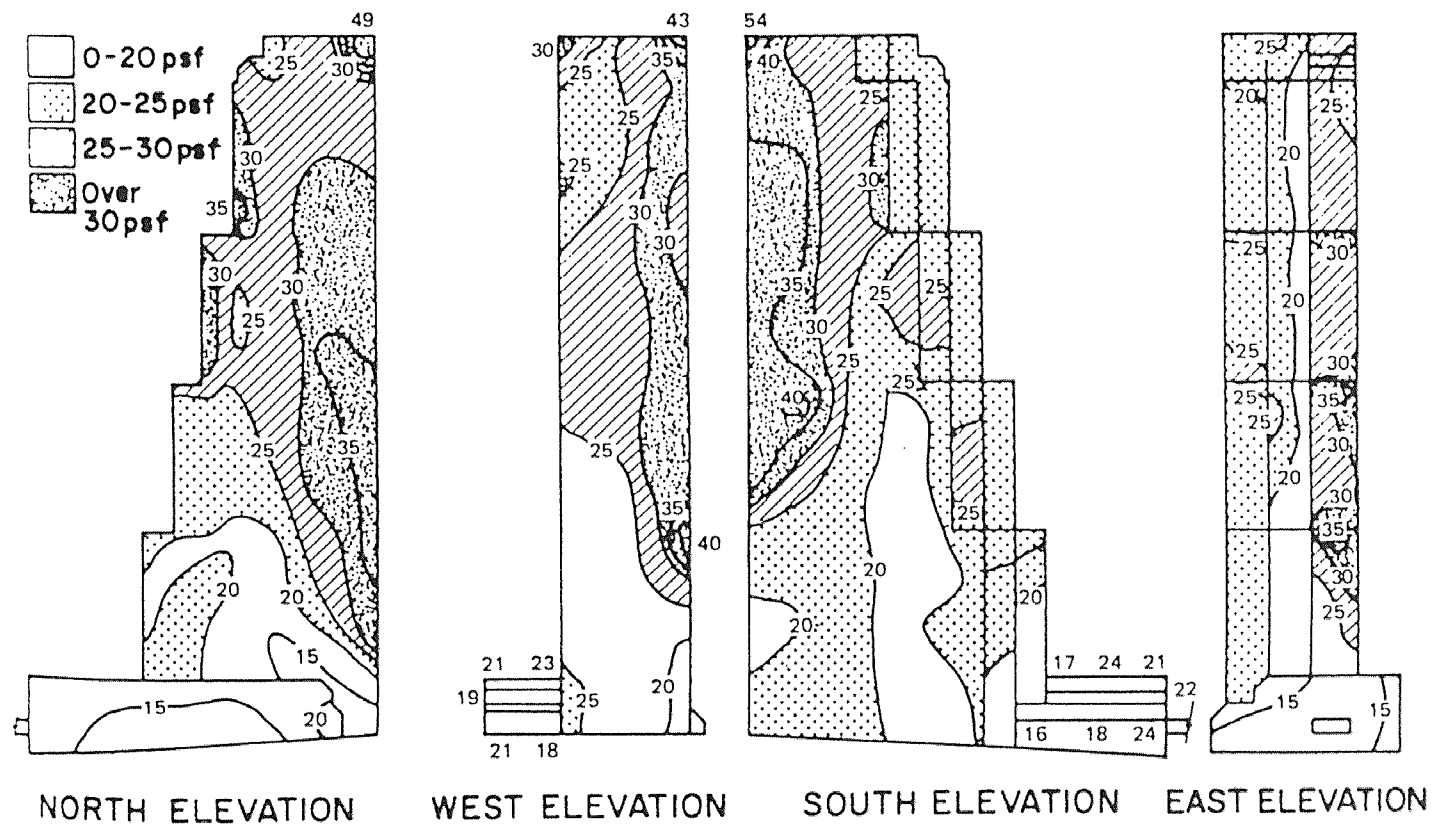
Figure 2.3 Wind Pressure on Scale Model (7)

Around the building as wind passes by it. For instance; the pressure at the leeward corner of a building may be as much as 73 pounds per square foot. Other areas may be subject to less than 37 pounds per square foot.

Figure 6-17 Contours illustrate test results showing that wind pressure on the facade of this building varies widely. (*ENR.*)

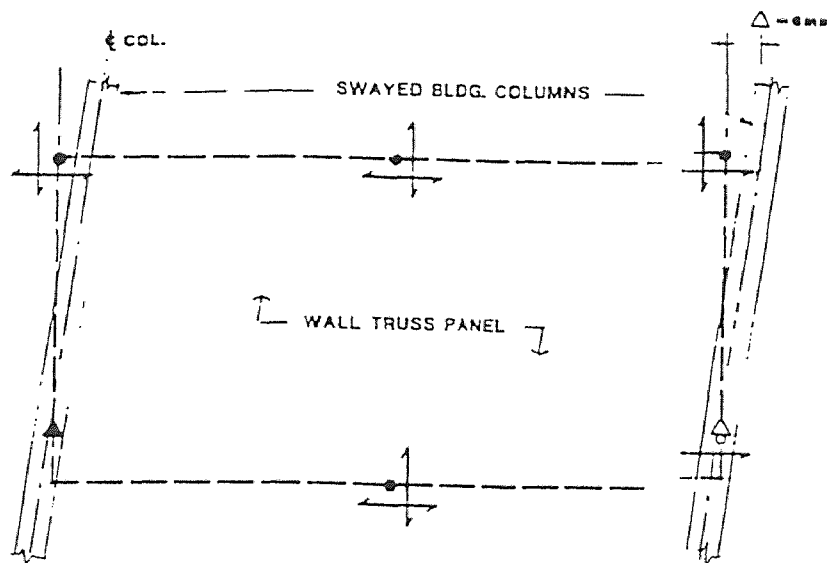
Figure 2.4 Panel Movement (4)

For example, building columns will sway causing stress on the curtain walls panels and/or attachments (see figure 2.4). This problem may be alleviated by the design of connections to allow movement. That is, the joint on the perimeter of the panel, must have some capacity to enlarge or contract. Typically in construction, this would lead to the design of a caulked detail. However, for reasons discussed later, this may not necessarily be the best solution for a curtain wall system.

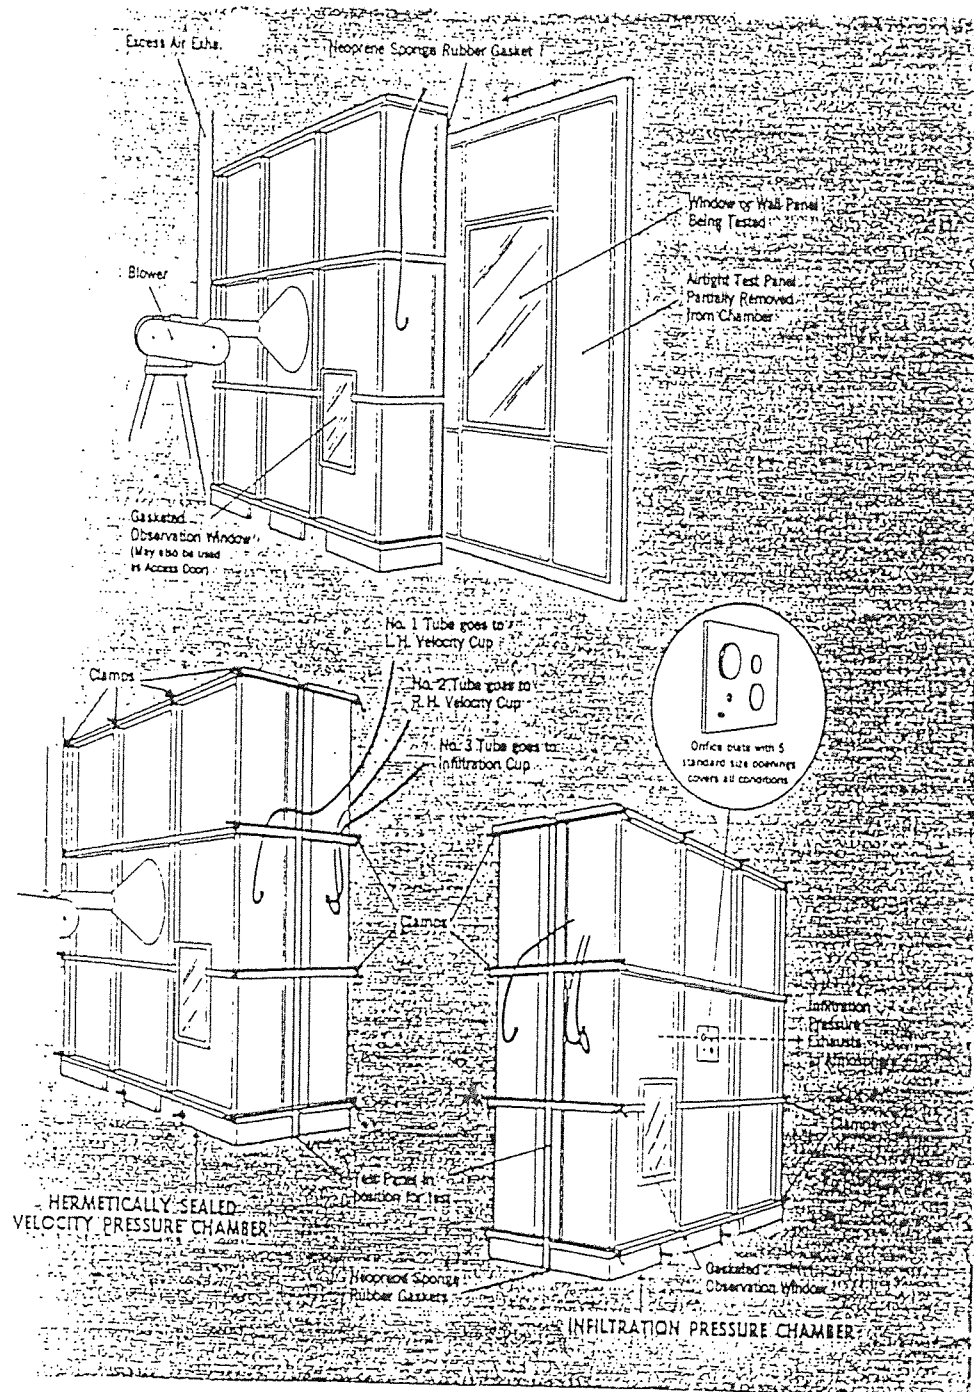
Figure 3.2 Water Penetration test (6)

Water penetration tests can be carried out in a static pressure chamber as detailed in Section 3.2, however these tests have important limitation for the most part. This test does not simulate the conditions at a curtain wall and does not experience water that is forced into the vertical and horizontal joints. Additionally, sample curtain wall assemblies rarely have a pressure differential between exterior and interior which of course, is the actual condition that the test is intended to simulate (see figure 3.2).

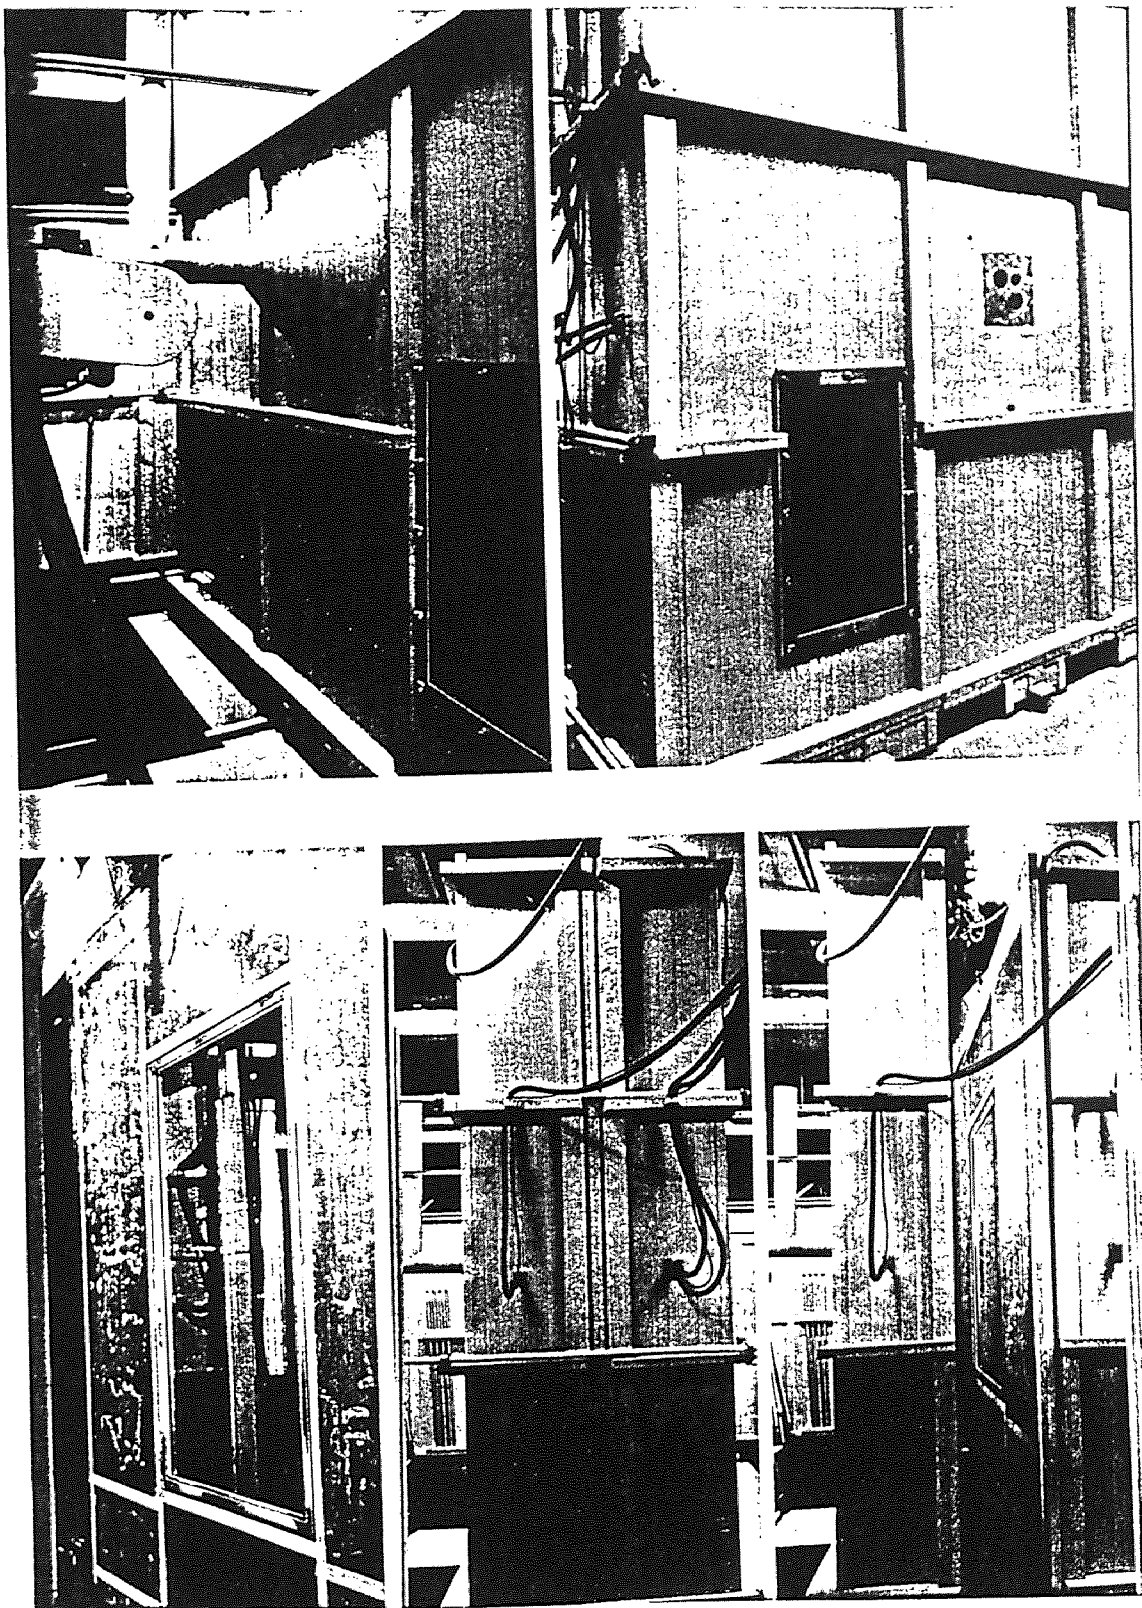
Figure 3.3 Dynamic Testing (6)

In this dynamic test, wind is simulated by the use of a large wind generator (or fan). These are positioned on the outside face of the sample curtain wall (see figure 3.3). Rainfall is simulated by introducing a water stream into the wind stream generated by the fans. This water will be forced horizontally until it strikes the curtain wall surface. At other locations, mainly above and each side of the test sample, more water is introduced into the test.

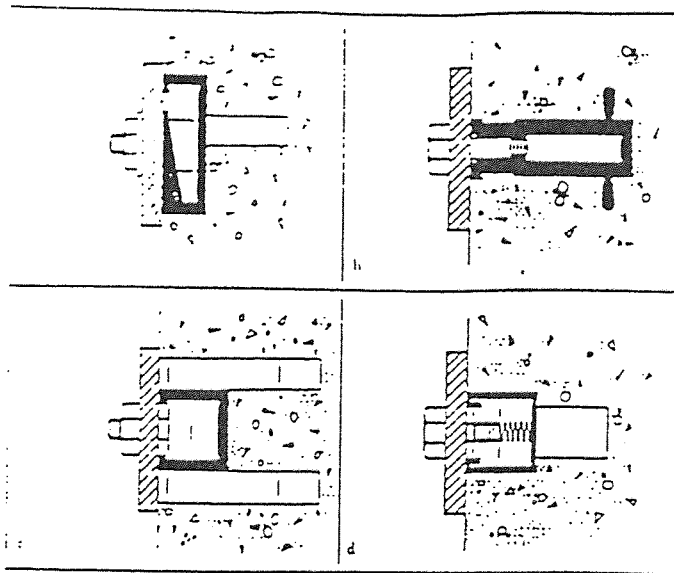
Figure 4.1 Metal Inserts

Slotted metal inserts are often specified as the attachment for curtain wall units. This is most often used for reinforced concrete frame buildings. (see figure 4.1) Metal inserts are cast into the concrete spandrel beams. These are designed to receive 1/4" to 3/4" bolts. In addition to this, these inserts are designed to allow flexibility during installation, that is building tolerances are allowed for.

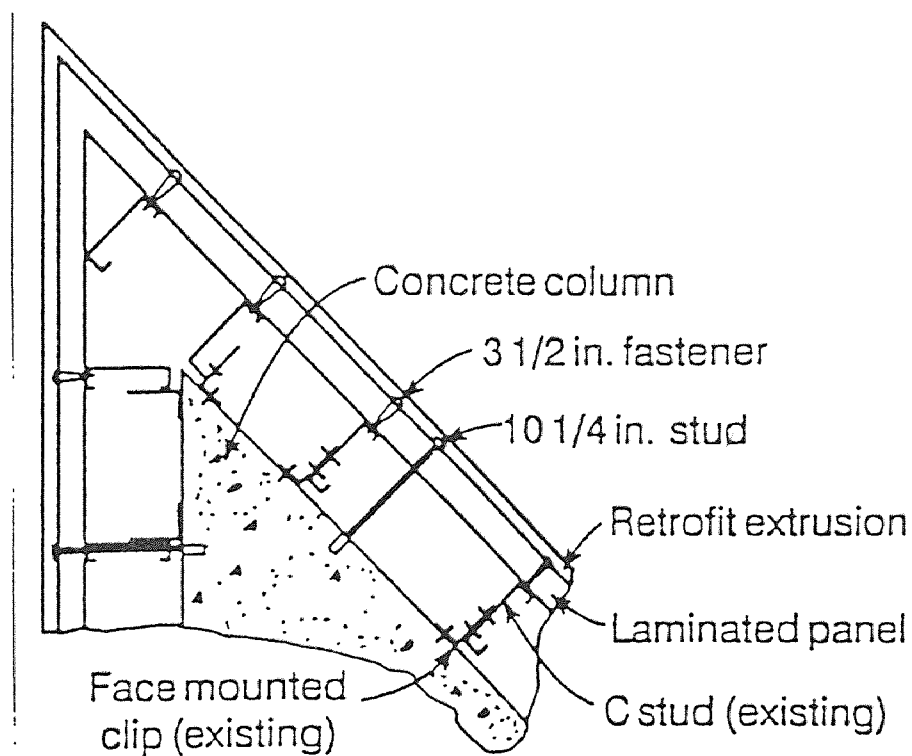
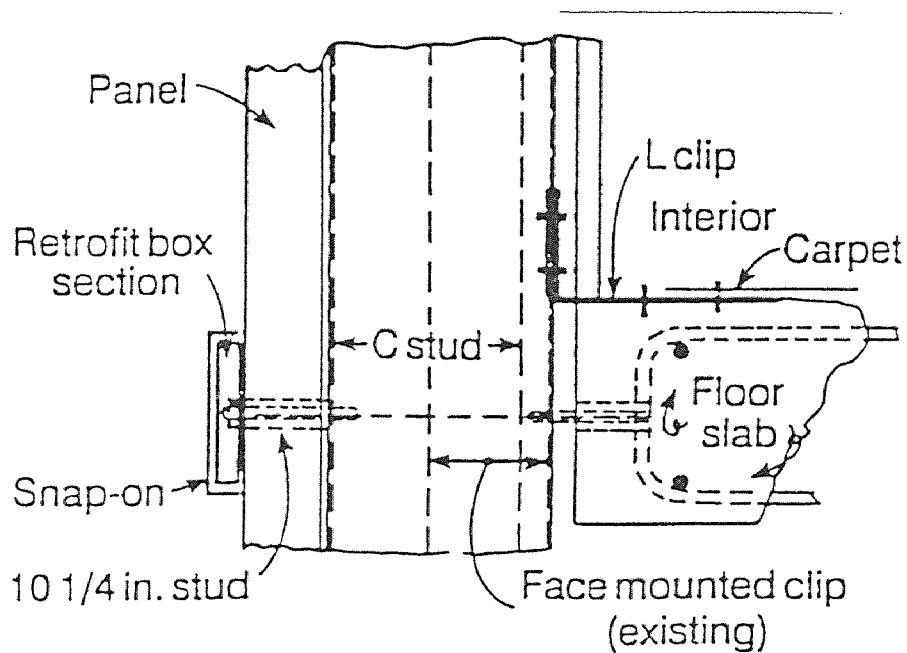
Figure 6.2 Retrofit System (10)

The Airport Hotel Enterprises, Texas commissioned Quest Engineering Development Company to design a retrofit system for the Sheraton Hotel and Convention Center. In this case, wind damage in Houston had caused the designed wind loading requirements to be increased. It was decided to reattach the curtain wall through the panels to the structure behind (see figure 6.2).

Specially fabricated extruded aluminum beams were attached to the concrete columns using 10-1/4" studs which were installed through the existing panels. This effectively resecured the panels to the structure. In addition to this, "L" clips were attached to the interior floor slab and subsequently attached to the stud system which formed the frame work for the curtain wall.

In order to reach the interior side of the stud wall, carpets had to be removed in the hotel rooms and dry wall sections had to be removed and subsequently patched. During construction in 1986, all the joints were resealed to prevent water infiltration. This retrofit was caused by the changing standards, however, we can see that the attachment of the curtain wall to the structure was deemed to be an important part of the design. A lot of money was spent in order to attach the curtain wall in a double system.

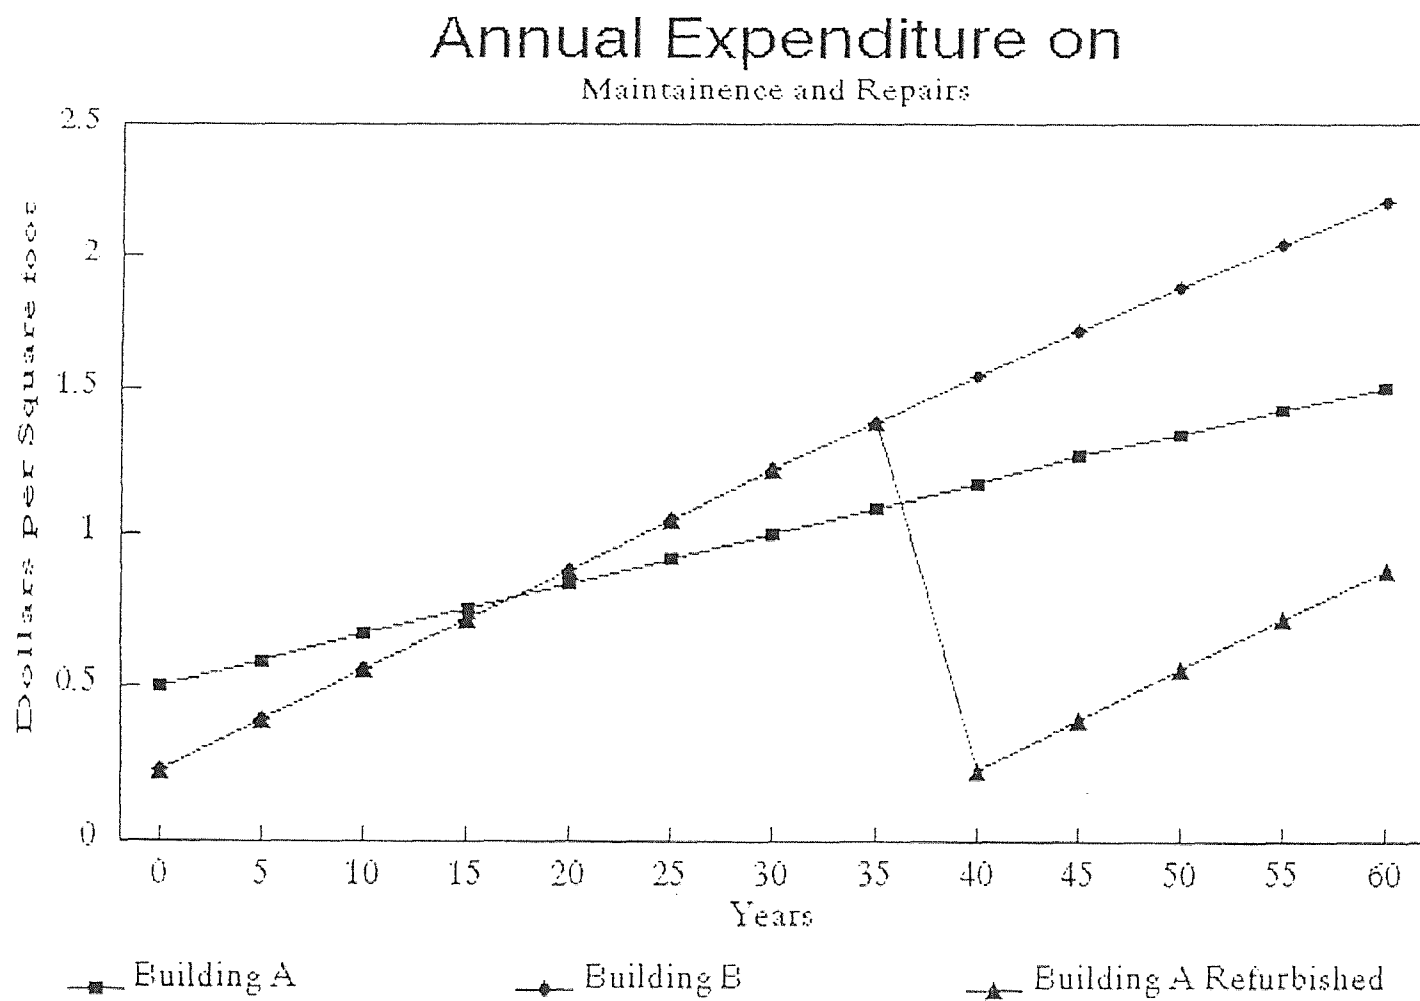
Figure 7.1 Annual Expenditure on Maintenance and Repairs

Figure 7.1 indicates that despite initial higher maintenance costs , the traditional building will cost less to maintain at some stage during the lifetime (approx. 30 yrs). If the owner elects to reclad the Curtain Wall (a 6 million dollar proposal in our case) maintenance costs will return to their initial value.

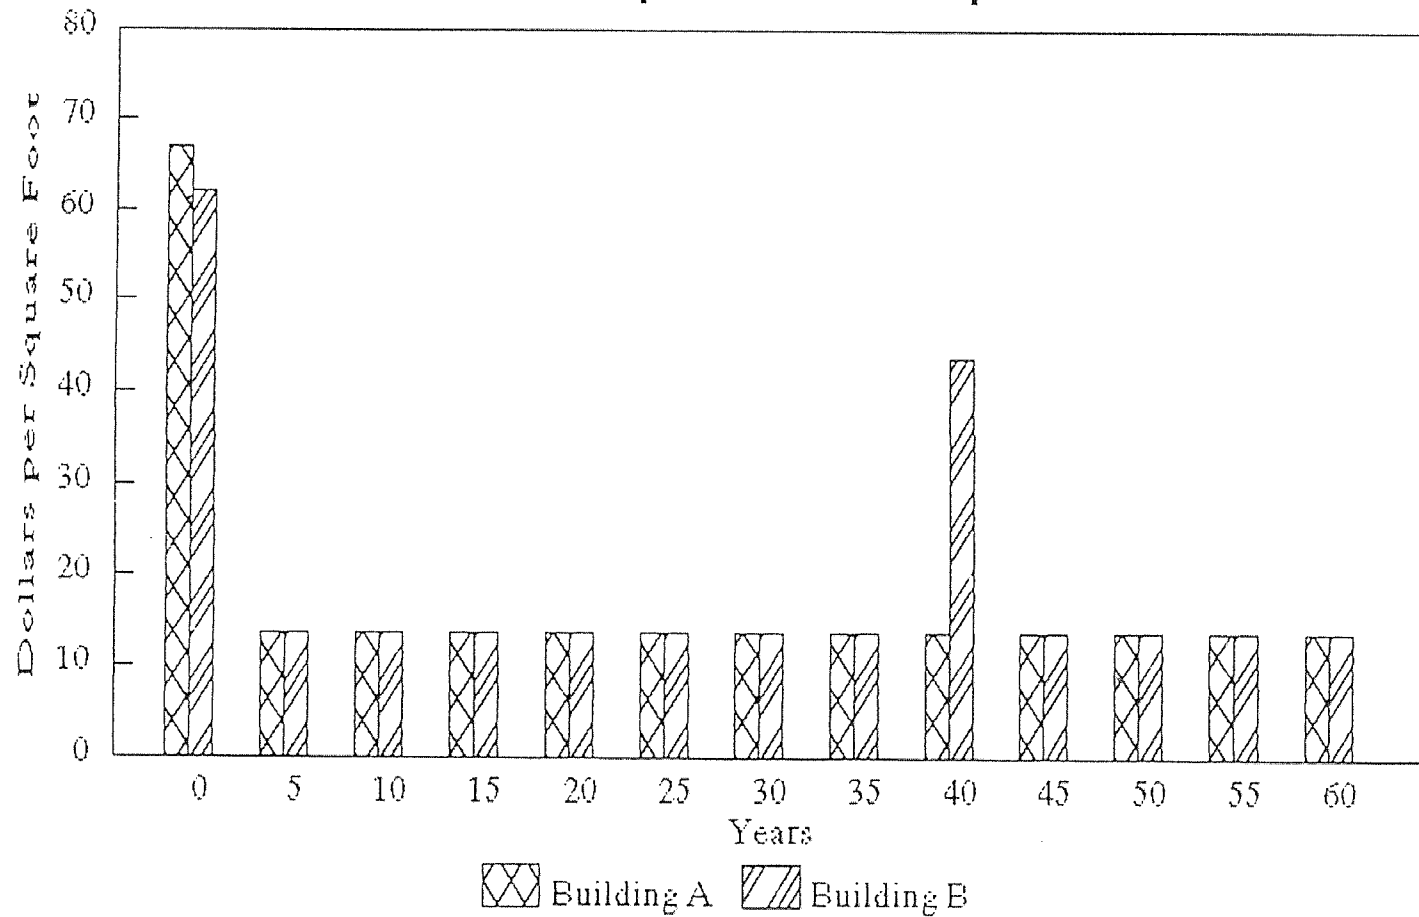
Total Quinquennial Expenditure

Figure 7.2 details an overall view of the building expenditure. Although the pattern of expenditure is very different, the present value of total investment is very similar. One of the reasons for this is that costs incurred after 20 years are relatively small when discounted back to present day value.

Building A Total Spent \$528

Building B Total Spent \$535
