**WEAR AND FRICTION OF HYLAMER AND
POLYETHYLENE AGAINST COBALT CHROMIUM
A PIN-ON-DISC STUDY**

**A Thesis
Submitted to the Faculty of
New Jersey Institute of Technology
in Partial Fulfillment of the Requirements for the Degree of
Master of Science in Biomedical Engineering**

January 1995

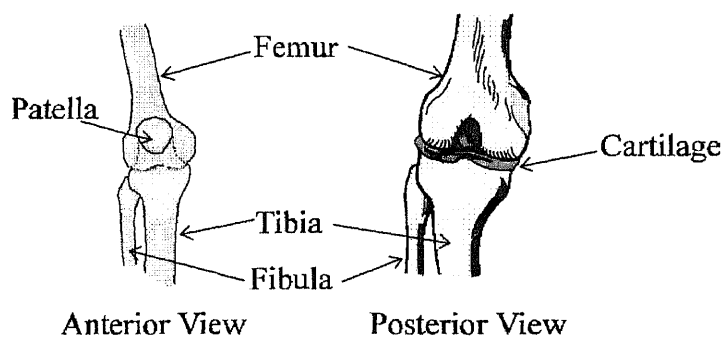
Figure 1.1. Anatomy of the Knee

Although the hip and knee are the two most replaced joints, the hip has undoubtedly received much more attention because it is the joint most affected by disease, and it is a much simpler articulation than the knee [1,5,6]. The hip is a two component system consisting of a ball and socket joint. This configuration allows for a multitude of movements, flexion-extension, abduction-adduction, and external-internal rotation. The knee, however, is a three component articulation consisting of the femoral component, the tibial component, and the patellar component (Figure 1.1). Along with the complex

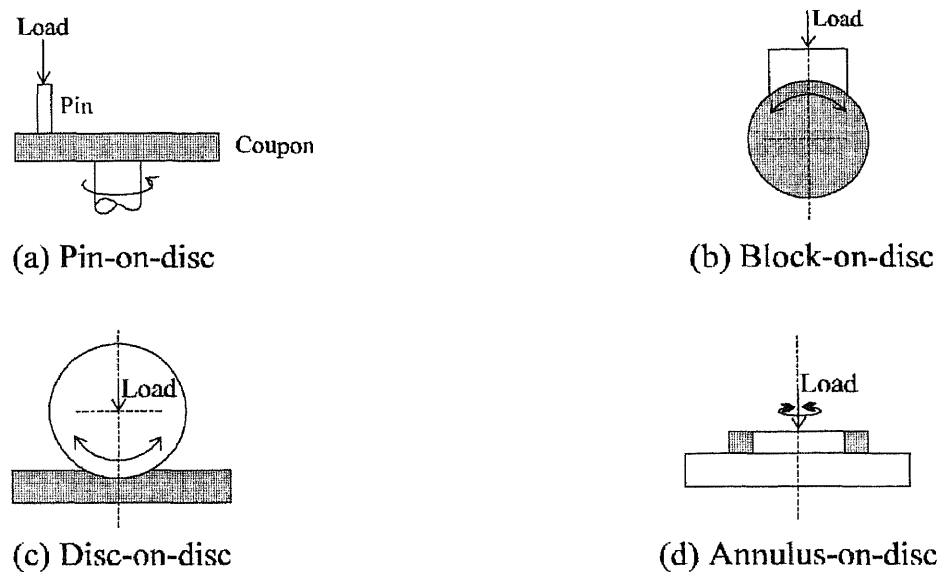
Figure 1.4. Simple Wear Machines [20]

The simple testing machines can have one of four different forms. Figure 1.4a

shows a pin-on-disc machine where a plastic pin is coupled with a flat metal rotating coupon. Figure 1.4b shows a block-on-disc setup in which a curved blocked is loaded and coupled with the curved side of a rotating disc. Figure 1.4c shows a disc-on-disc setup where the curved edge of a rotating disc is coupled with the flat of another disc. And finally Figure 1.4d shows and annulus-on-disc where bottom of the annulus is rotating and coupled with the flat of the disc. No matter what the setup, these machines have the same

basic purpose which is to rapidly and simply test the wear of two materials under loading and motion. The purpose of these tests is to screen materials for use in the body or joint simulators. Although these machines will not simulate implant designs or motions, by obtaining the correct physiologic loads, sliding speeds, environment, sliding velocities, and stresses, materials can be evaluated rather simply as to their functioning for use as implants. Also, the type of motion used by the machine is important. The motion could be either oscillating or uni-directional. Oscillatory machines have several advantages over unidirectional types. Human joint motion is oscillatory; therefore, non-oscillating

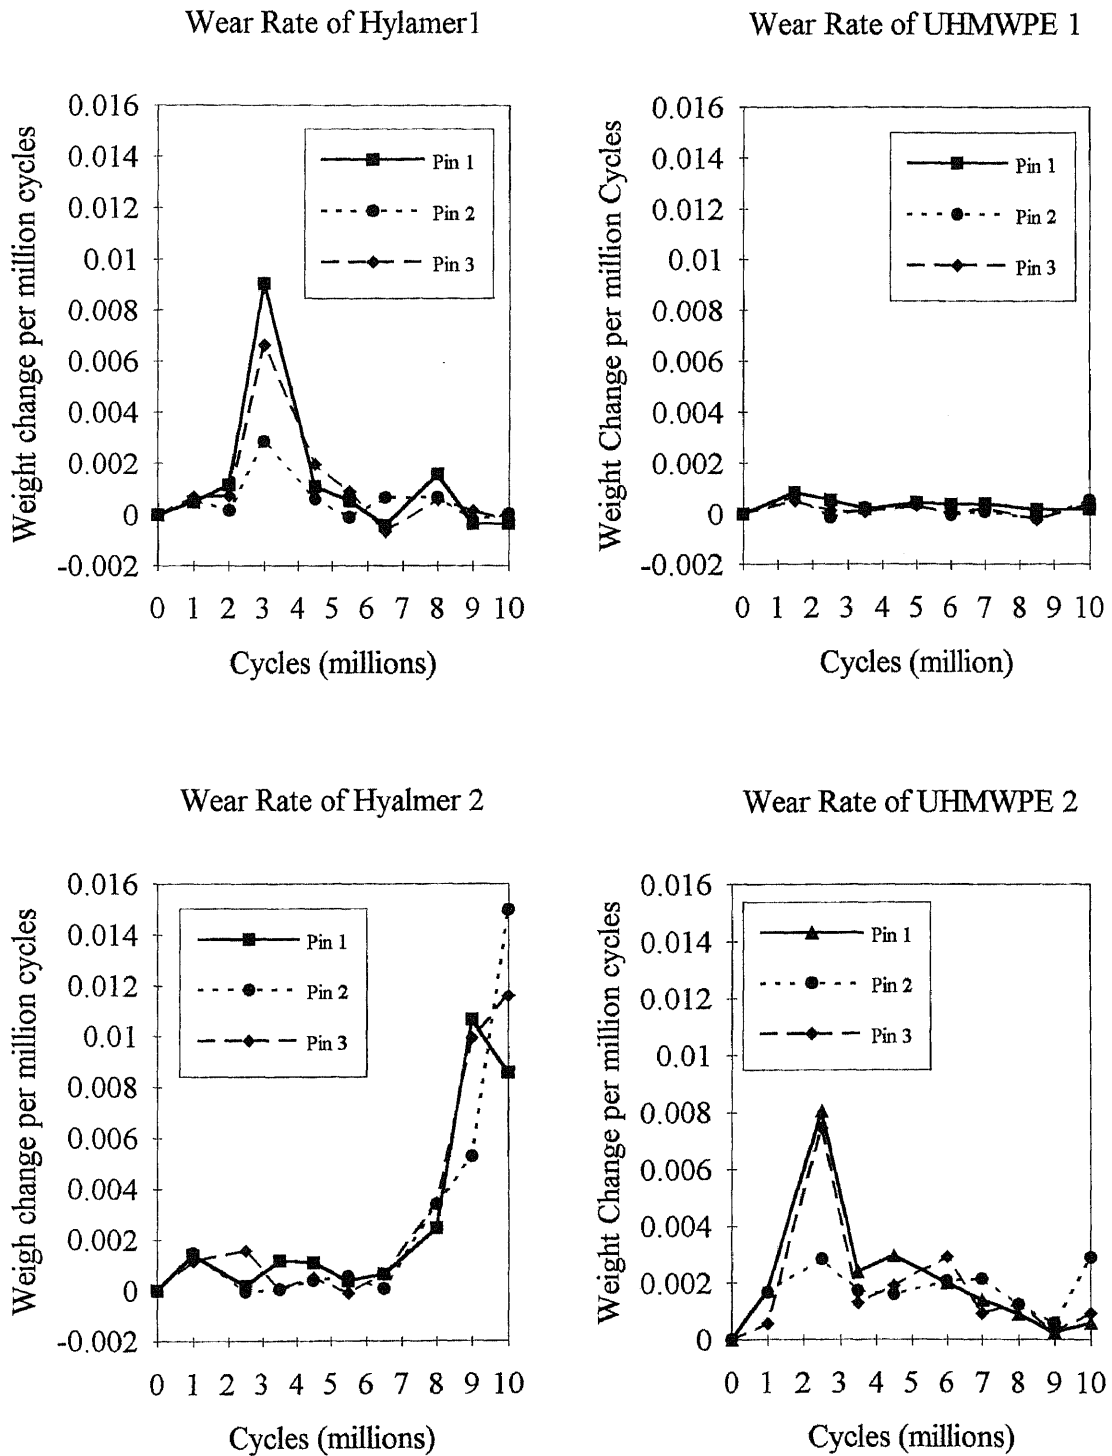
Figure 3.4. Wear Rate of Individual UHMWPE and Hyalmer® Pins on Co-Cr Coupons

Figure 3.4 display the wear rate for the individual pins of each test. At three million cycles, Hylamer® 1 has an accelerated jump in rate for all three pins. Pins 1 and 3 have higher jumps than pin 2, 9.0×10^{-4} mm³/million cycles, 6.6×10^{-4} mm³/million cycles and 2.9×10^{-4} mm³/million cycles; nevertheless, the wear rates drop back to almost the same values before the jump. All three pins for UHMWPe 1 follow the same trend, and no jumps or variations are present. Hylamer® 2 pins show a slight variation in wear rate before seven million cycles. After this the wear rate continually accelerates to values of almost ten times the previous values. UHMWPe 2 also displays a jump in the wear rate at 2.5 million cycles. The value does return to previous values; however, there is variance between the three samples after the jump. At the jump, pin 1 and 3 have a high wear rate of 1.47, 1.26×10^{-3} mm³/million cycles, and pin 2 rate is 0.632×10^{-3} mm³/million cycles.

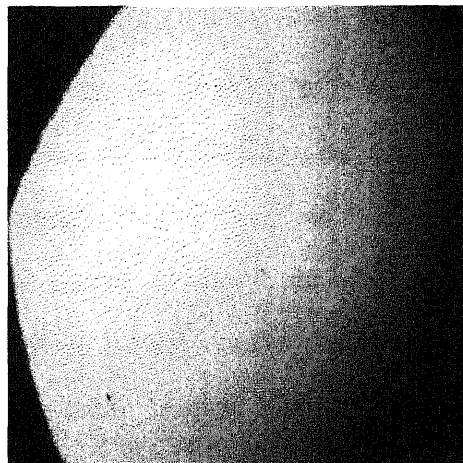
Photomicrography of pre and post-test conditions of the coupons are shown in Figures 3.6 through 3.10. Figure 3.6 shows the condition of the Hylamer® 1 Co-Cr coupon after 10 million cycles. It is important to note the differences between the scratches in the metal coupon itself and those in the polyethylene transfer film present on the coupon. On Figure 3.6 the letter "a" denotes scratches in the poly while "b" identifies scratches in the coupon. The transfer film scratches are identified by a non-distinct border on its edge. The metal scratch has a straight, distinct border. Heavy scratches were present on the Hylamer® 1 coupon as compared to Figure 3.7, the coupon for UHMWPe 1. They are much wider and deeper than those present in the UHMWPe samples. Figure 3.8 shows Hylamer® 2 upon completion of the test. Along with the scratch are blotches. This could be dirt, or other foreign matter. It could also be rips or breaks in the polyethylene transfer film. The coupon for UHMWPe 2, Figure 3.9, has slightly heavier scratches than the first UHMWPe test; however, they are not as heavy as the ones found in the Hylamer® tests. Figure 3.10 shows an unused coupon before testing which is a cobalt chromium alloy that has been polished. Notice that there are no scratches present, and the surface is clear.

Figure 3.6. Hylamer® 1 Coupon After 10 million cycles @ 20x.

Figure 3.7. UHMWPe 2 Coupon After 10 million cycles @ 20x

Figure 3.8. Hylamer® 2 Coupon After 10 million cycles @ 20x.

Figure 3.9. UHMWPe2 Coupon After 10 million cycles @ 20x.

Figure 3.10. Pre-Test Surface Condition @ 20x.

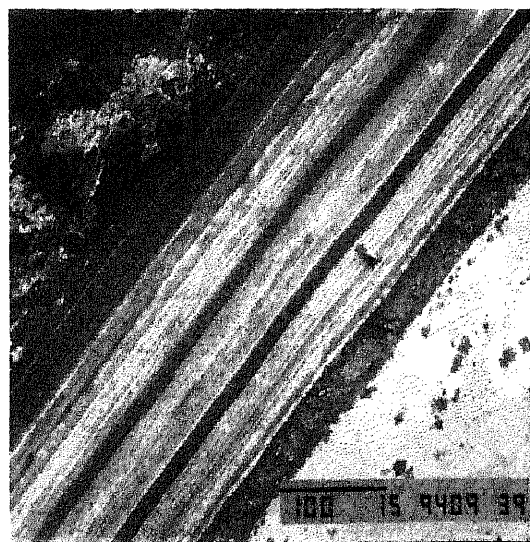
Figure 3.17 shows one of the heavier scratches that was observed. Upon completion of the test, two heavy scratches were present in the Hylamer® 2 coupon in the circular arc of the wear track. This scratch was investigated using the scanning electron microscope (SEM). Figure 3.18 shows the scratch magnified using the SEM. The composition of the scratch was determined two ways. First backscatter was used. By performing this all the black areas are elements of high atomic number of high density. Figure 3.19 is the backscatter picture of the same area shown in Figure 3.18. Notice the white areas, which are low in atomic number and are assumed to be polyethylene. Figure 3.20 shows the elemental analysis for the scratch is composed of cobalt, chromium, and molybdenum.

Figure 3.17. Heavy Scratch in Hylamer®
Coupon @ 20x

Figure 3.18. SEM of Hylamer® Scratch

Figure 3.19. SEM Backscatter of Hylamer®
Scratch

Figure 3.20. Elemental Software Analysis
