HYDROLOGICAL AND GEOTECHNICAL INVESTIGATION OF A SPARTA, NEW JERSEY LANDSLIDE

**by
James Talerico**

**HYDROLOGICAL AND GEOTECHNICAL INVESTIGATION
OF A SPARTA, NEW JERSEY LANDSLIDE**

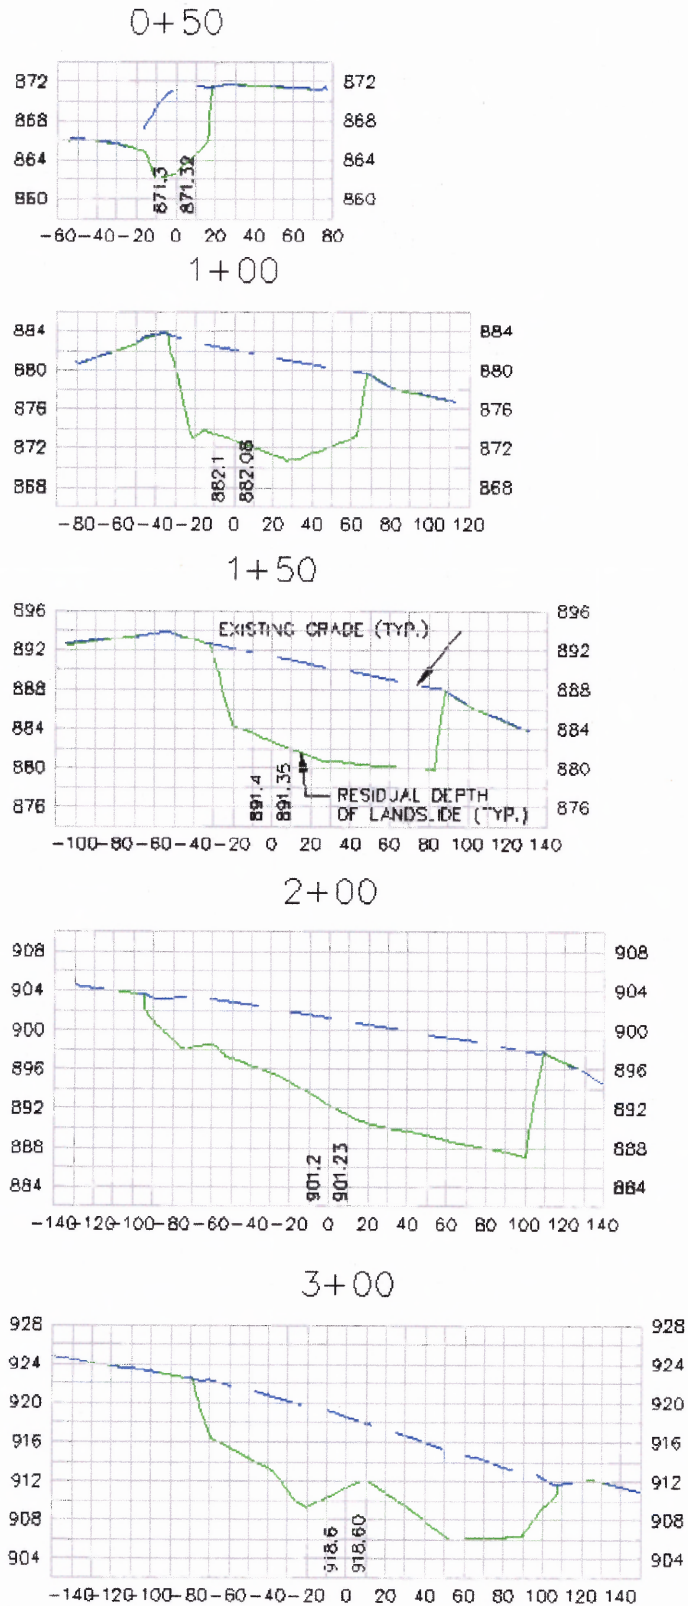
Figure B.4 Cross Sections at 50 feet stations of landslide.

This appendix contains the topographic survey of the landslide. This information shows the existing and proposed topography, a centerline profile, and 50 foot cross sections of the landslide area. This information was then used to generate the overall volume of the landslide which is also included herein.
