SEEPAGE MONITORING AND DIAGNOSIS OF DISTRESSES IN AN EARTH EMBANKMENT DAM USING PROBABILITY METHODS

by
Seyed Mohammad Reza Mousavian

August 2017

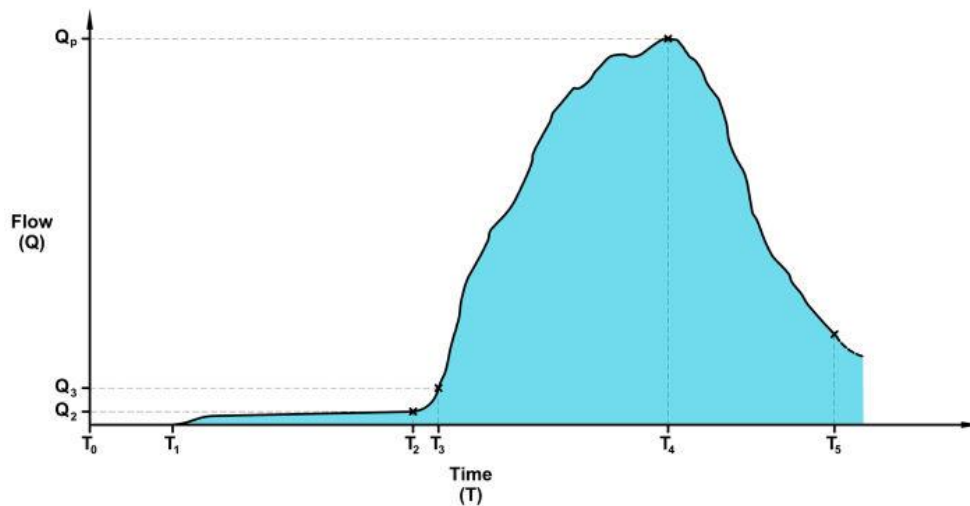
Figure 1.1 Generic breach flood hydrograph.
 Source: *Breaching Processes: A state of the art review* (Morris, 2009).

- Time T_0 : No sign of erosion and no breach initiation
- Time T_1 : Start of Breach Initiation
- Time T_1 – T_2 : Progression of Breach Initiation
- Time T_2 – T_3 : Transition to Breach Formation
- Time T_3 – T_5 : Breach Formation
- Time T_4 : Peak Discharge

In this hydrograph, at time of T_1 , Seepage through the embankment initiates that could be detected or undetected. Here, stage Time T_1 – T_2 is the most critical stage in determining the most appropriate action for maintenance, repair or emergency planning. In this stage, flow is typically small and rate of change is slow. Internal erosion and progressive material removal proceeds and breach flow increases slowly through increased loading. When piping erosion is suspected of occurring or has already been detected on the site, the rate of development is difficult to predict in order to develop the flood hydrograph. Some scholars put forward equations for prediction of time of failure according to

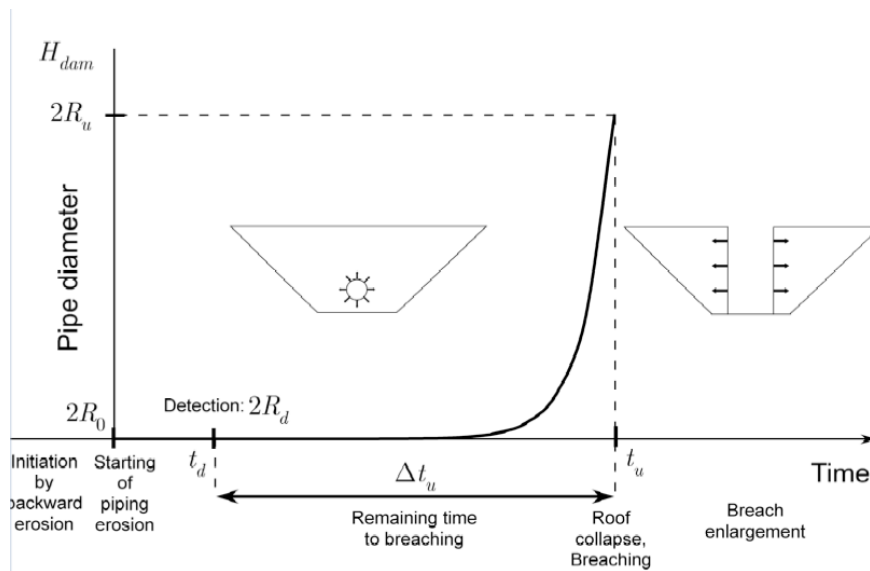
Figure 1.4 Piping erosion in a water retaining structure, phases from initiation to breaching.

In the next step, an expression for the remaining time for breaching is proposed. The piping process begins at time t_0 with the initial radius R_0 , both unknown. A sketch of the description is represented in **Figure 1.4**. A visual inspection defines the initial time $t_d > t_0$ for detection, and can provide an estimation of the output flow rate, thus an estimation of the radius $R_d > R_0$. R_u and t_u are taken to denote the maximum radius of the pipe before roof collapse, and the collapse time, respectively.

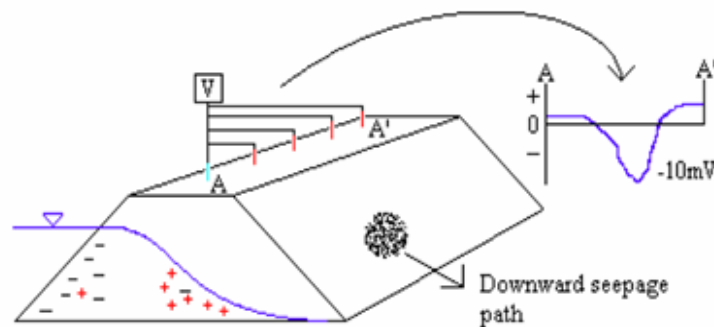
Figure 1.8 Illustration of an electrode array set up along the crest of a dam and the SP anomaly generated from downward seepage.

is a passive technique used to measure small naturally occurring electrical potentials generated by fluid flow, mineralization, and geothermal gradients within the earth. Water flowing through the pore space of soil generates electrical current flow. SP is measured by determining the voltage across a pair of non-polarizing electrodes using a high-impedance voltmeter. This electrokinetic phenomenon is called streaming potential and gives rise to SP signals that are of primary interest in dam seepage studies. Implementation of SP method is relatively simple and the anomalies can be detected with single survey. Different resolutions and depths by changing the distance of electrodes and Cross-comparing data at different reservoir levels can reveal the potential flow paths. However, this method is sensitive to external factors like physical properties and electrical noises. Also, presence of some minerals may result in SP anomalies. **Figure 1.8** is illustrating of generic SP electrode array setup along the crest of a dam and the monitoring results, locating potential seepage zone.

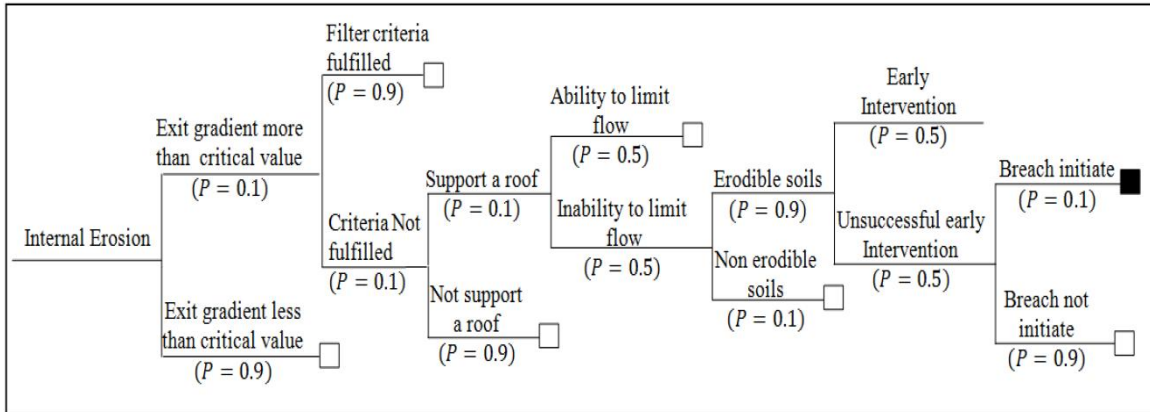
Figure 1.17 Internal erosion event-tree in Doroudzan dam, Iran.

estimated under two different conditions. An event-tree was developed to demonstrate the internal erosion process of the studied case and the probability of each event was determined from USBR database (**Figure 1.17**).

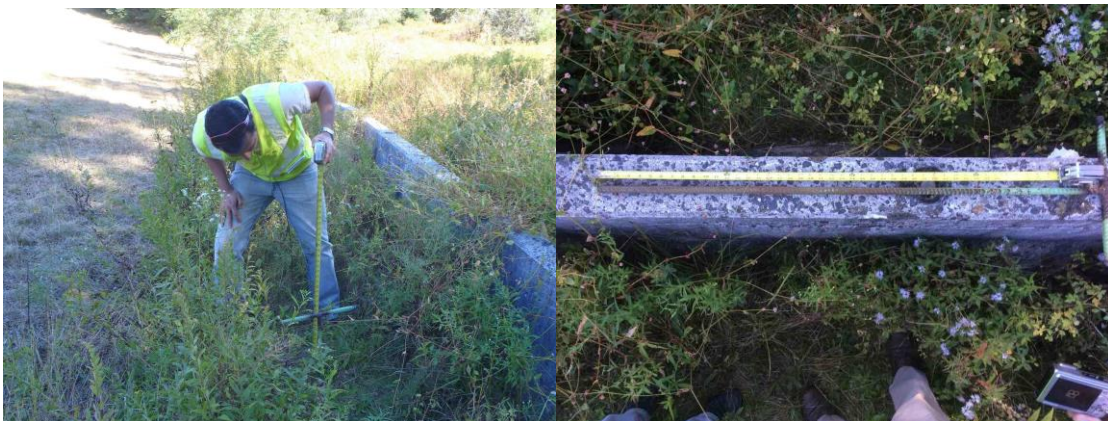
At the downstream toe immediately upstream of the concrete jersey barriers and at station about 0+70 from the right end of the jersey barriers is a soft and moist zone. A 4 ft. metallic bar was used to check the stiffness of the soil. The bar could easily penetrate into the soil at this area and soil seems to be saturated at the larger depth (**Figure 3.1**). This zone was also reported in the 2014 inspection report.

Figure 3.1 Detection of wet soft soil at the downstream toe.

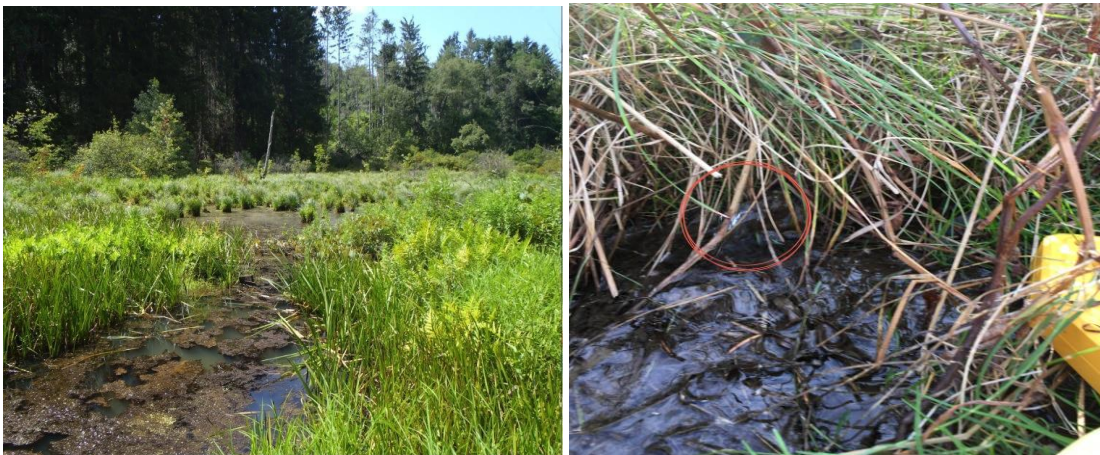
Immediately downstream of the concrete jersey barriers along downstream toe, there is a spring and pool of standing water stands. This incident was reported since 2014. However, more investigation revealed the exact location of the outflow that located at station 0+70 from right end and 10' downstream of the of the jersey barriers (**Figure 3.2**). Standing water at this area was reported in the previous inspection reports, however this zone was not observed within the 2014 inspection.

Figure 3.2 Standing water and seepage outflow downstream of the parapet jersey barriers.

The outflow water was clear and no sign of piping/erosion was observed visually. The temperature of the outflow water was measured as 39.4° F while the water temperature at the surface of the reservoir was measured as 38.2° F, indicating the source of water with high certainty is within the reservoir rather than the underground water. Site investigation revealed an area downstream of the right abutment where large numbers of the trees were fallen. **Figure 3.3** is an aerial photo clearly shows this zone. Slight change in vegetation was also discovered in this area. The fallen trees and change in vegetation could be a sign of moist or saturated soil in this region.

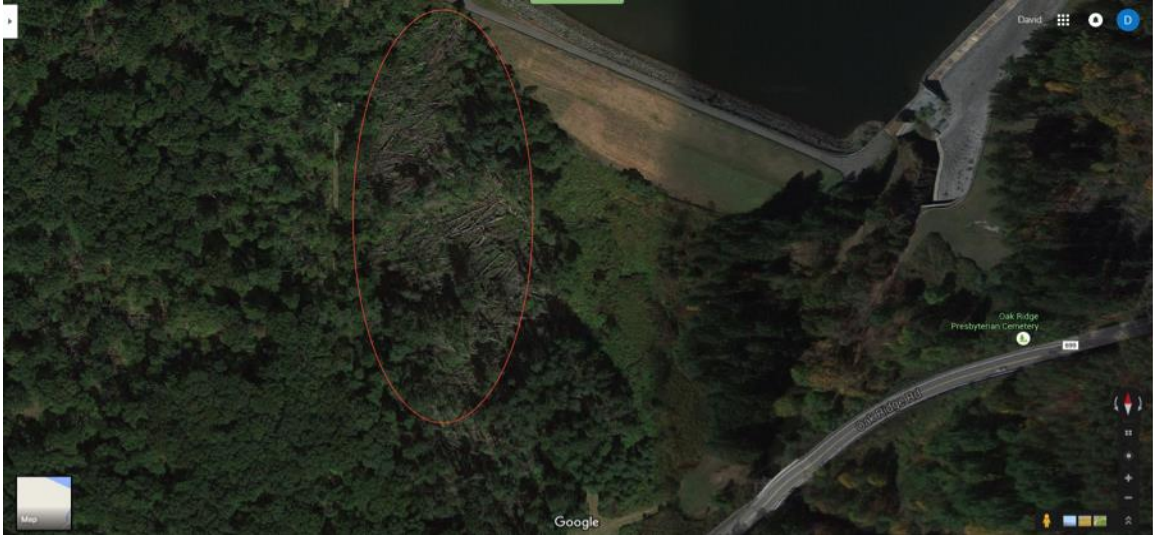
Figure 3.3 Area with the fallen trees downstream of the right abutment

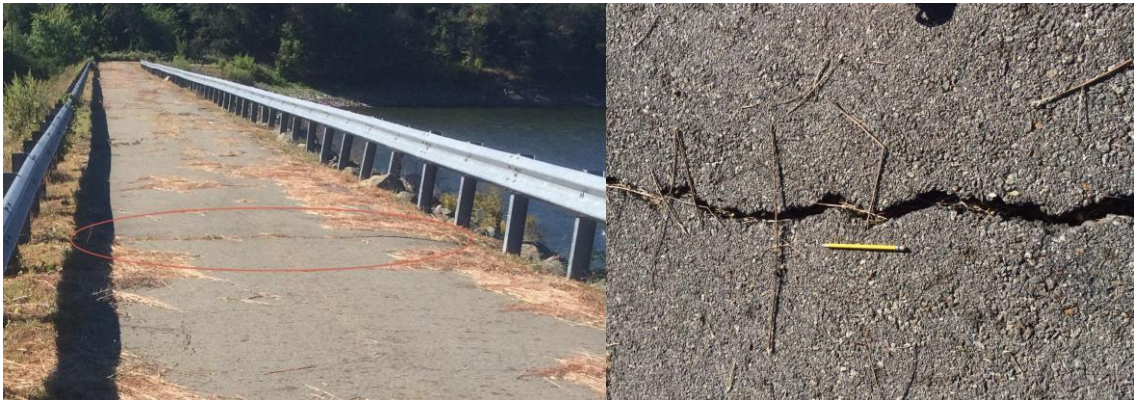
Several transverse cracks were observed along the crest in the pavement. Cracks were extended across the asphalt pavement (**Figure 3.4**). These cracks were reported since 2011 and the wideness of the cracks was between 3/8” and 2”.

Figure 3.4 Transverse cracks along the crest.

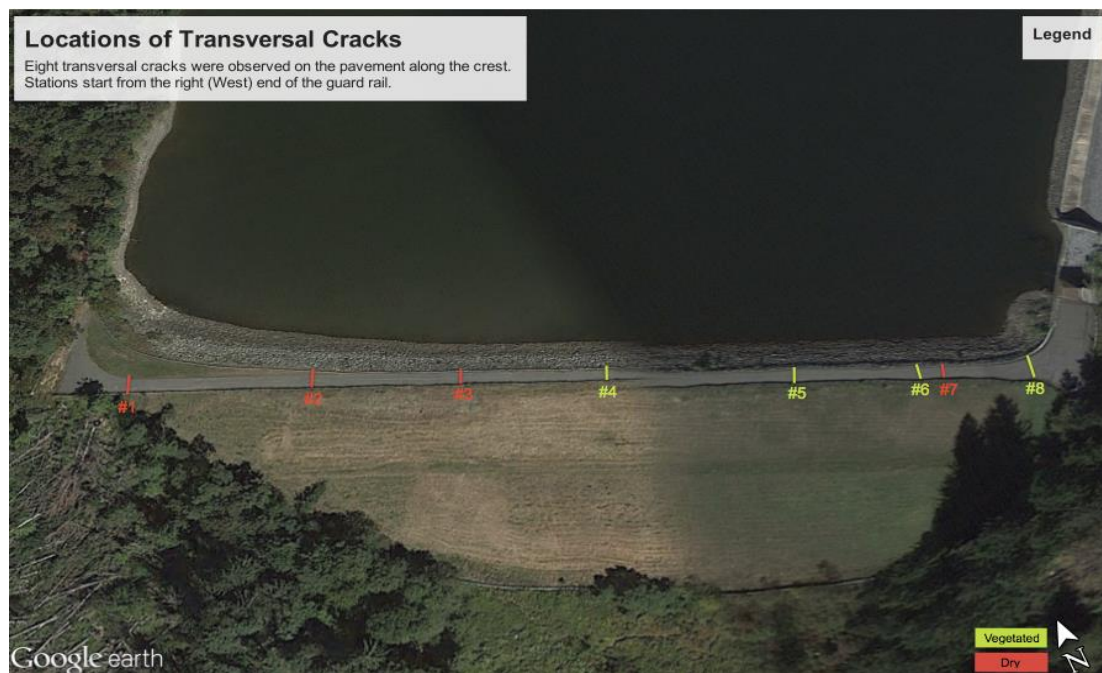
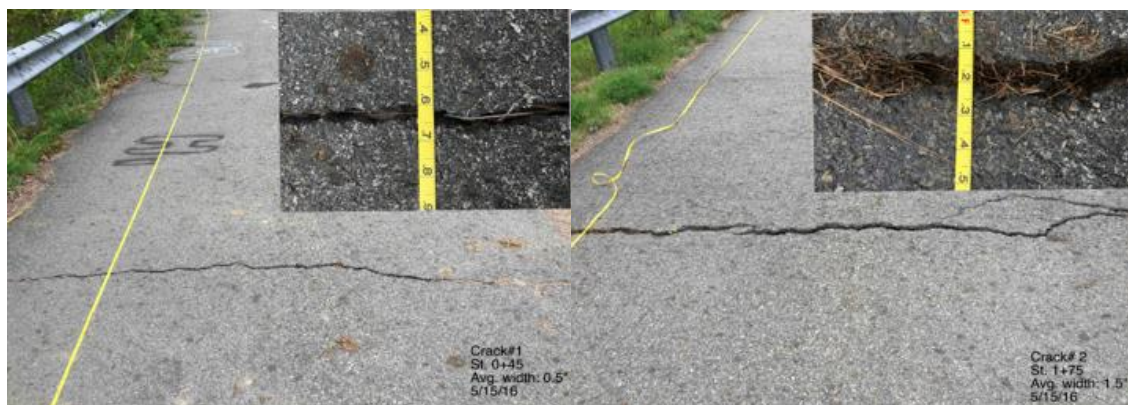
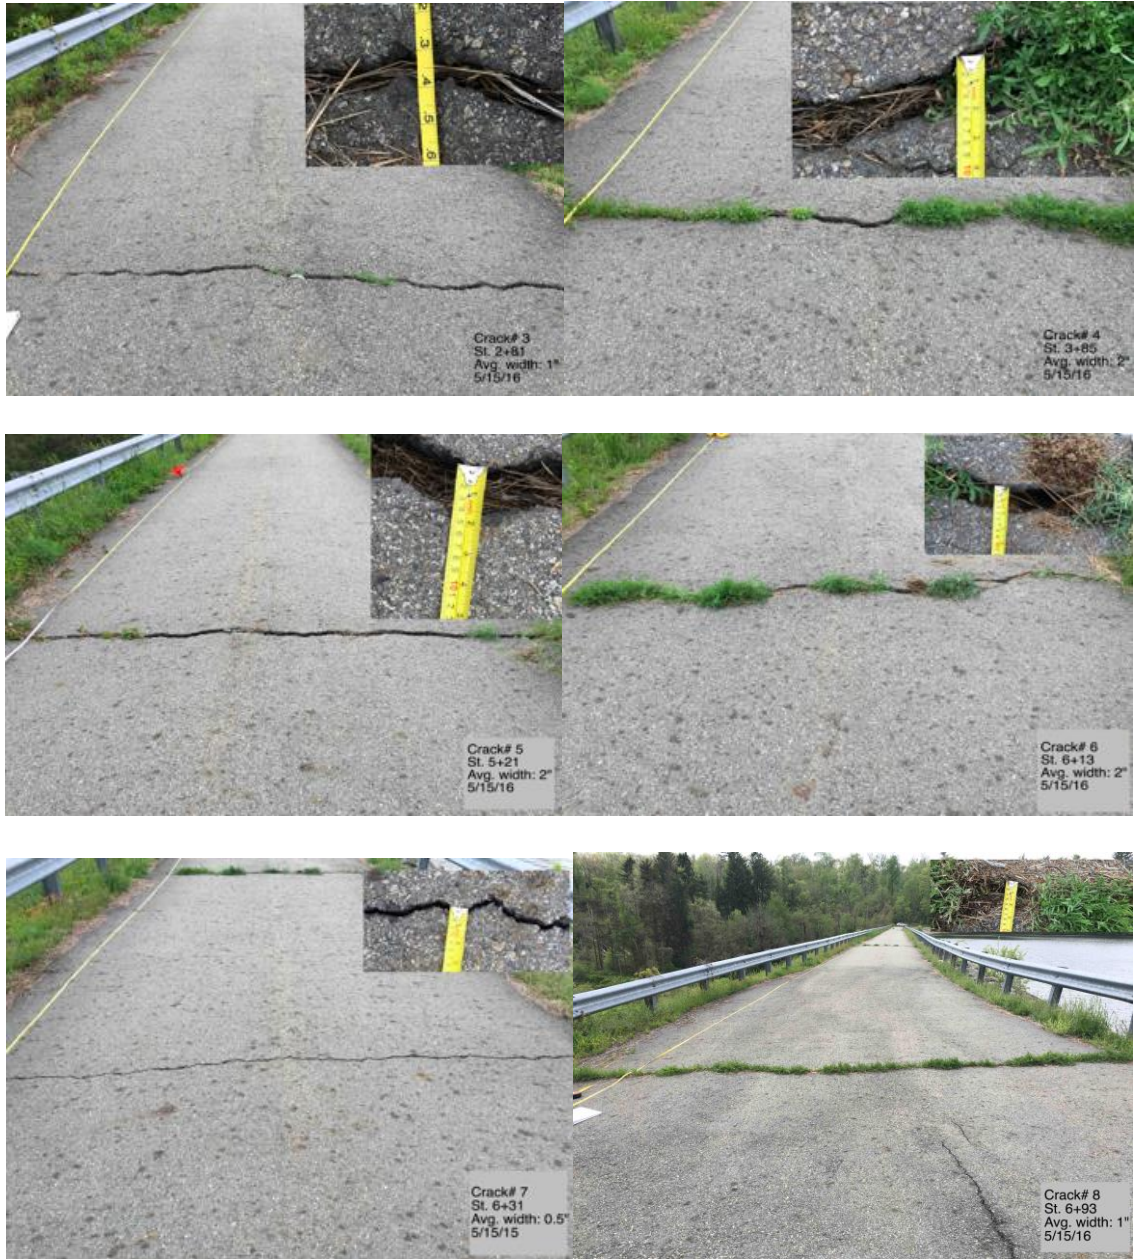
were also observed during previous inspections. All the cracks were extended all across the pavement. The widths of the cracks were between 0.5” to 2”. **Figure 3.5** shows the locations of the cracks on the dam and statements about each one. Four of the cracks were dry (cracks #1, 2, 3, 7) whereas grass and lawns were growing out of the other four (cracks #4, 5, 6, 8). The vegetated cracks were mainly located on the east side of the dam. Growing grass through the cracks could be an indicator of existence of wet soil at these areas. Crack #7 was not observed during the previous inspection and looks like a new crack. The wideness of this crack was measured as 0.5”.

Figure 3.5 Location and status of observed transverse cracks along the crest (Continued).

Figure 3.5 (Continued) Location and status of observed transverse cracks along the crest.

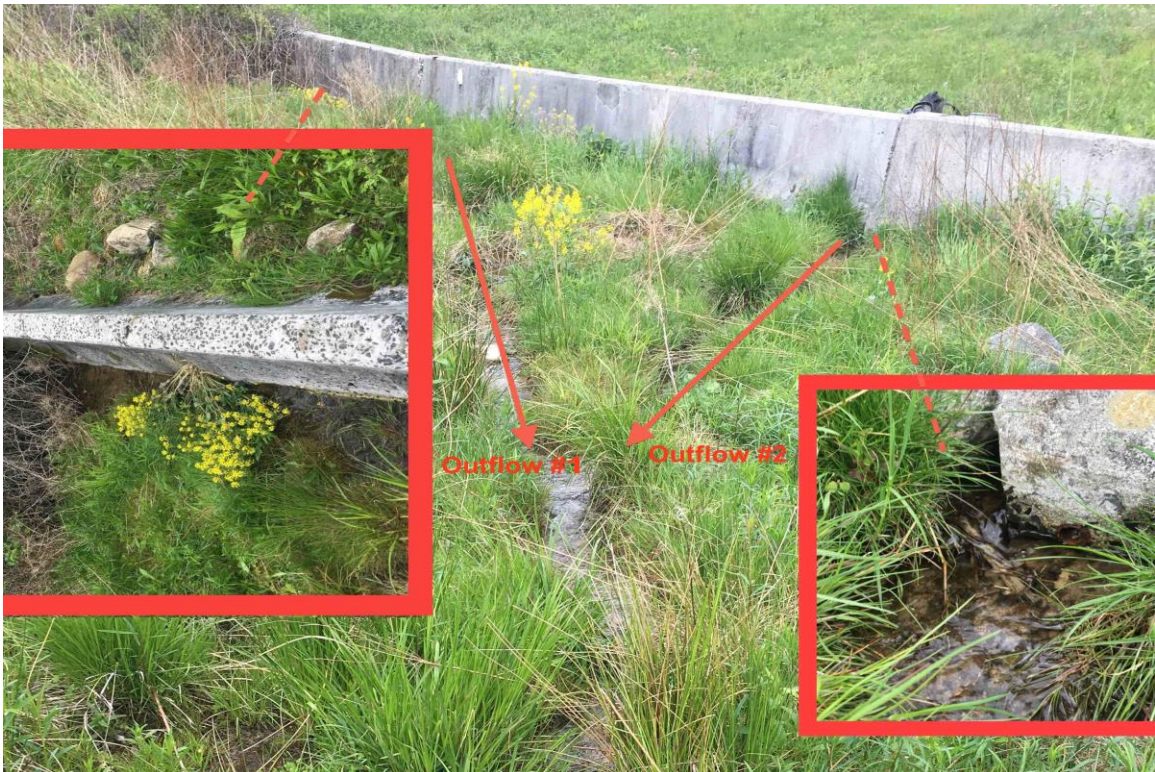
and 10' downstream of the jersey barriers during the visit in fall 2015 was not observed during this inspection. However, water is flowing out of an opening in the jersey barriers (outflow# 2) around the same station. The flowing water was clear and no sign of piping was observed visually.

Figure 3.6 Detected downstream outflows.

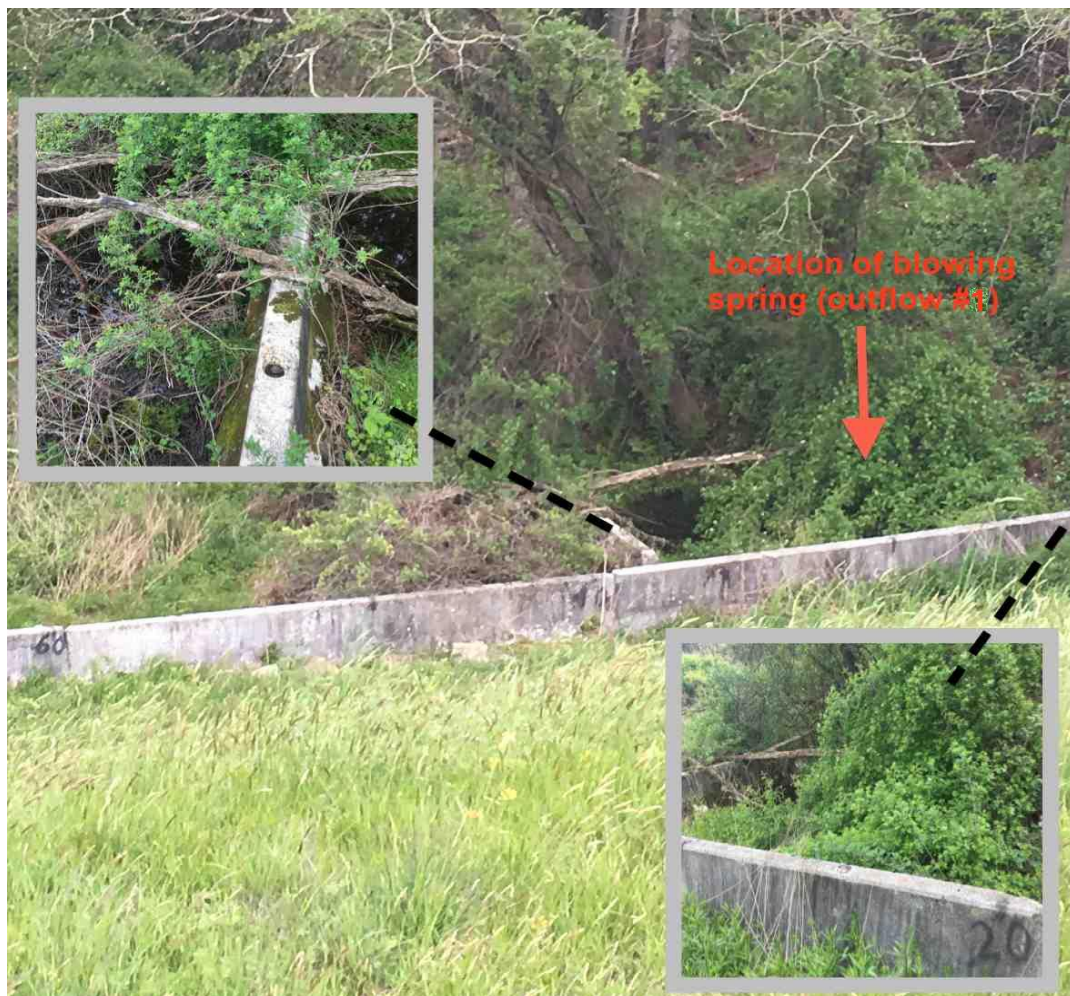
For Outflow #1 although the discharge flow is clear, it is possible the washed out sediments were deposited within the pond and just clear water is flowing out. The area around the pond and along the right abutment is covered with dense bushes and fallen trees, which limited the access to these areas. As reported in 2014 inspection, some slight depressions were observed at mid-level bench along the contact with the upper center abutment. Depression could be a sign of washing out of soil materials that results in subsidence of the ground at the depressed zone.

Figure 3.7 Location of blowing spring. Looking from the downstream slope towards the toe.

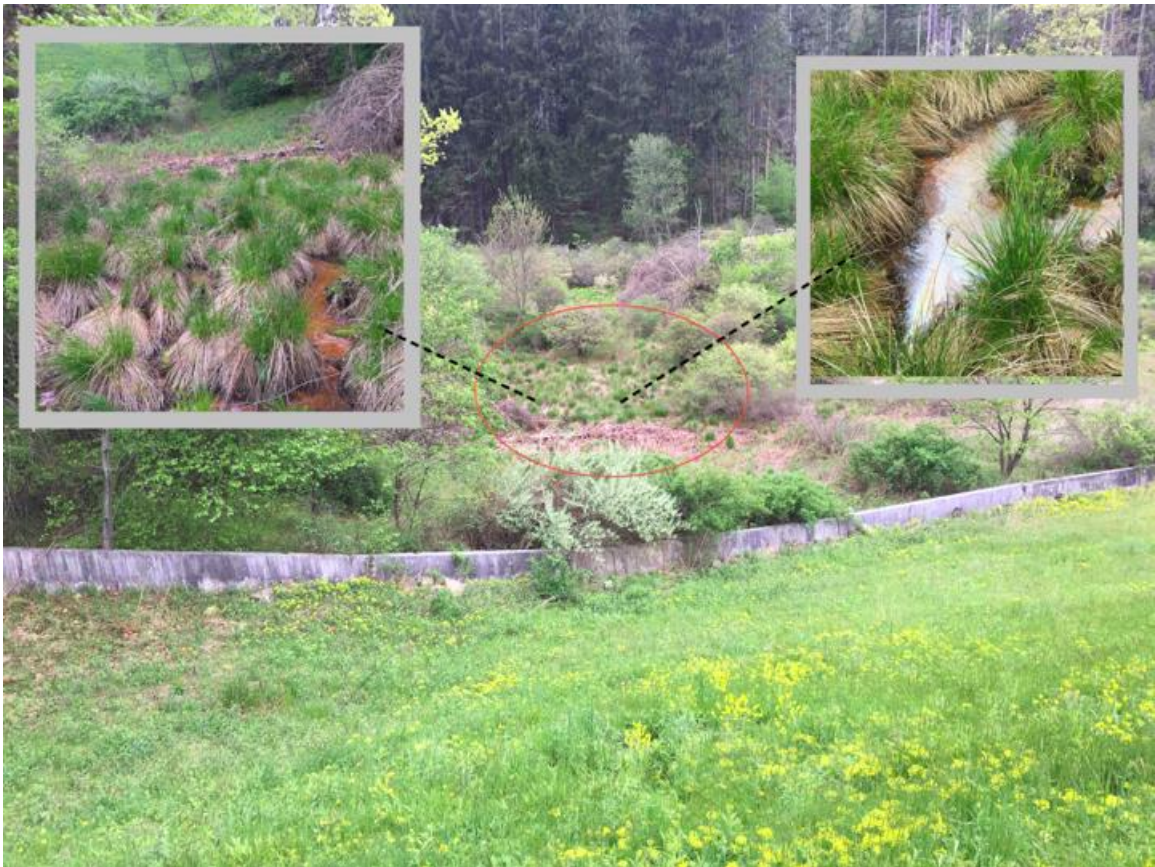
An area of standing water was observed around station 2+60 from the right end and about 30' downstream of the concrete jersey barriers. The outflow spot for this standing water was not detected via visual inspection. No sign of sinkhole or settlement was observed on the embankment and the left abutment. The standing water looks like to be contaminated. **Figure 3.8** shows the location of this swamp and contaminated water.

Figure 3.8 Location of standing water downstream of the jersey barriers at station around 2+60.

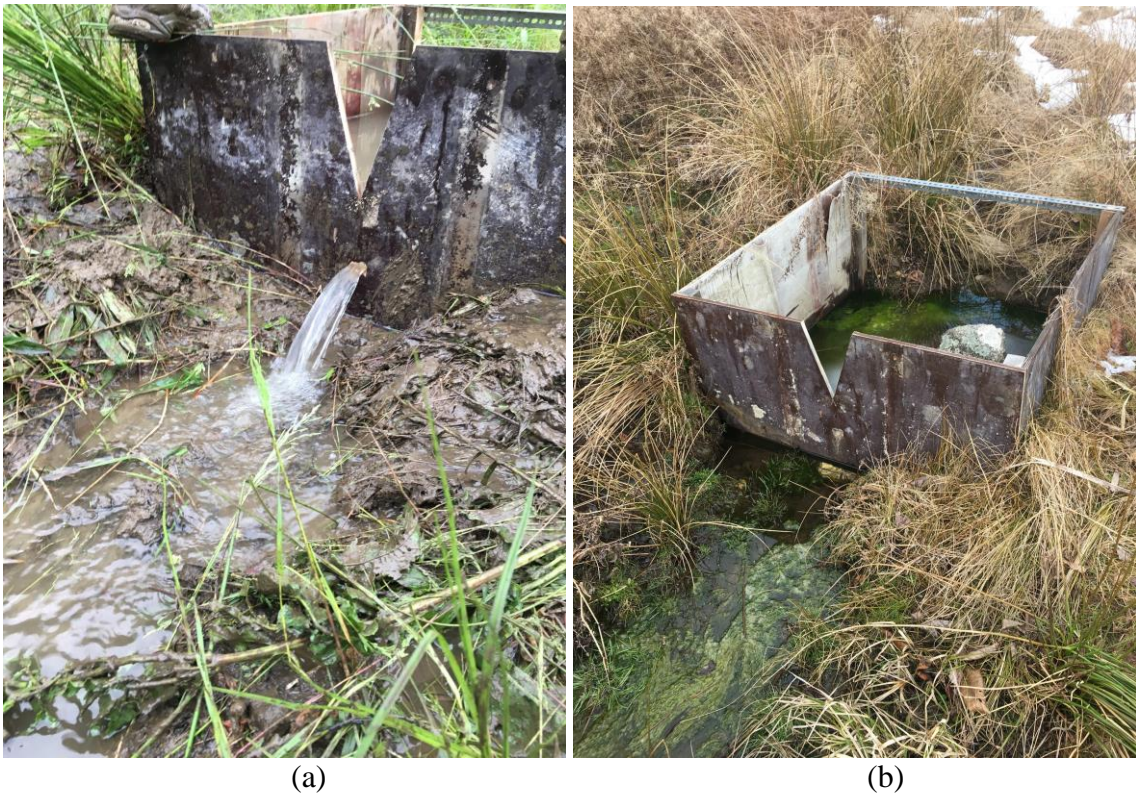
The amount of discharge was also measured with an average of 0.0137 cu ft/s manually within multiple trials.

Figure 3.9 Orifice weir at outflows #1 during (a) Spring 2016 and (b) Winter 2017.

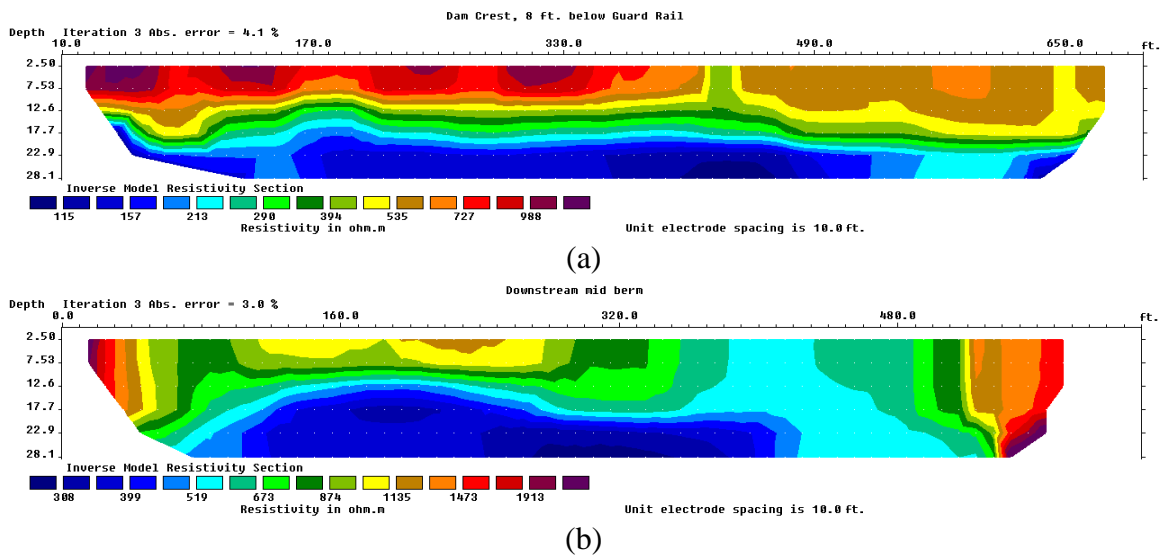
Figure 3.12 ERT results along (a) crest, (b) mid-berm of the studied dam (Continued).

For each surveying line, the recorded data is processed into a specific format to be used as input to the inversion software. The required data for the model are the title of the graph, number of the surveying points, unit distance between the electrodes, stations in the middle of the potential electrodes and apparent resistivity of each reading point. In this study, Res2vity software was employed to invert the reading data and prepare the resistivity profile along the surveying lines. **Figure 3.12** is showing the ERT profiles along three surveying lines.

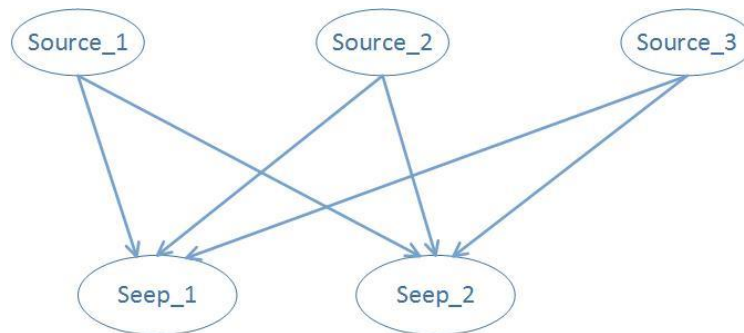
Figure 5.1 Causal network representing seepage incidents in the studied dam.
