The Collapse of the Cypress Viaduct During the Loma Prieta Earthquake of October 17, 1989

Mohamed M. Eid

This study includes investigations about the Cypress Viaduct collapse reported by:

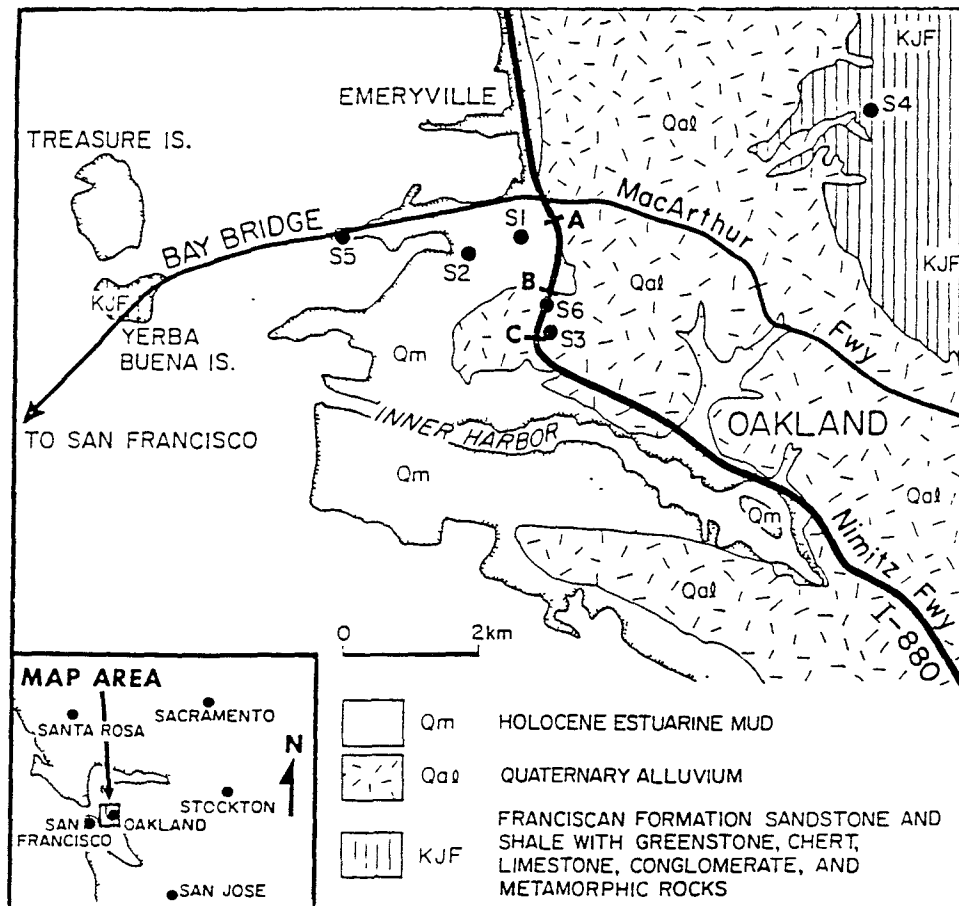
Figure 1.7 is a map of Oakland showing near-surface geology. Section AC indicates the extent of the effected portion of the Cypress Viaduct by the earthquake. AB indicates the segment that collapsed, and BC indicates the segment that was damaged but did not collapse.

would be less than section AB, and that explains why section BC was damaged while section AB collapsed.

Figure 1.7 Map of Oakland Showing Near-Surface Geology. AC Indicates the Extent of the Effected Portion of the Cypress Viaduct. AB Indicates the Segment that Collapsed; BC Indicates the Segment that Was Damaged But Did Not Collapse [3].

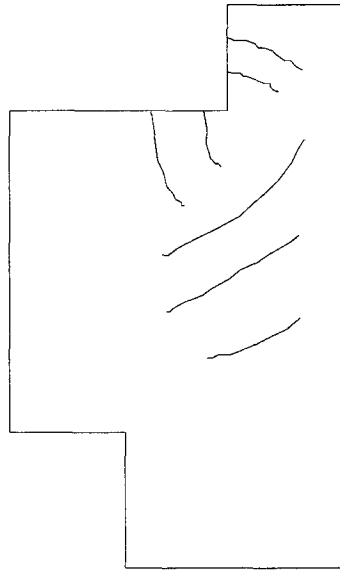
Static analyses: The Uniform Building Code (UBC, 1988) assumption of an inverted triangular distribution of the effective lateral load due to the earthquake was used to determine the forces at both decks. The force at the upper level is twice that at the lower level. Thus two-thirds of the total base shear is applied to the upper level bents and one third to the lower bent. These forces were used as input for static finite element analyses of bent type B1 and B2. Vertical loads were applied as a uniform acceleration of 1.06g (including gravity load), based on the peak vertical acceleration components at the seismic station previously mentioned. The contours of maximum principal tensile stress indicate that the column support pedestal for the upper columns in type 1 bents is highly stressed and that crack initiation will occur beneath the shear key with the crack pattern as shown in Figure 2.2.

Figure 2.2 Lower Column-to-Girder Joint.

Crack initiation in the concrete was assumed to occur at a tensile stress of 460 psi, based upon the ACI tensile strength formula (ACI, 1989) for a compressive strength of 6,000 psi.

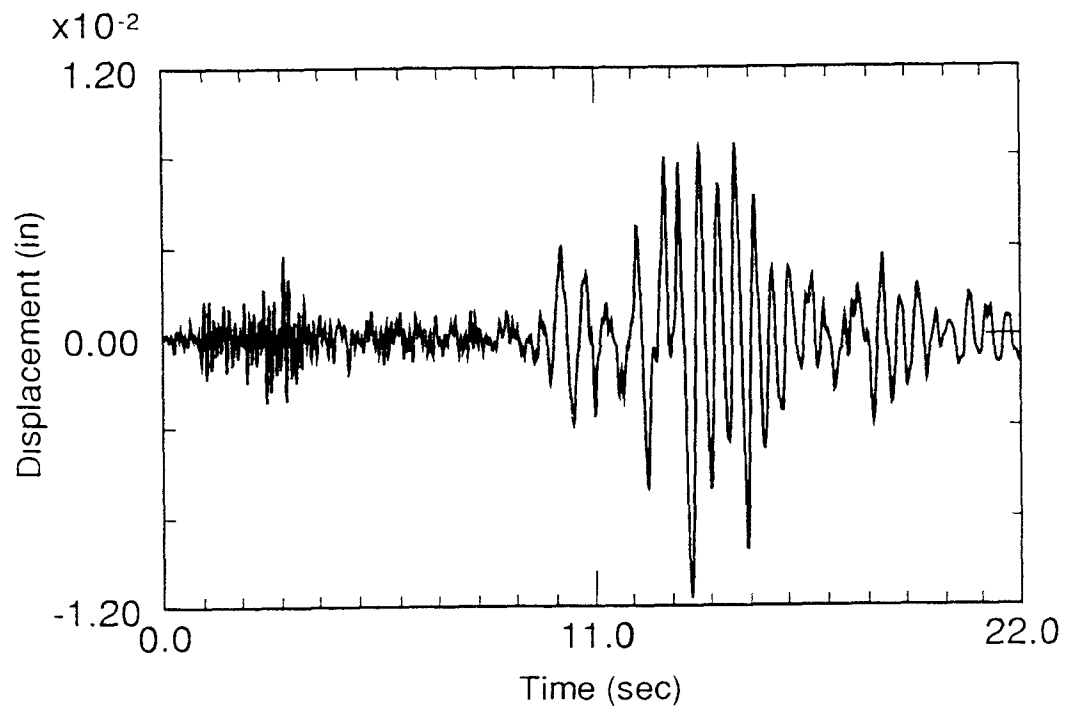
Figure 4.11 Vertical Displacement (Node 2)

There were almost no vertical displacements throughout the bent (nodes 2 and 4) as seen in Figures 4.11 and 4.12.

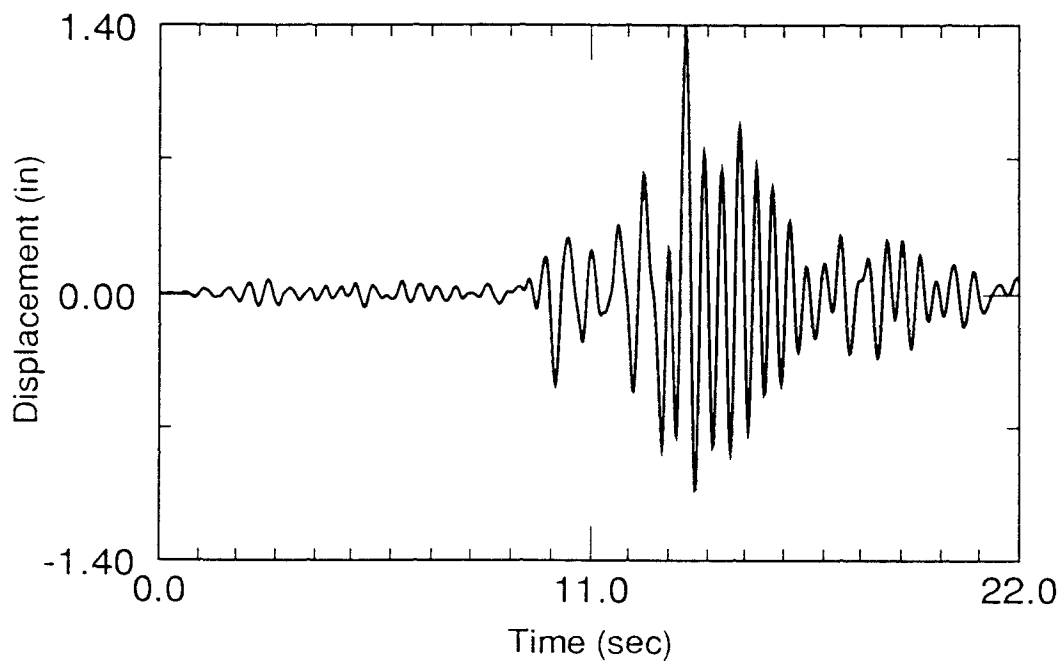
Figure 4.23 Lateral Displacement (Node 3)

The top level lateral displacements (node 3) are 1.39 in. (Figure 4.23) and 1.88 in. for bent heights of 46 ft and 54 ft, respectively. These are significantly higher than the top level displacements of 0.72 in. and 1.3 in. for the unretrofitted and the retrofitted structures (as mentioned before in Chapter 2, Section 2.1.2), which indicates that the structure had undergone large inelastic deformations in the upper story especially in columns just below the shear keys.

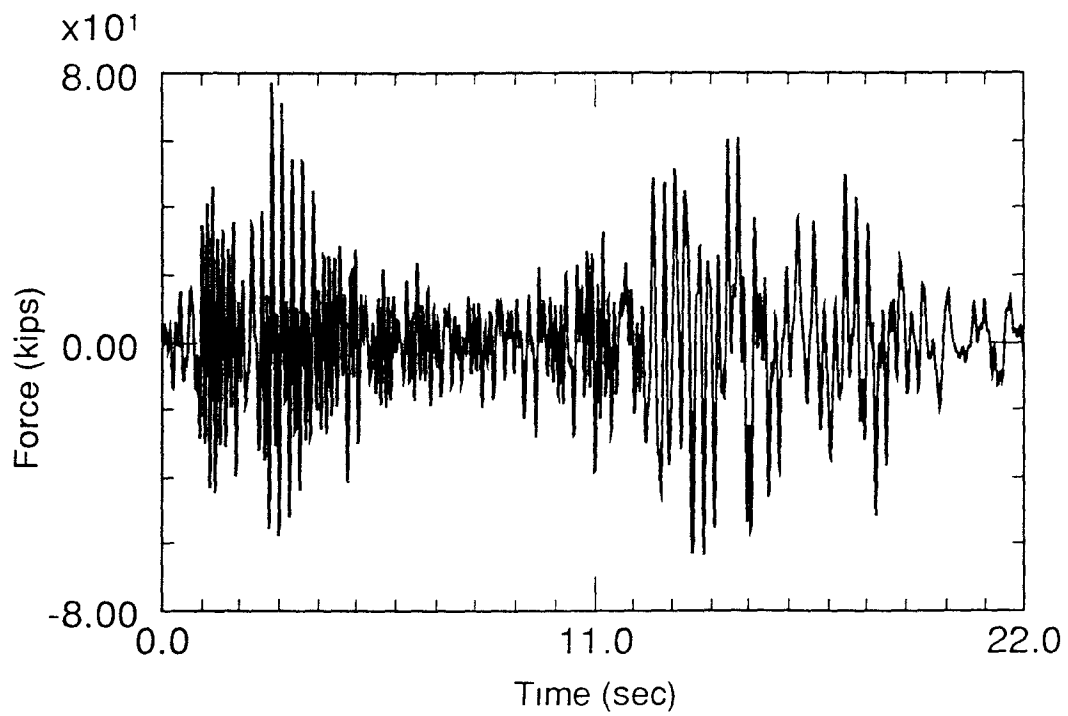
Figure 4.41 Seismic Axial Force (Node 1)

The maximum seismic axial tension force (635 kips), shown in Figure 4.41, did not exceed the vertical compressive force (708 kips) resisted by the upper column due to gravity loads, which shows that net force acting on the upper columns during the earthquake was compressive, implying that there was no effect on the shear strength of concrete at section 2–2 by the axial force (where tension forces reduce the shear strength).

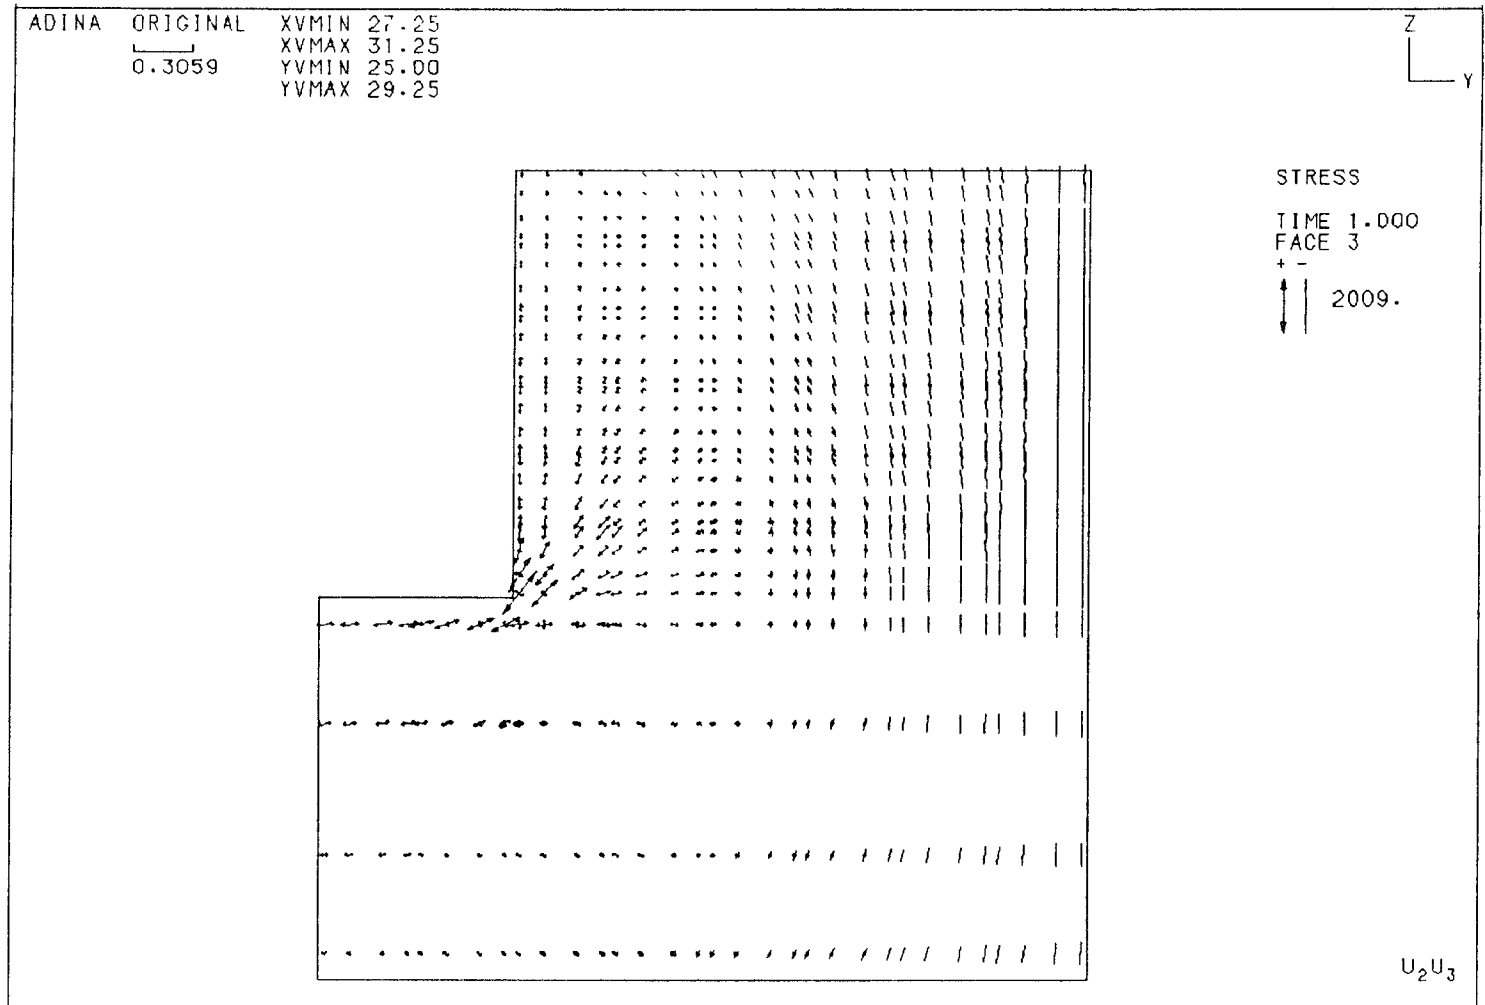
Figure 4.43 Stress Vectors in the Upper Column (Below the Shear Key)

Figure 4.43 shows the stress vectors in the column indicating high tensile stress concentration at the inner side of the joint.

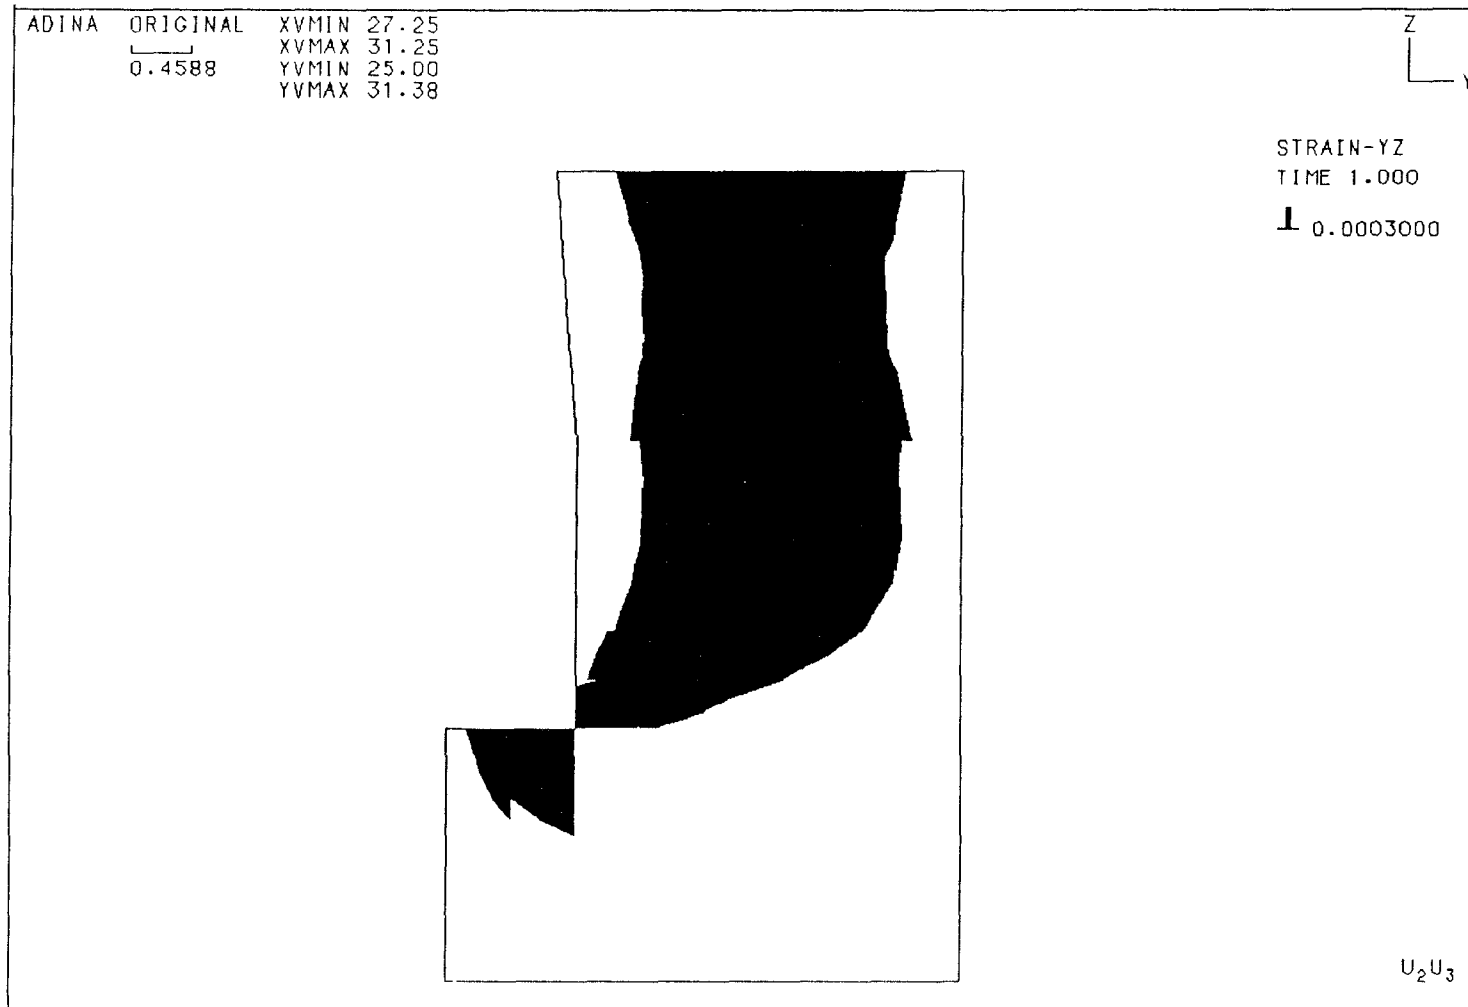
Figure 4.44 Strain Distribution in the Lower Joint

Figure 4.44 shows the strain distribution in the previous joint. Below the shear keys, the upper columns are subjected to strains far exceeded the tensile strain of concrete (0.000124), indicating extensive cracking at these locations.
