### **DEVELOPMENT OF GIS DATABASE FOR HAYWARD**

#### **FAULT**

**Olugbope Maku**

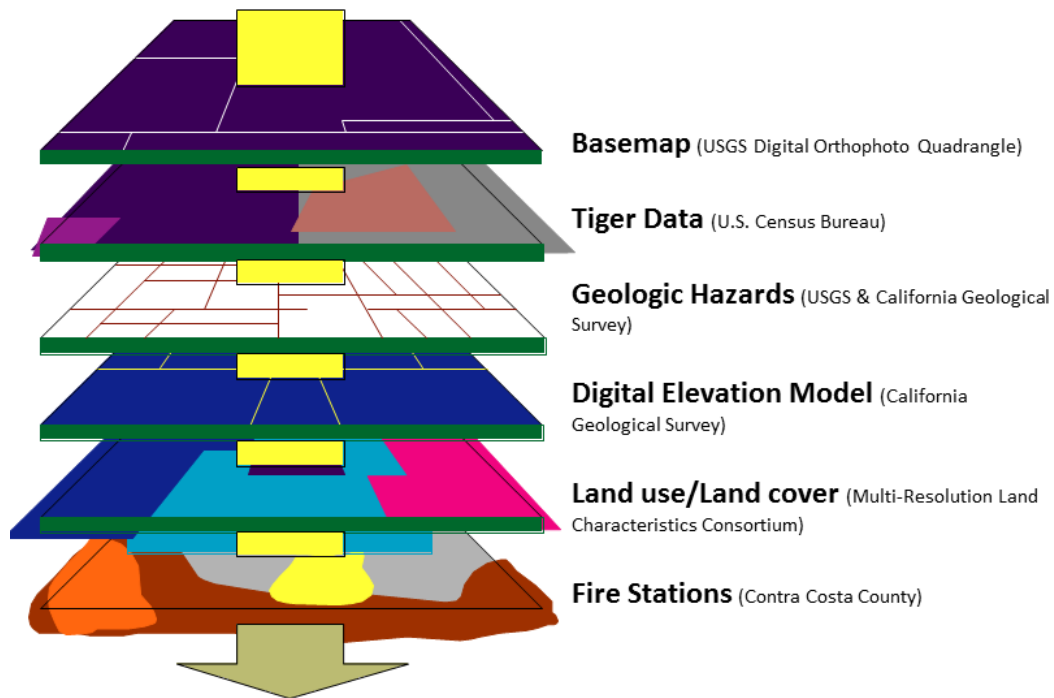
## GIS CONCEPTUAL DATABASE OF HAYWARD FAULT

**Figure 1.1: GIS conceptual database of Hayward Fault**

This study utilizes the USGS Digital Orthophoto Quadrangle (DOQ) as base map for Richmond, Mare island, Petaluma Point and San Quentin California; other data layers include Tiger data from the U.S. Census Bureau comprising roads, hydrography and community services such as hospitals, schools, police station, public library and religious centers. The digital elevation model (DEM) obtained from the California Geological Survey. Map Layers of springs, trench, and areas susceptible to creep and landslide obtained from the USGS and California Geological Survey. The locations of fire stations obtained from the Contra Costa County GIS database. The soils layer from the Natural Resources Conservation Service (NCRS) and land use/land cover layer from the Multi-Resolution Land Characteristics Consortium (MRLC). The conceptual database is as shown in Figure 1.1

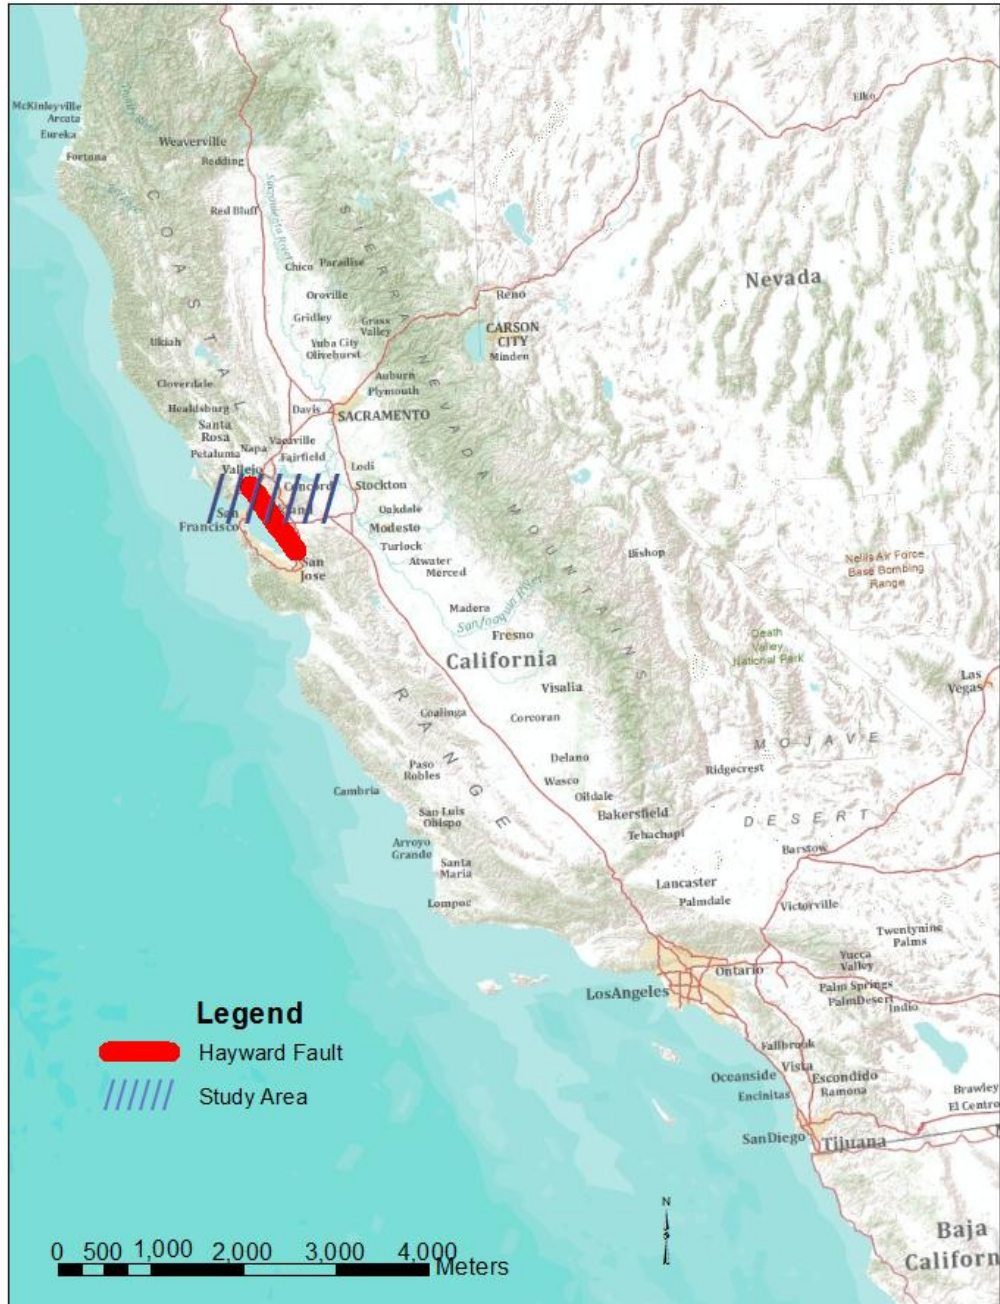
## LOCATION OF HAYWARD FAULT WITH THE STUDY AREA

Figure A.1: Map of the study area

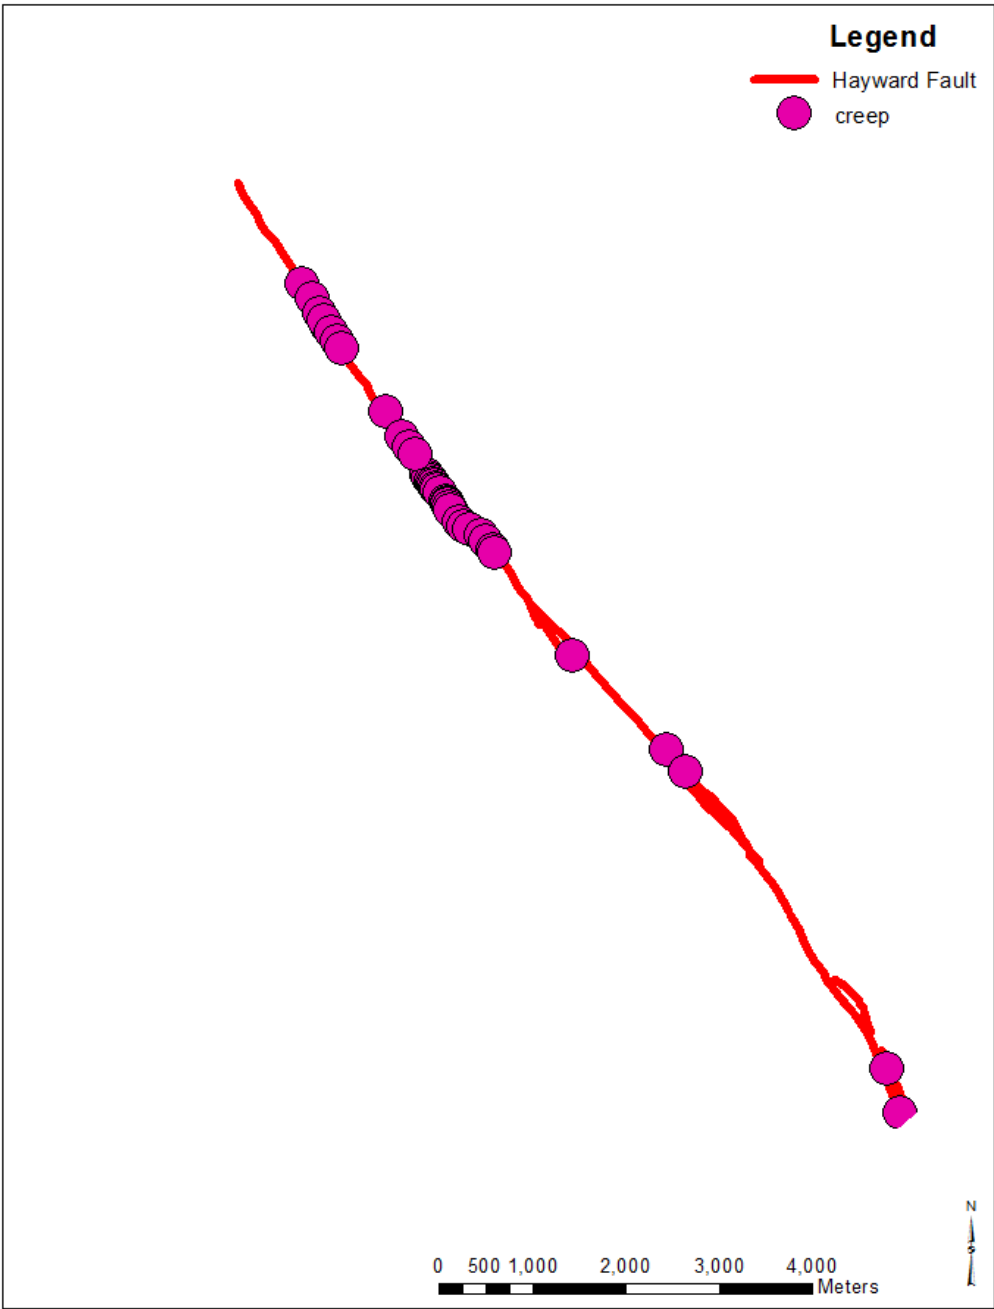
# HAYWARD FAULT CREEP LOCATIONS

**Figure A.3: Hayward Fault creep locations**

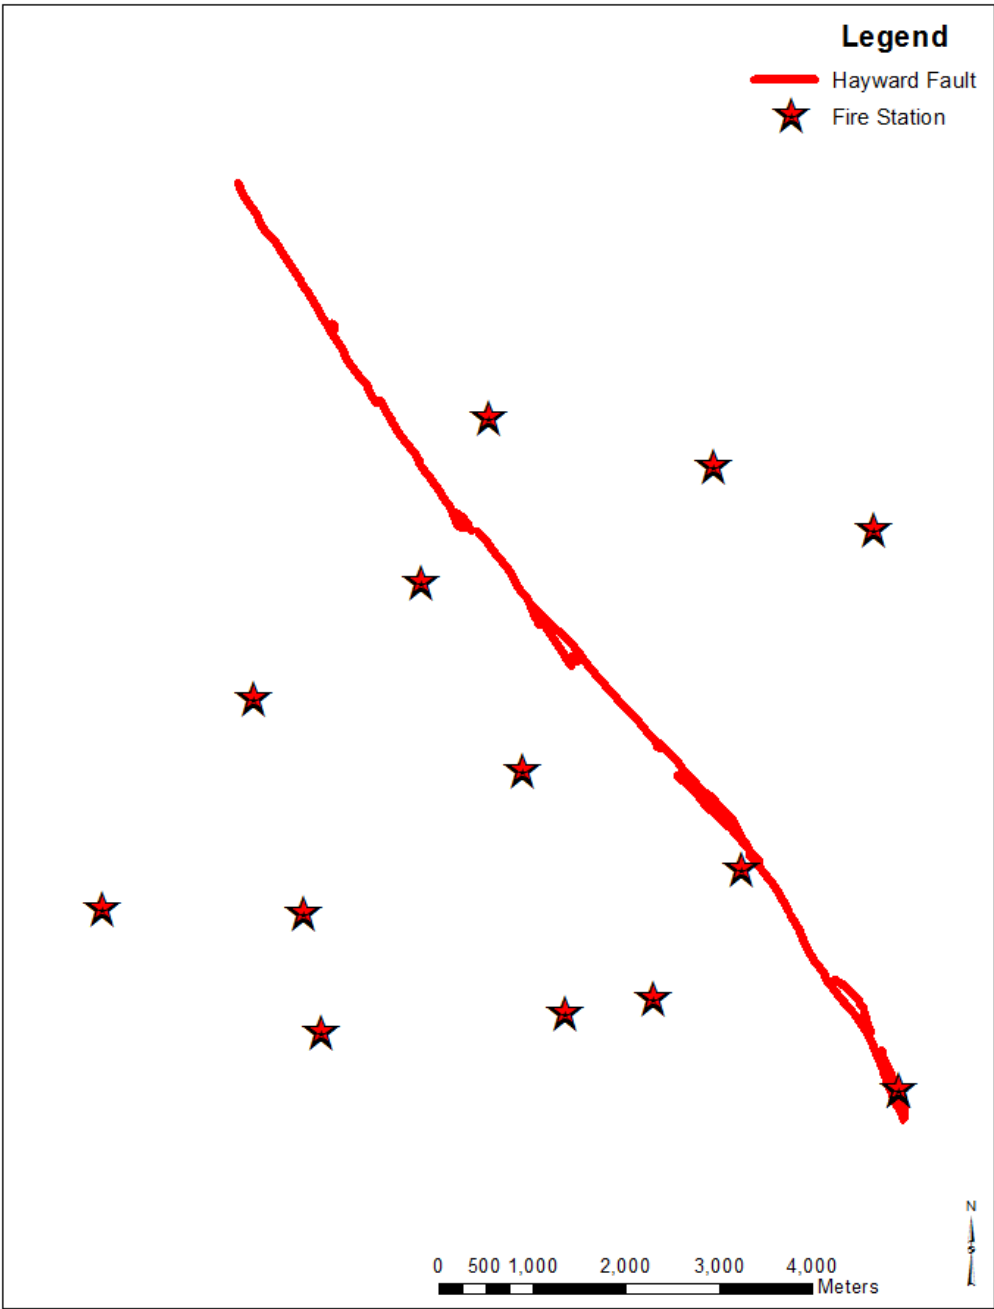
# HAYWARD FAULT WITH FIRE STATION LOCATIONS

<http://www.ccmmap.us/information.asp>  
**Figure A.4: Hayward Fault fire station locations**

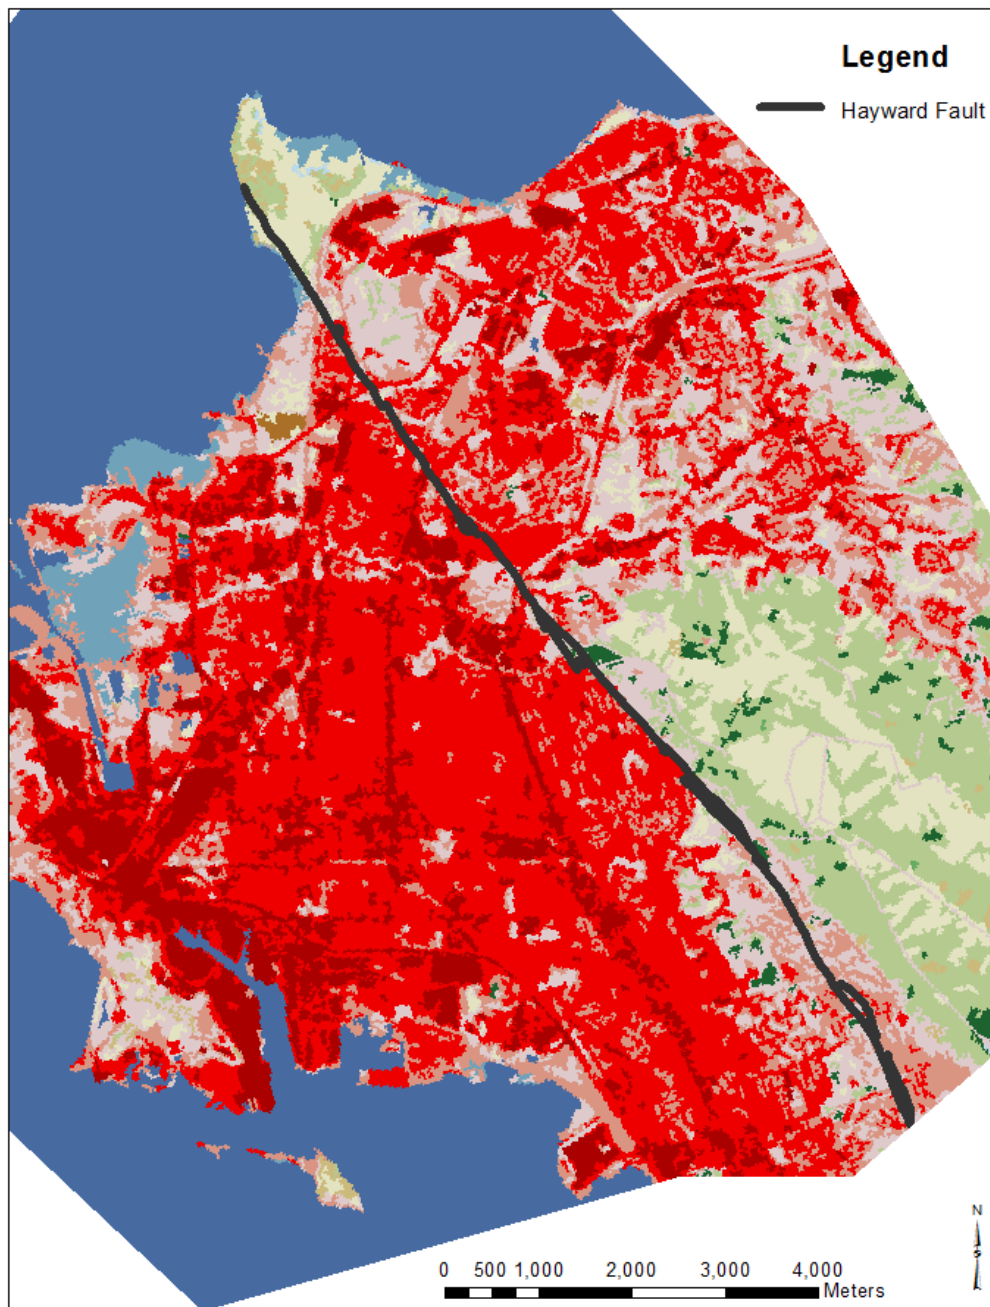
## HAYWARD FAULT LAND USE/LAND COVER MAP

Figure A.5: Hayward Fault land use/land cover map

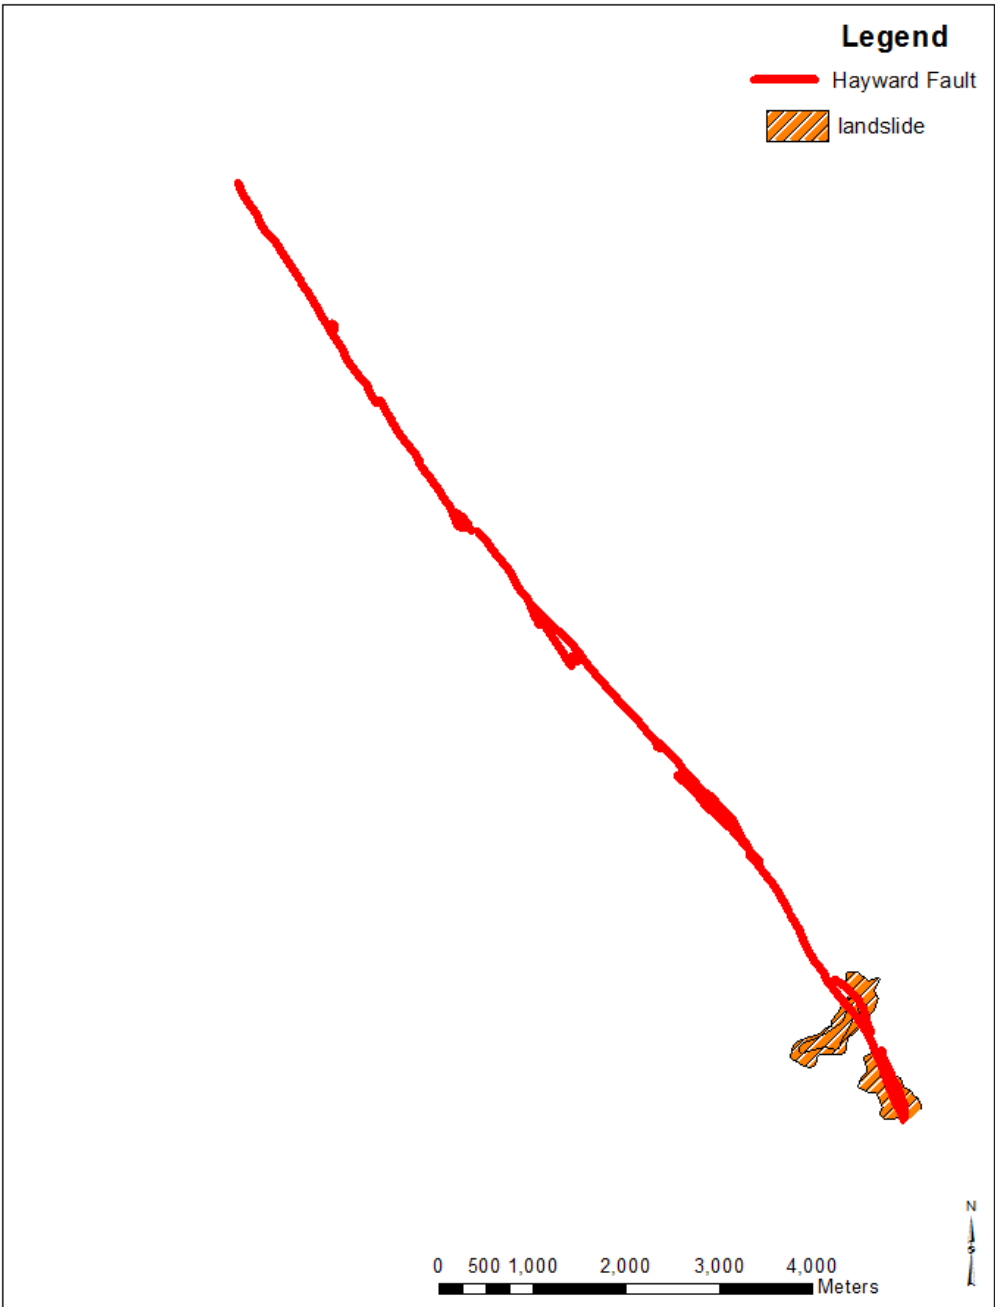
# HAYWARD FAULT WITH POTENTIAL LANDSLIDE LOCATIONS

**Figure A.6: Hayward Fault potential landslide locations**

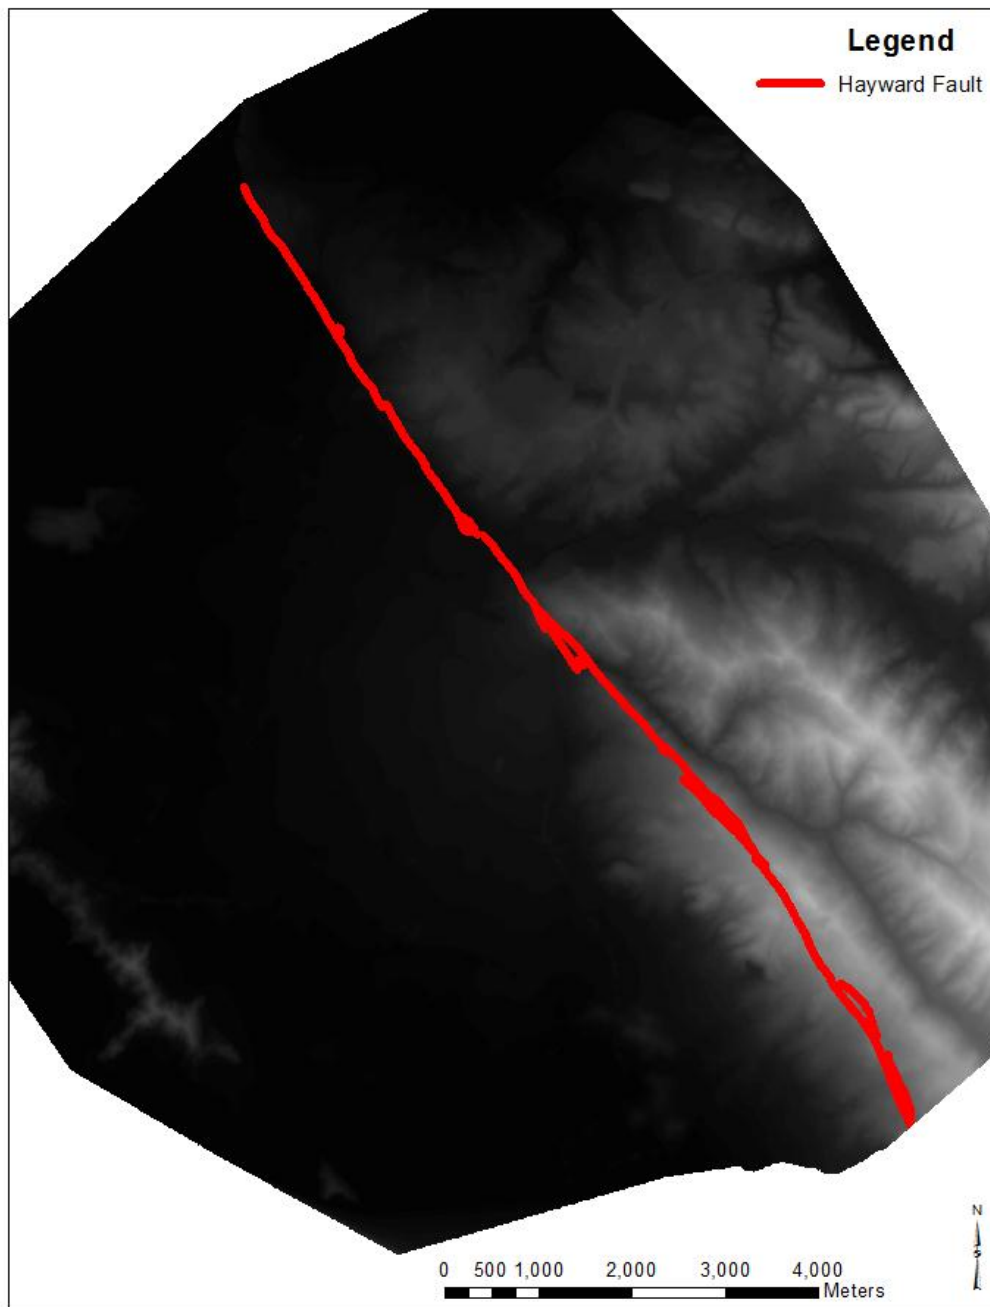
## HAYWARD FAULT DIGITAL ELEVATION MODEL

**Figure A.8: Hayward Fault digital elevation model**
