THE MORPHOLOGY OF UHMWPE WEAR DEBRIS GENERATED BY A HIP JOINT SIMULATOR

**THE MORPHOLOGY OF UHMWPE WEAR DEBRIS
GENERATED BY A HIP JOINT SIMULATOR**

**A Thesis
Submitted to the Faculty of
New Jersey Institute of Technology
in Partial Fulfillment of the Requirements for the Degree of
Master of Science in Biomedical Engineering**

May 1995

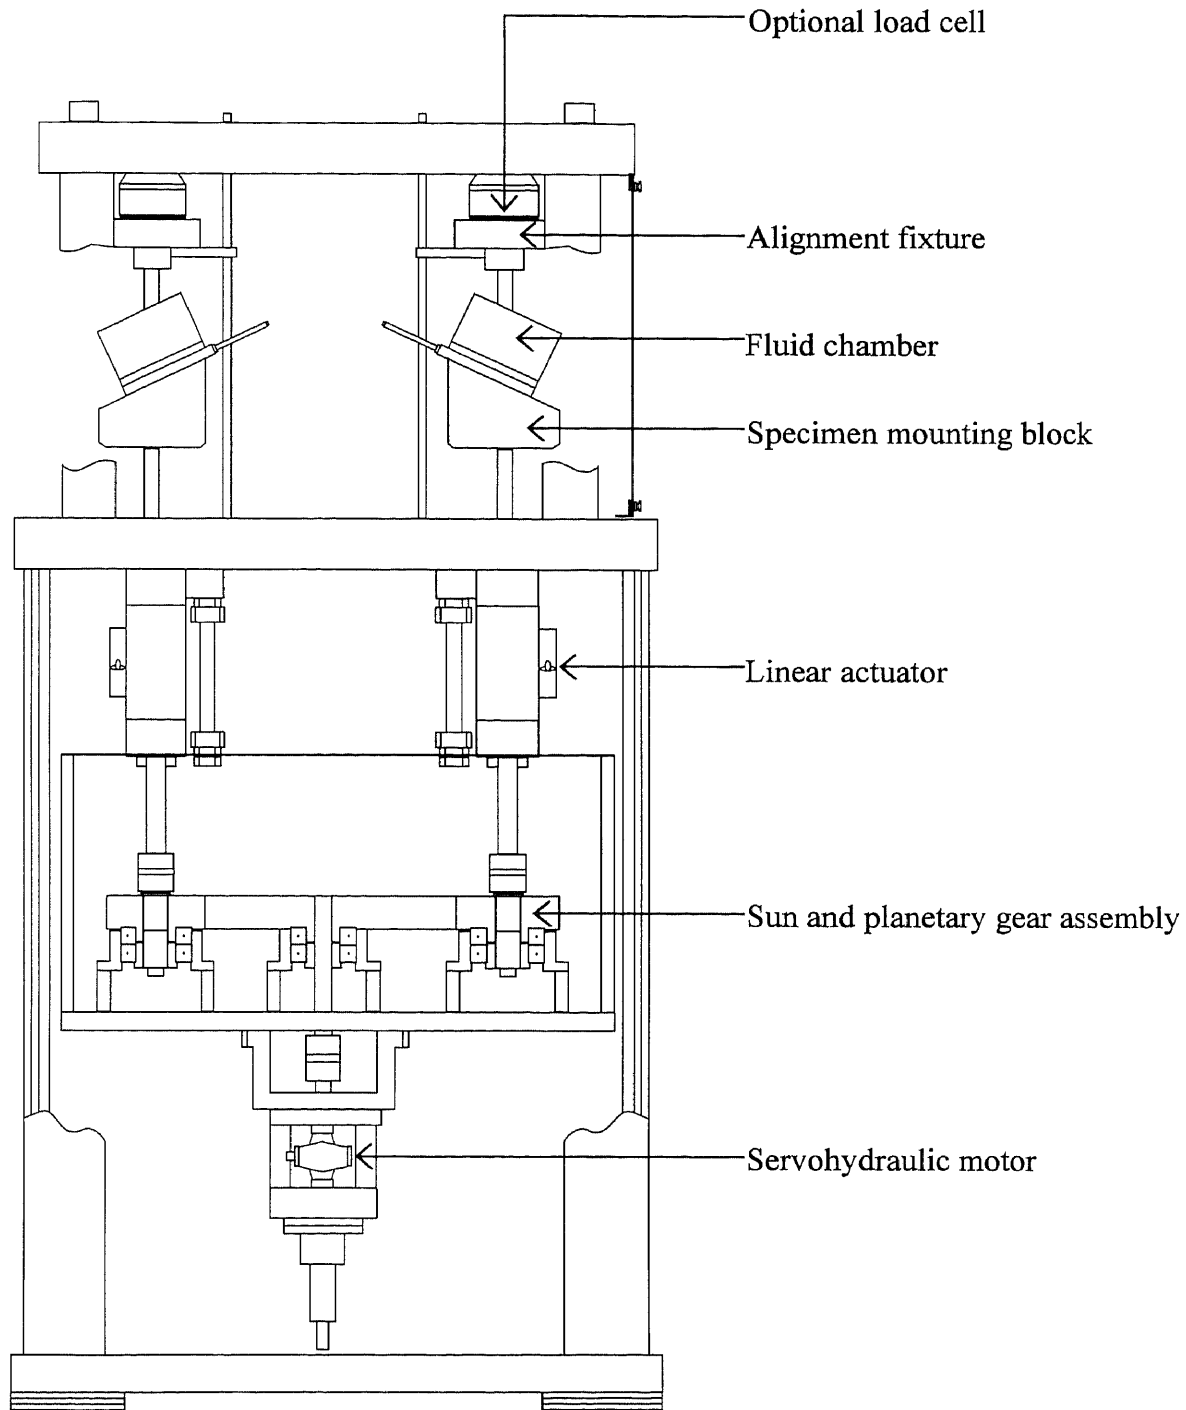
Figure 1. Schematic of MTS/Howmedica Hip Joint Simulator

The simulator was constructed by MTS systems and was digitally controlled. A detailed paper describing the simulator can be found in the literature but a brief description will be given here [34]. The system consisted of a load frame accommodating eight separate stations with control provided by a remote panel. A schematic of the simulator is shown in Figure 1, and overall operation is similar to that developed by McKellop and Clarke [35]. Figure 2A is a schematic of one station and shows a spigot for fixation of the head above the test chamber. The chamber houses the acetabular cup and is fixed to a rotation block by a bearing. This block has an inclination of 23° and is rigidly fixed to the load shaft. This configuration allows a single shaft to provide simultaneous biaxial motion comprised of rotation and axial loading. Loading is provided by a linear actuator through which the shaft passes, while rotation is imparted to all eight individual station shafts by a motor and planetary gear system. Each station shaft thus loads and rotates each block and the rotation block bearing allows the block to turn without subsequent chamber rotation which is prevented by an anti-rotation pin. Motion of the chamber is provided by the angled face of the rotation block. As the block rotates along with the shaft the angled face causes the chamber to oscillate in an oval motion. The cup was seated in a polyurethane mold which was fixed within the chamber by several dowel pins. A steel collar provided additional support. This is shown in

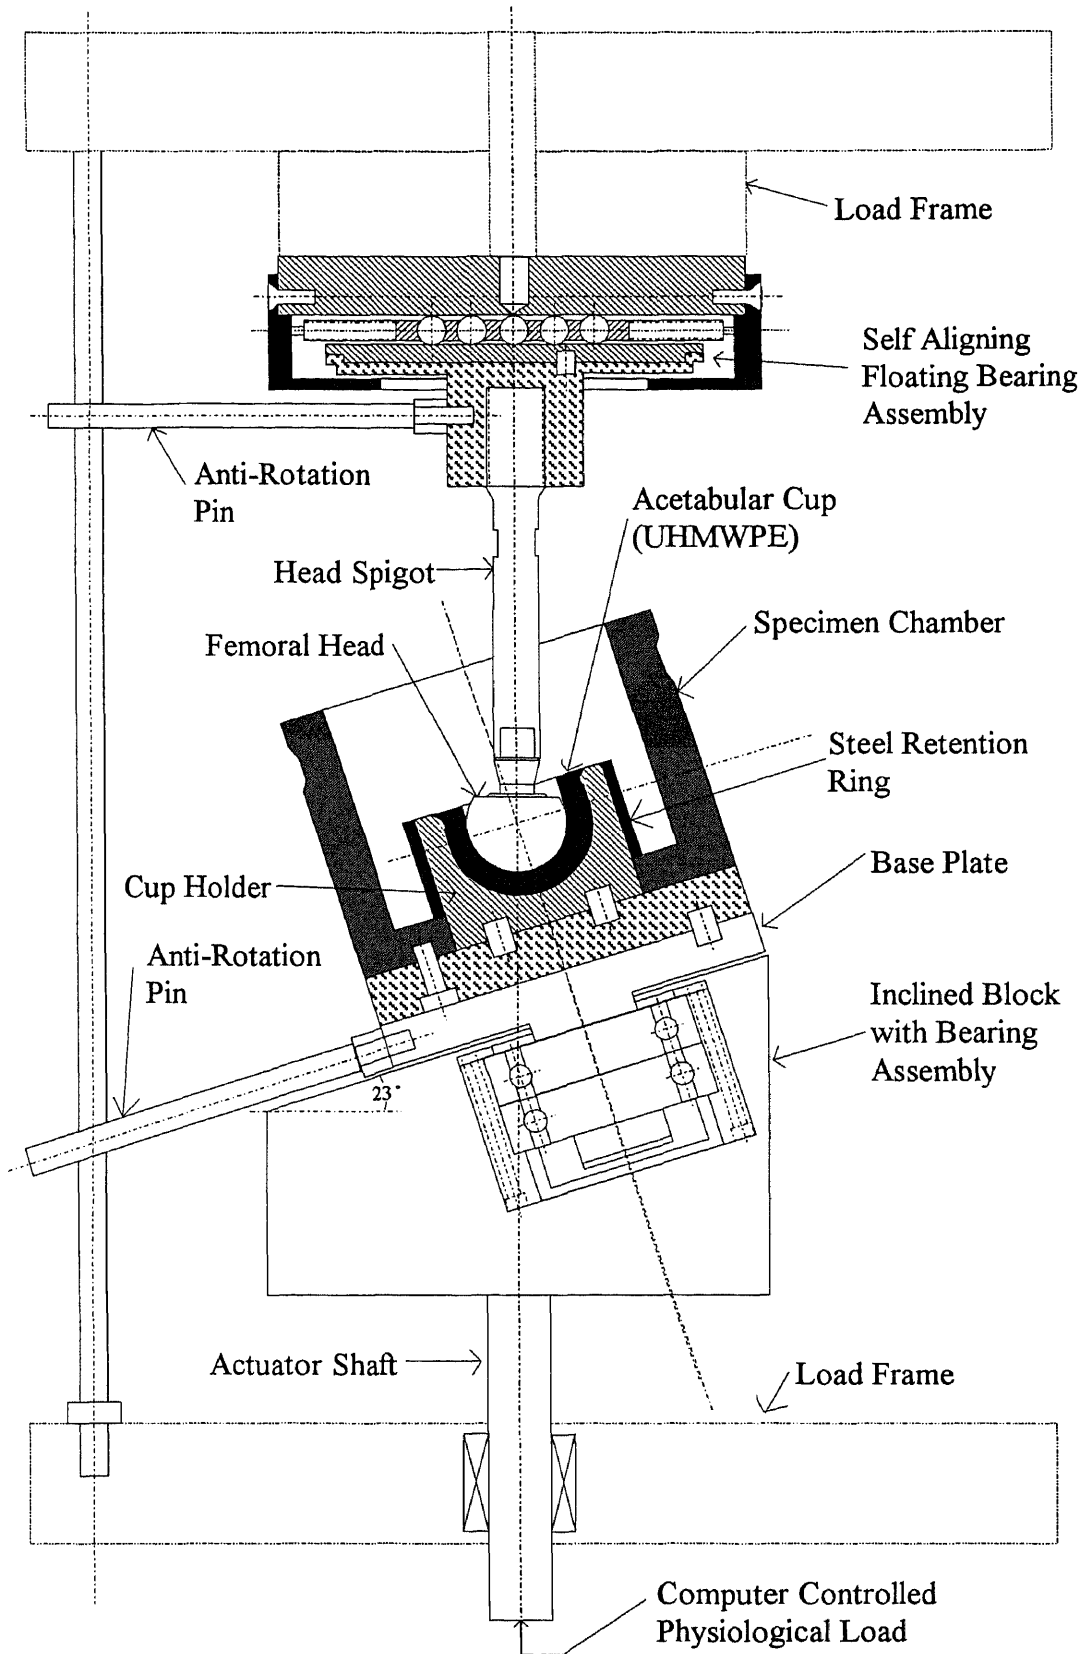
Figure 2A. Schematic of Simulator Showing a Blow Up of the Head/Cup Interface

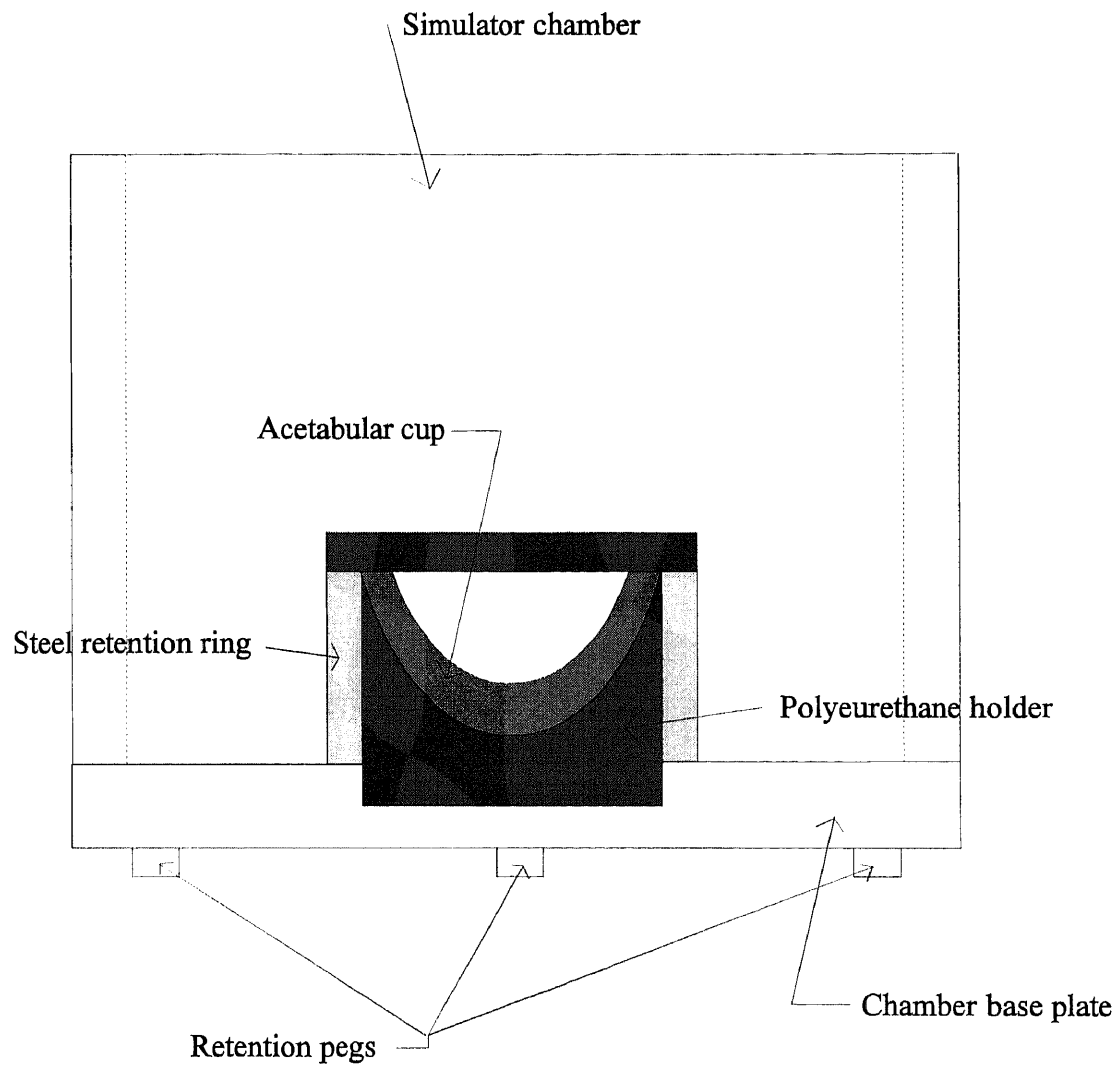
Figure 2B. Schematic Showing Specimen Chamber for Simulator

Figure 2B. Thus articulation follows the same oval motion that the chamber experiences. The head spigot above the chamber is mounted to a floating load bearing, allowing for self alignment. All loading and motion is caused from the load shaft below however, so this point may be considered fixed.

The simulator fixturing provided a specimen chamber that was filled with bovine calf serum. (0.3% sodium azide added as an anti-bacterial agent) It was the bovine serum lubricant that was collected as a source of wear debris particles.

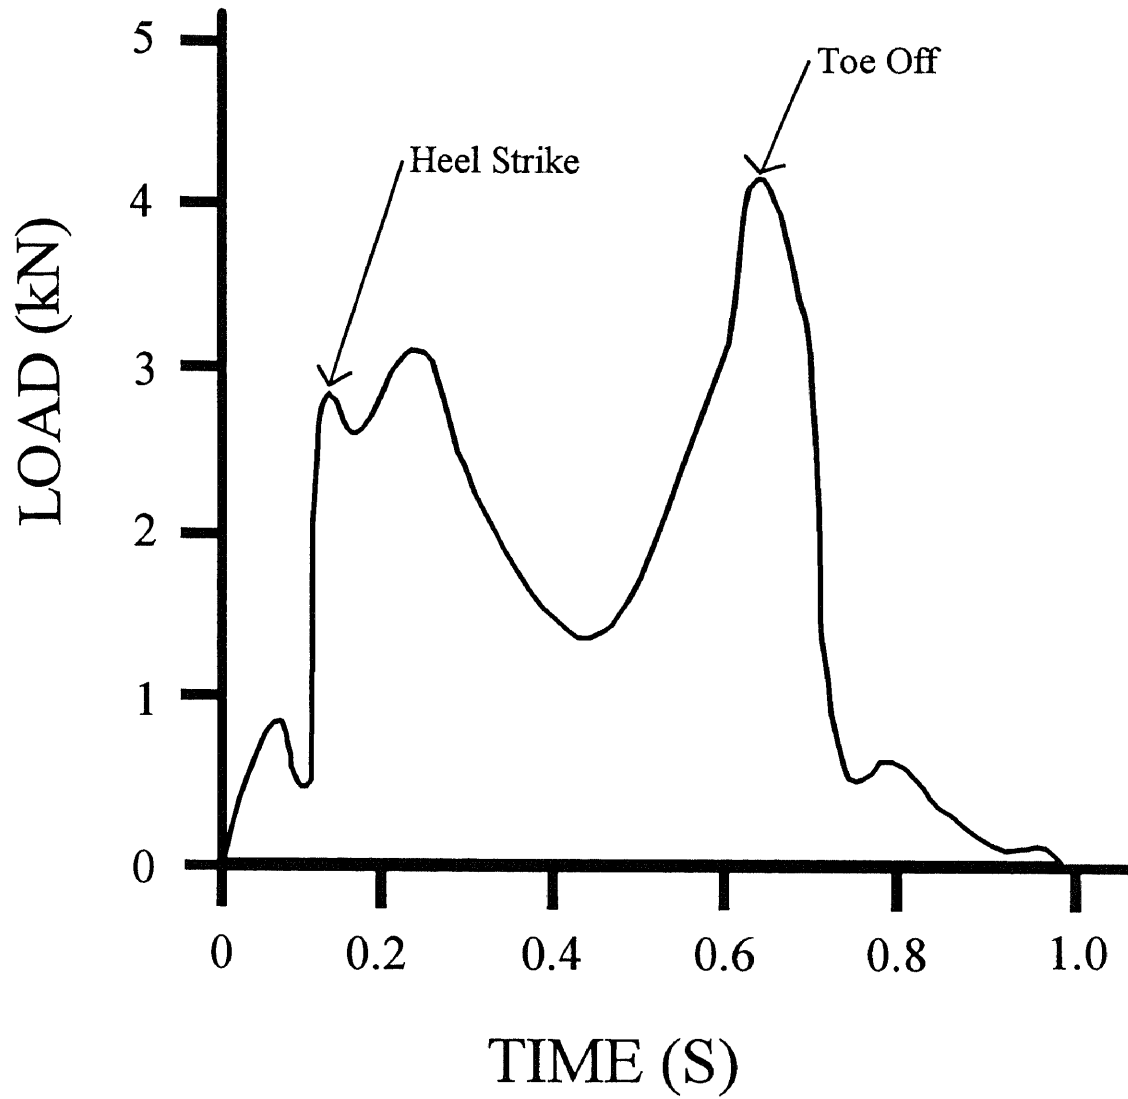
Figure 3. Loading Profile Used for Simulator Testing (Reference [34])

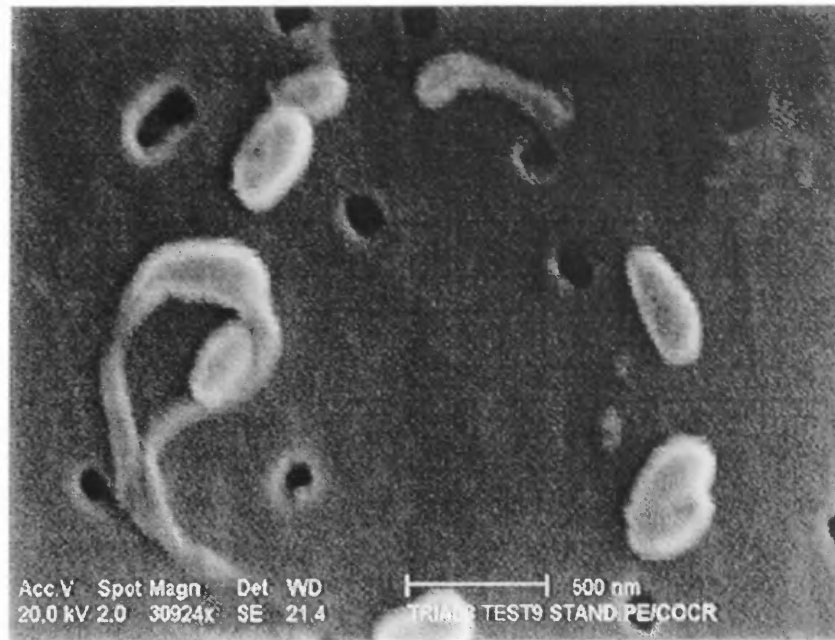
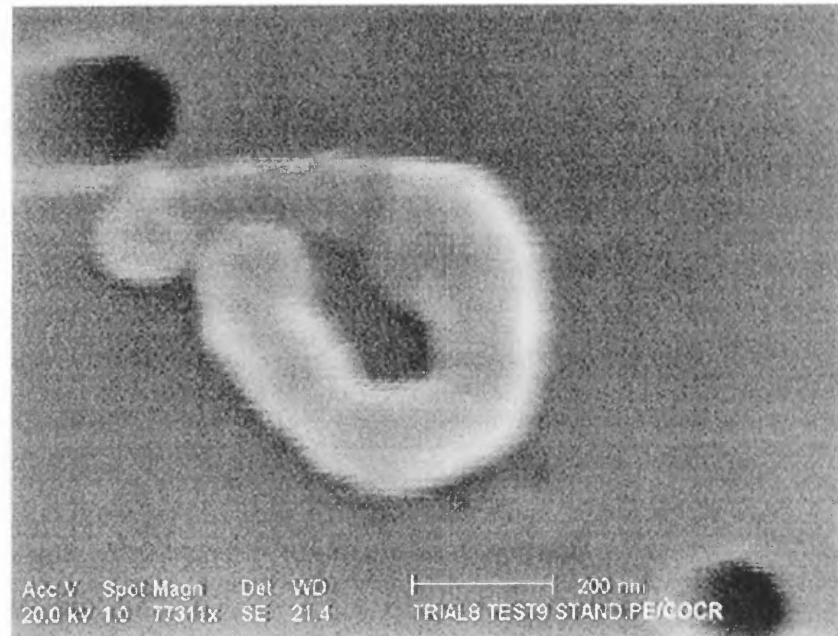
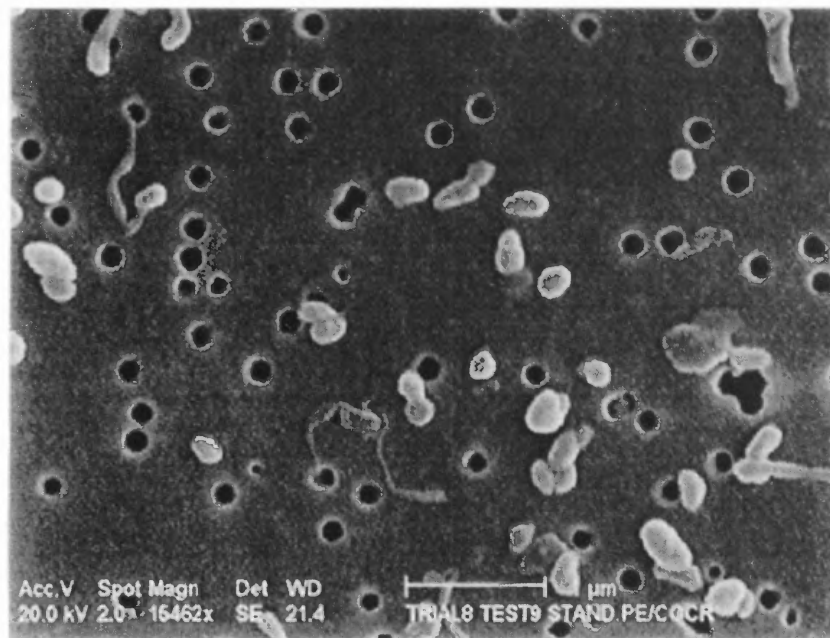
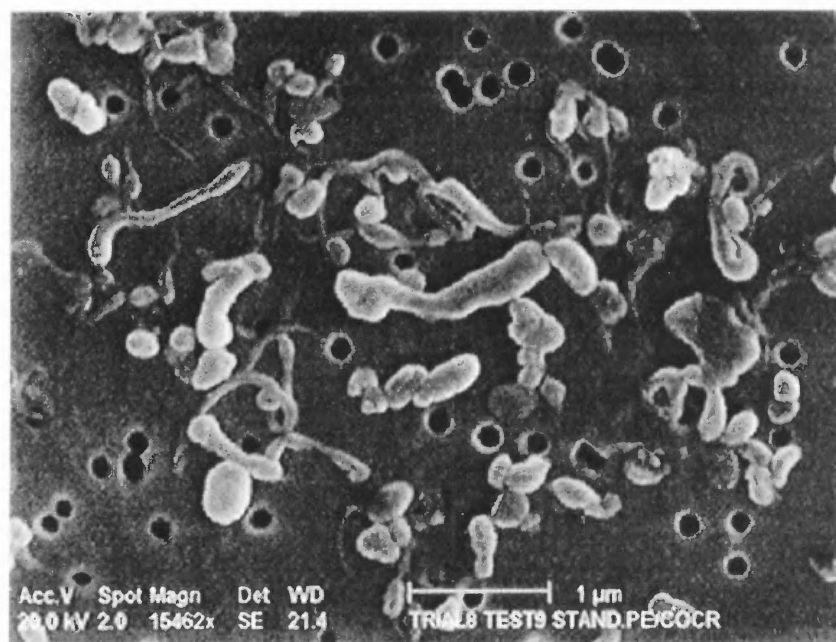
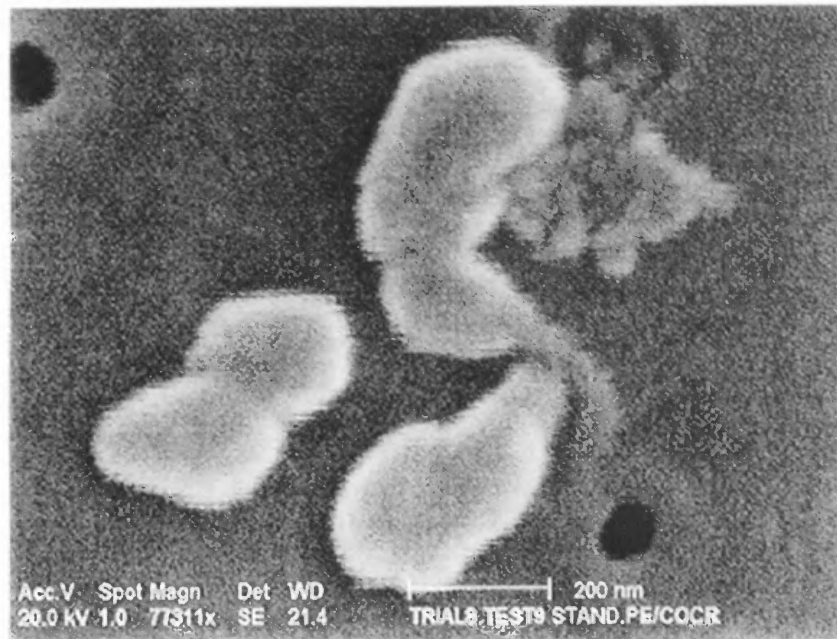
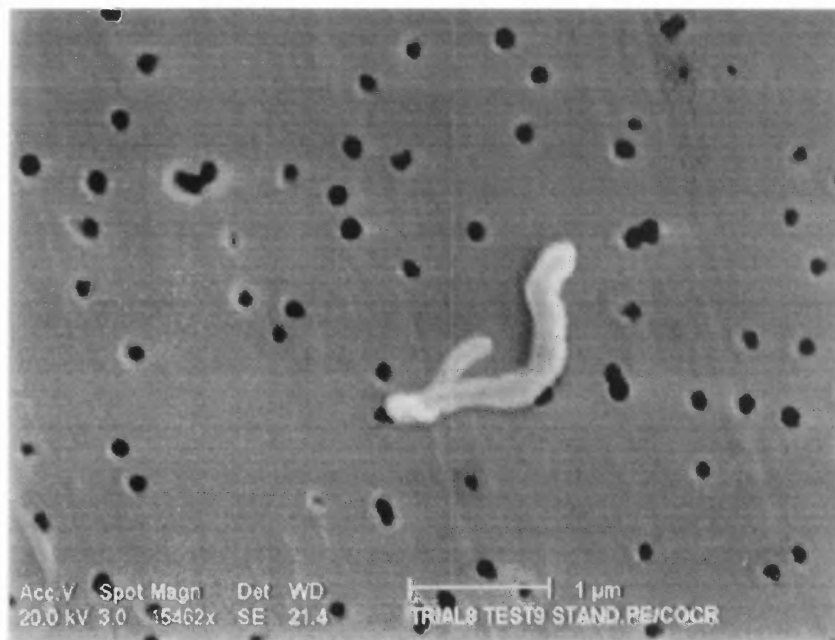
Figure 8. Micrographs of Trial 1 (CoCr-UHMWPE) Wear Particles

A standard material pair used in THRs, CoCr against UHMWPE, was used as the standard control for comparison. purposes. This trial proved to be very successful, yielding a vast number of microscopic particles. These are shown in Figures 8A-8Z (see APPENDIX A). These figures show micrographs of the observed particles. The background surface shown is the actual surface of the 0.2 μm filter used for particle collection. The round dark spots that can be noted are the holes in the surface of the filter. Note the very regular and smooth appearance of the filter surface. This allows for easy identification of any particles collected. The particles appear as lighter colored irregular objects resting on the surface.

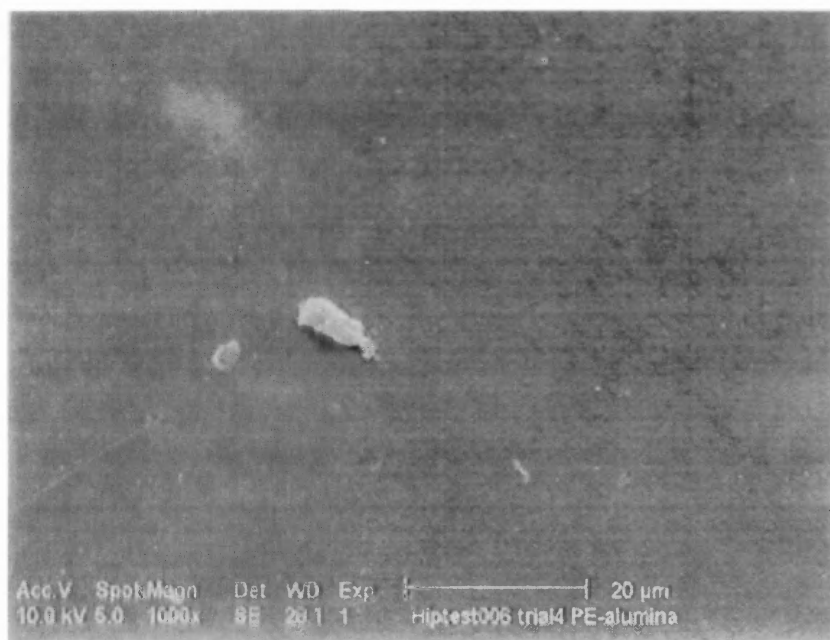
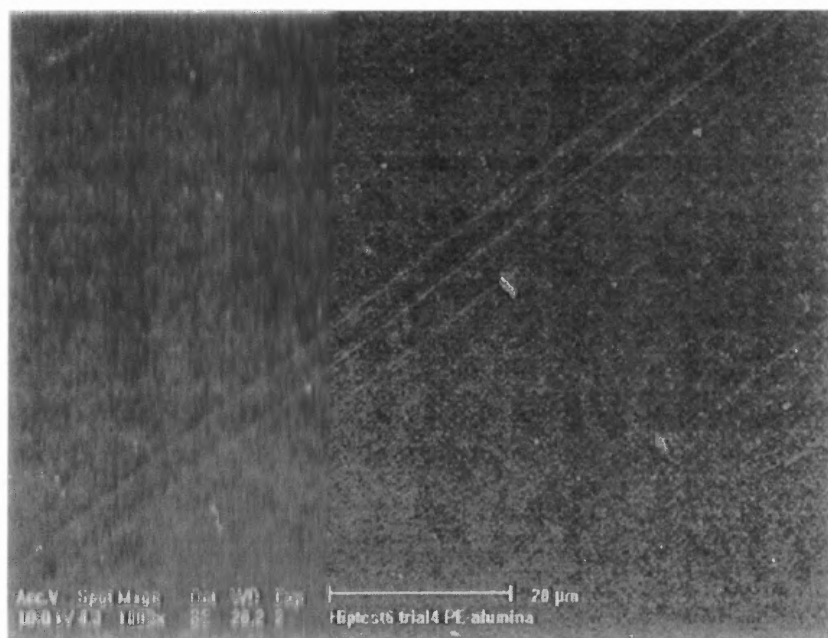
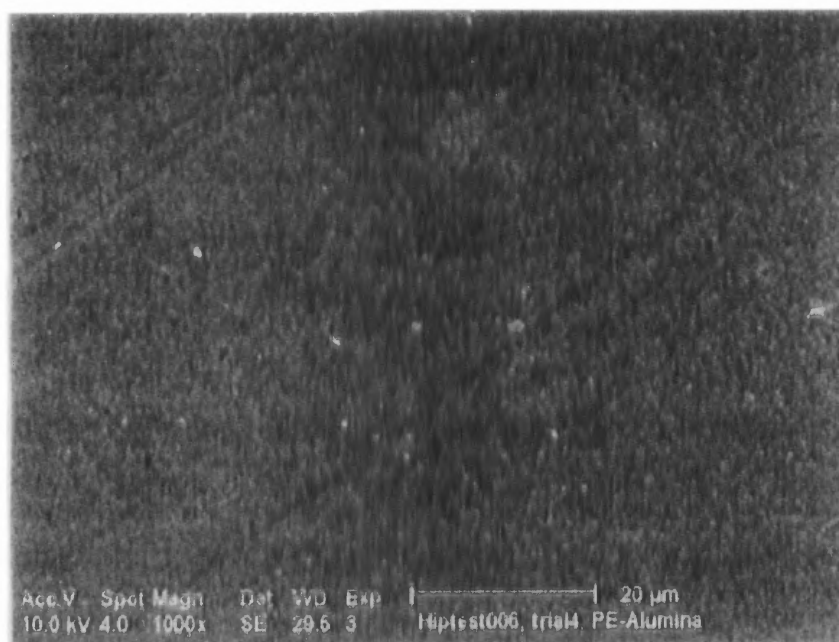
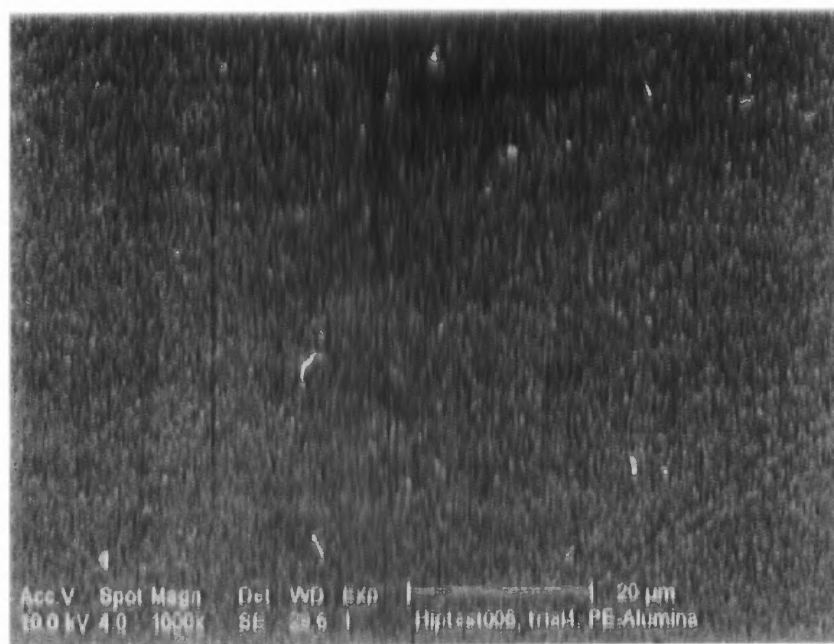
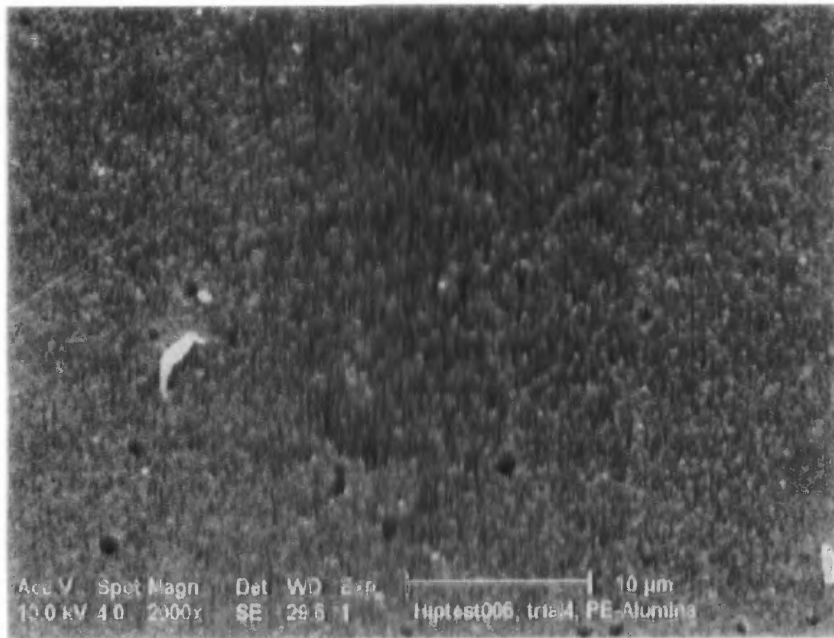
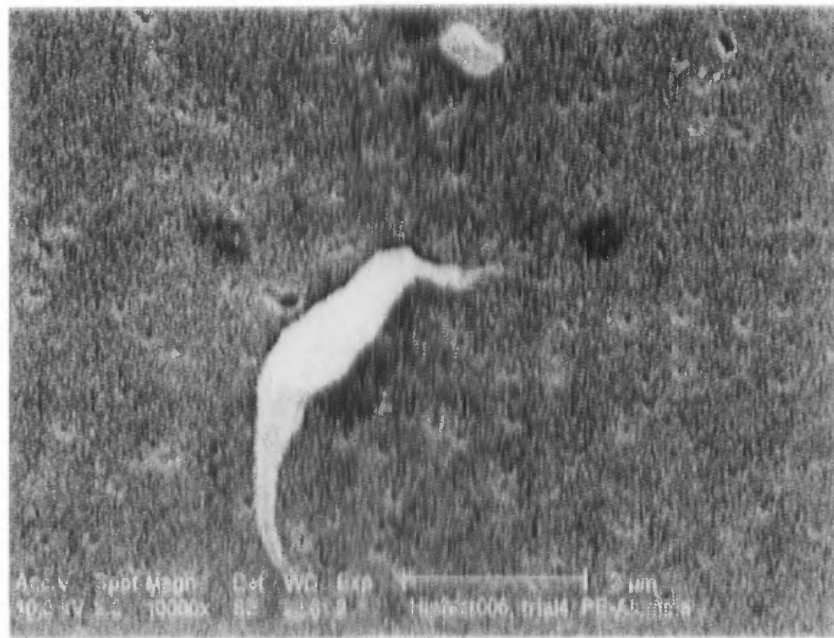
Figure 10. Micrographs of Trial 2 (Alumina-UHMWPE) Wear Particles

was apparently very diluted as the particles seen were somewhat spread out on the filter surface. The particles observed were similar to those seen for the CoCr control. Two separate particles types were again noted. These included the same small spherical type 1 particles as well as the larger fibrous type 2 particles. The smaller ones were egg shaped or elongated ovals, with a size range of 0.2 μm to about 0.75 μm in largest dimension. These smaller particles appeared to have a slightly less smooth or regular surface than that of the control. The second larger type of particle was also present with similar thread or shard like shapes. The size of these appeared to range from 1 to 5 μm , with all smaller than 10 μm and they were observed to be curled in some cases. A "head" was also present on some of them, as well as regions of necking. This second particle type was generally larger than the corresponding type seen with the control. It is interesting to note that some of the larger particles (Figure 10N) actually appeared to be agglomerates or collections of smaller particles stuck or fused together. This was generally not observed for the control, which demonstrated reasonable distinction between individual particles.

The approximate average size of a Trial 2 particle was also determined using the same measurement technique already described. Micrographs with a magnification of 10000x were selected and enlarged 200x. A total of 90 particles were randomly selected from several micrographs. The average length of a particle was found to be 0.903 μm , with a width of 0.337 μm and an aspect ratio of 2.97. Frequency distributions are shown in Figure 11. Although these particles averaged a larger size than the control, the average shape was similar if the aspect ratios are considered. This value again indicates the average particle was about 3 times longer than it was wide.

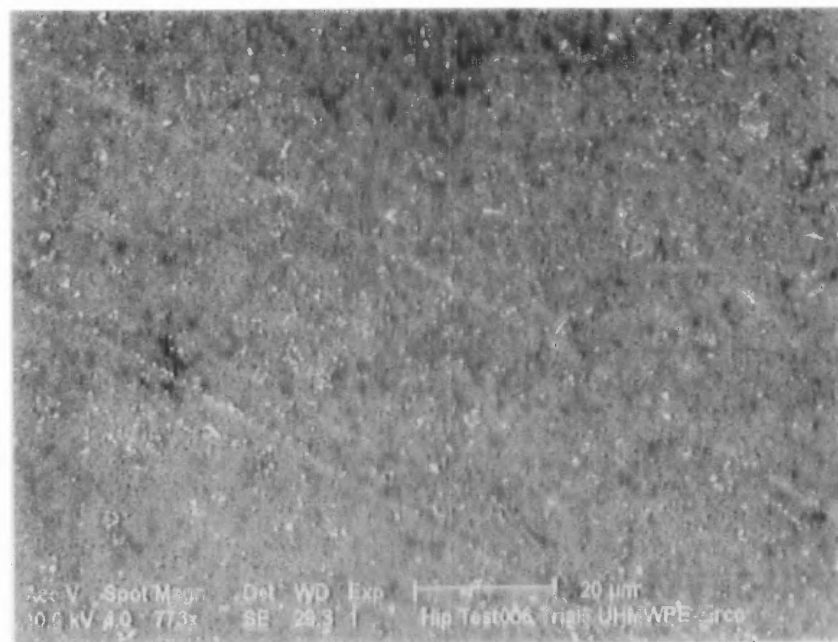
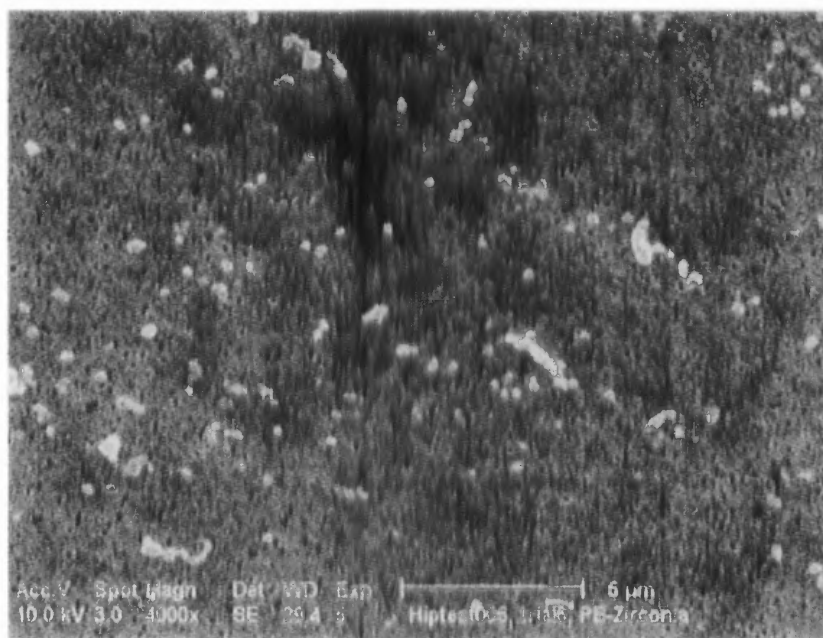
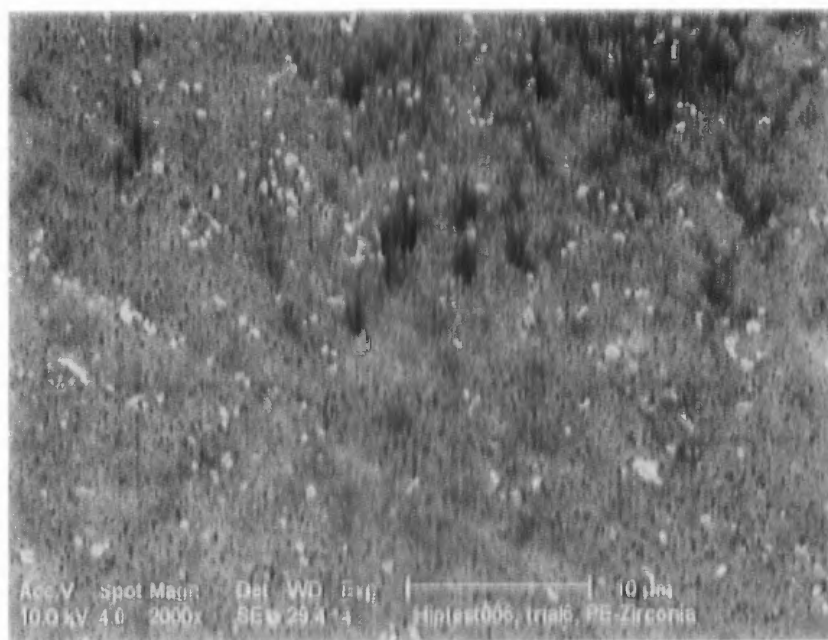
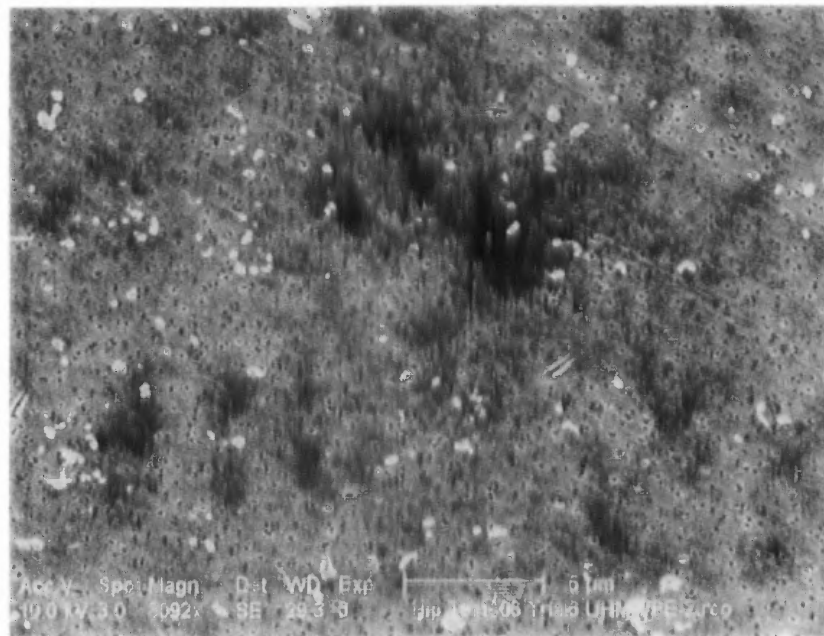
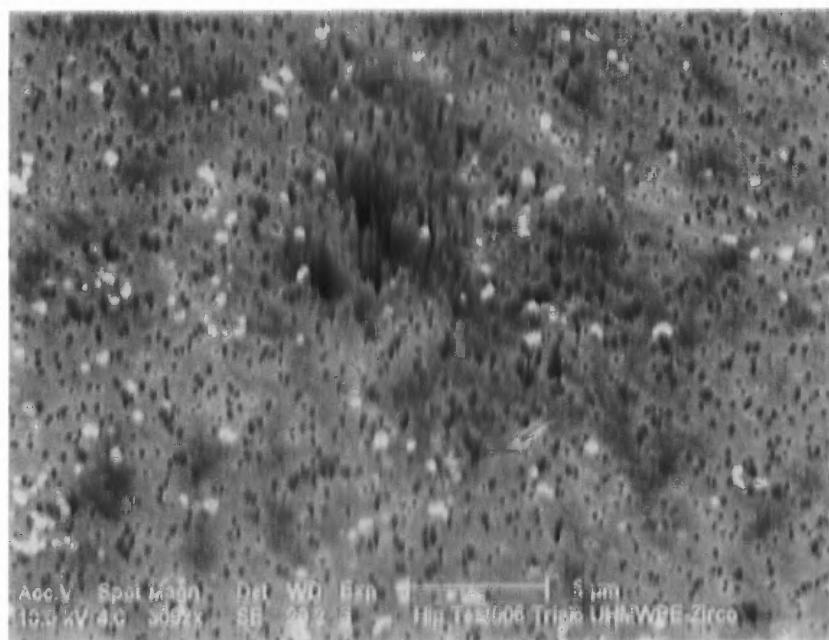
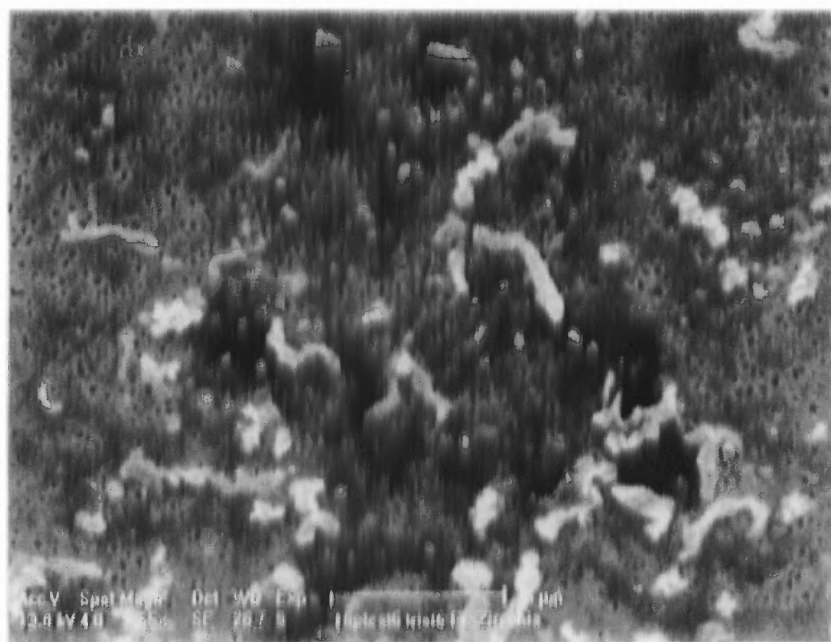
Figure 12. Micrographs of Trial 3 (Zirconia-UHMWPE) Wear Particles

trial was run on serum collected from UHMWPE-zirconia articulation and figures 12A-12M show results (see APPENDIX C). This trial was successful yielding vast numbers of particles. The two particle types already mentioned were again observed. The type 1 particles were observed to be generally smaller than $0.5\ \mu\text{m}$ in largest dimension although some slightly larger ones were noted. All were less than $1\ \mu\text{m}$ in size and many were similar in size to the $0.2\ \mu\text{m}$ pores in the filter surface. The shape of these particles was somewhat regular, displaying a generally oval or egg like shape. They could also be described as pebbles. They were generally seen to possess smooth edges. The second particles type was present as well. These were again shard like or fibrous in shape with a size range of 1 to $5\ \mu\text{m}$ in length. Width was generally less than $0.5\ \mu\text{m}$. These particles had a less regular shape when compared to the smaller ones and some were noted to be bent and slightly curled. Some necking was also noted with these particles appearing "sperm like". Some particles had the head or bulbous region noted on particles from the other trials. Some larger particles appeared to be clusters of smaller particles as well.

however. A lesser degree of clustering was observed with the Trial 3 particles as well. This clustering may have contributed to the overall larger measured size for the Trial 2 particles. The morphology appears similar.

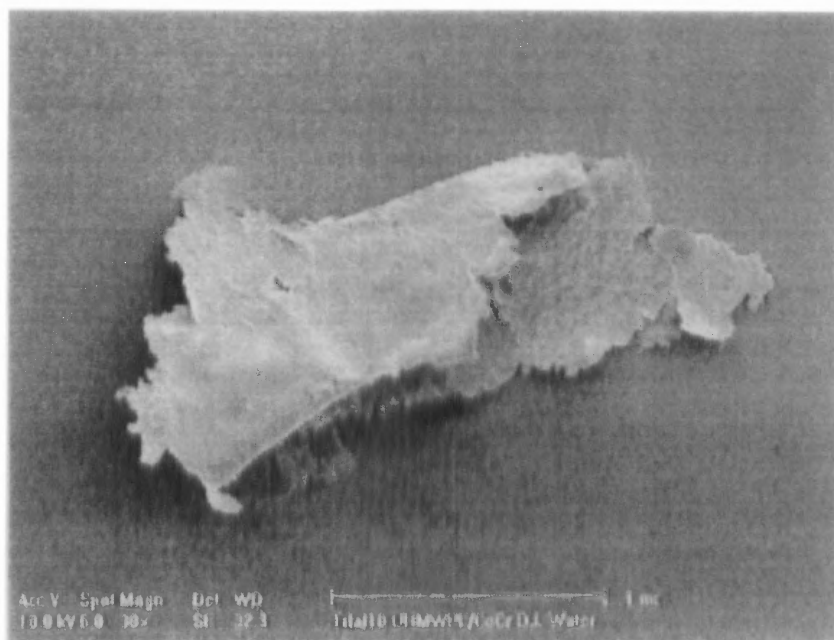
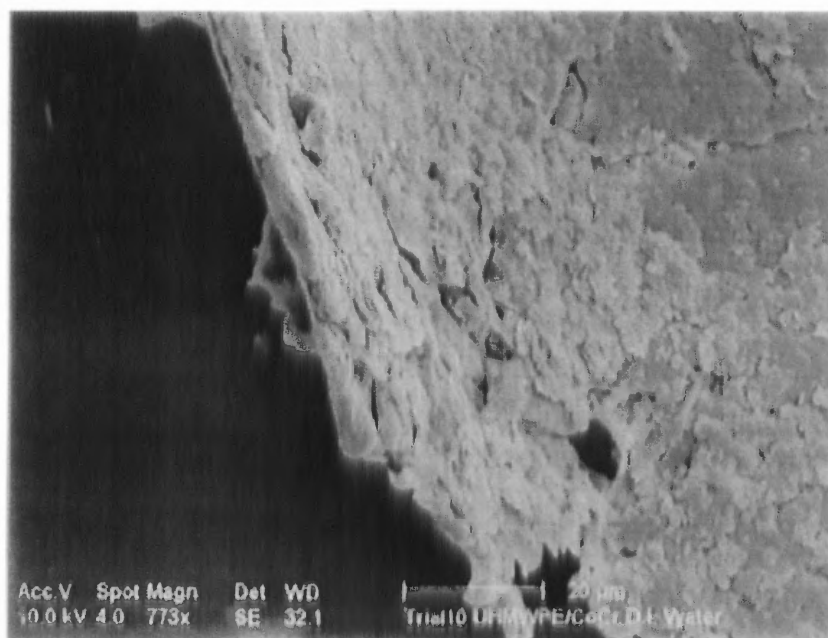
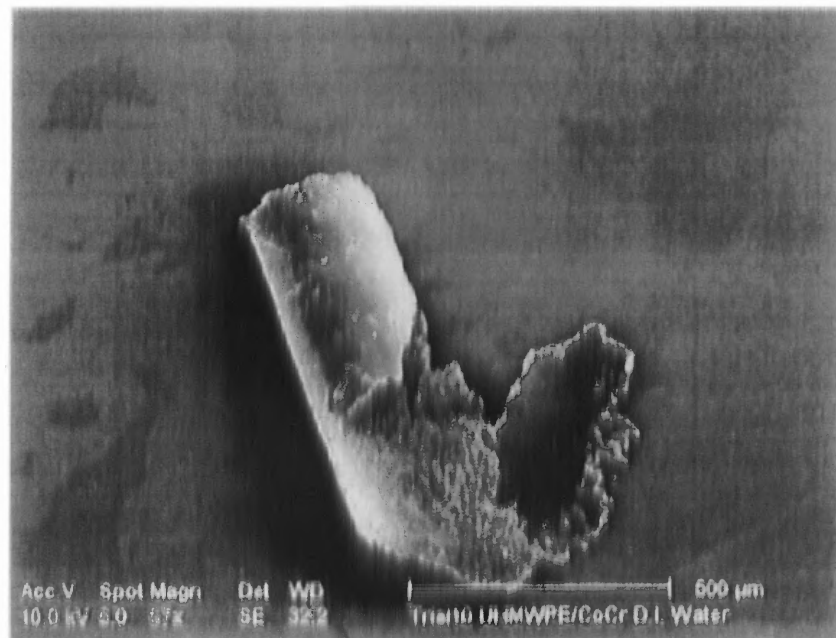
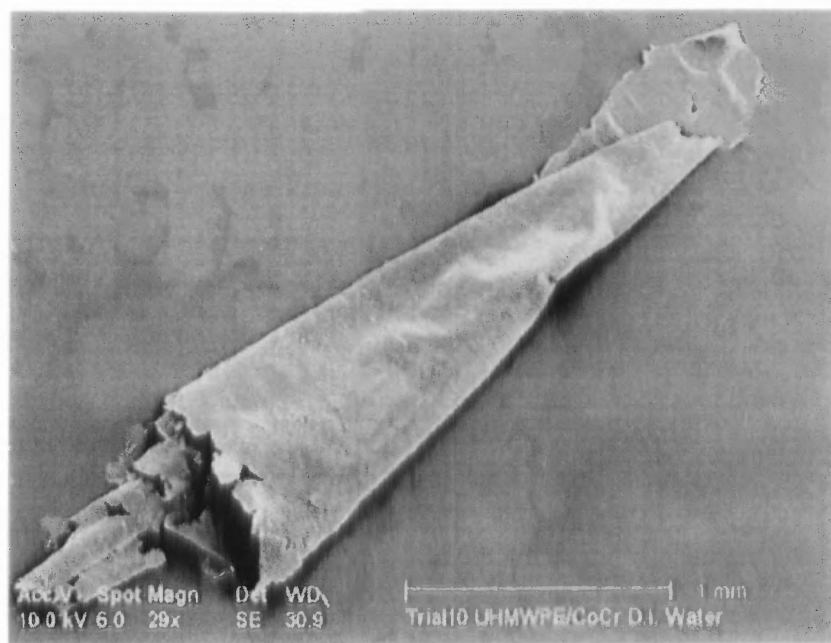
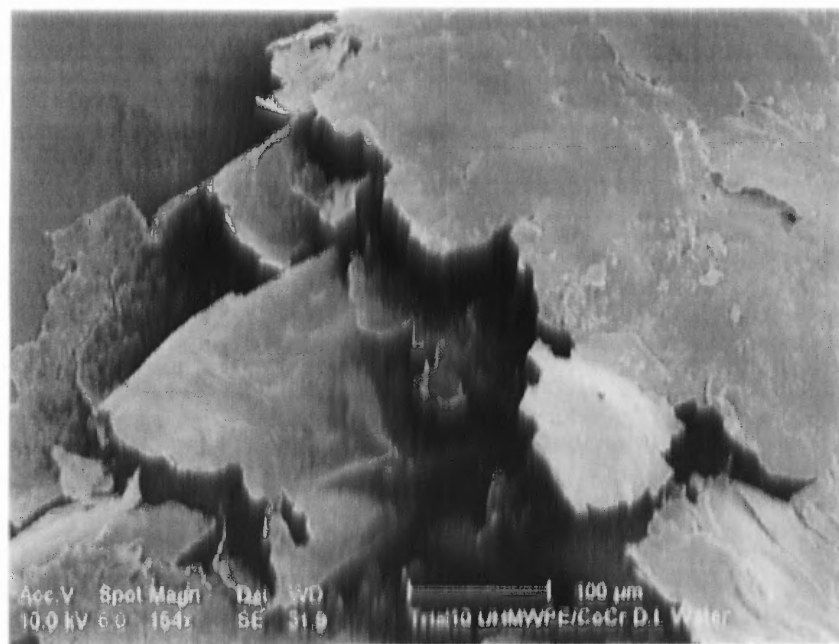
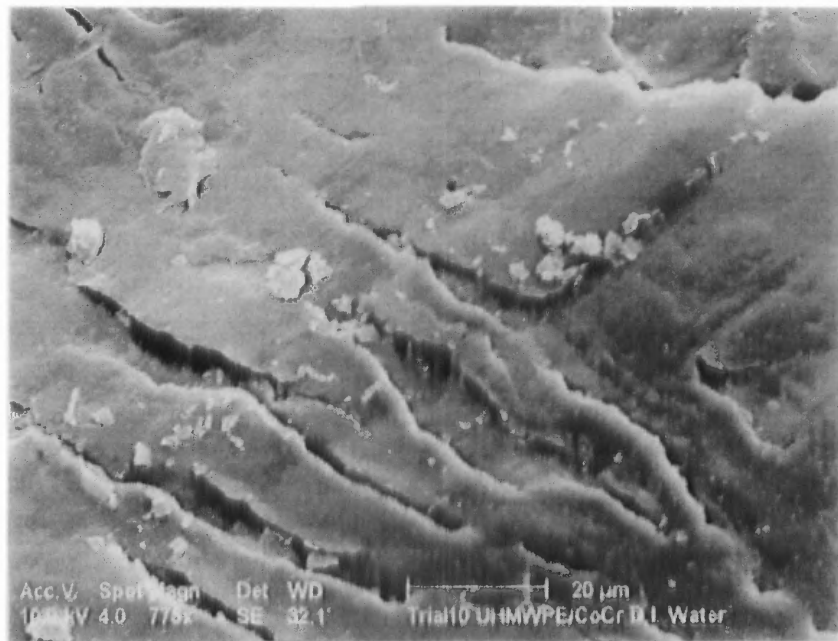
Figure 14. Micrographs of Trial 4 (CoCr-UHMWPE in D.I. Water) Wear Particles

The results for this particular trial were somewhat different than the others. During the final isopropanol centrifuging step large pieces of debris could be seen in the interlayer. The micrographs for this trial showing some of these large pieces can be found in Figures 14A-14Z (see APPENDIX D). Several large particles on the order of millimeter size were noted, ranging from 0.5 mm to 2 mm in largest dimension. These particles appear as flakes or sheets of material. Several close ups are shown in figures 14G-14J. The surfaces of these large flakes appear to have cracks and pits as well as pieces of smaller debris adhering to them. If the apparent cracks are closely examined it can be seen that the flakes appear to be comprised of many thin sheets of material pressed together. At least some portion of each large flake is rolled over on itself as well, providing an exposed edge for examination. When the edge is observed the thin layer composition is particularly apparent. As already noted these giant flakes of material were visible by unassisted eye.

A second type of particle not clearly visible was also found. When the surface of the filter was observed many smaller flake like particles were found. These smaller particles appear similar to the small particles adhering to the giant flakes. Sizes for these as shown by the scale in each micrograph are generally around 2-3 μm in largest dimension. These

smaller particles were not as prevalent as the small particles noted in the previous trials, probably due to the fact that the giant flakes would account for most of the wear experienced by the articular surface. A cluster of the small flakes up to 20 μm wide was also noted. Submicron particles were only occasionally seen and one cigar shaped shard was seen as well. An insufficient number of small particles was found to enable the same rough sizing estimate used in the other trials but based on visual observations the overall particle size for this trial was somewhat larger than the others with a probable average of about 2 μm in length. This of course excludes the giant flakes. The predominant shape was also somewhat different from all other trials consisting almost exclusively of flat flake like particles.
